Manhole Inspection Report

Date:	03/26/2018	Weather:		Coding:	RZMACP
MH#:	M-208-012	Owner:	NA	Len. Surveyed:	14.6
P.O.#:		Surveyor:	John Kuglmaier	Rim to Invert:	14.9
Customer:		Cert. #:	U-1215-07002349	Wall Material:	Concrete (reinforced)

Street:	58th Pl. East of Brookview Ct.	Project:	Hobart, IN
City:	Hobart, IN	GPS Northing:	0.0
Location:		GPS Easting:	0.0
Drain Area:	Southwest	GPS Accuracy:	Nearest Meter
Cover Shape:	Circular	Evidence of Surcharge:	Yes
Cover Size:	22.5	Potential for Runoff:	None
Comments:

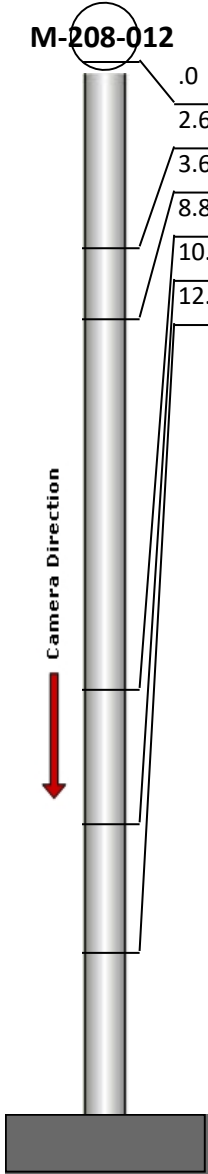
.0	MGP	General Photo	10	NA
	2.6	MGP	General Photo	29	NA
	3.6	IS	Infil Stain	45	NA
	8.8	IS	Infil Stain	67	NA
	10.7	DSF	Deposits Settled Fine	82	M 2
	12.5	MGO	General Observation	97	NA

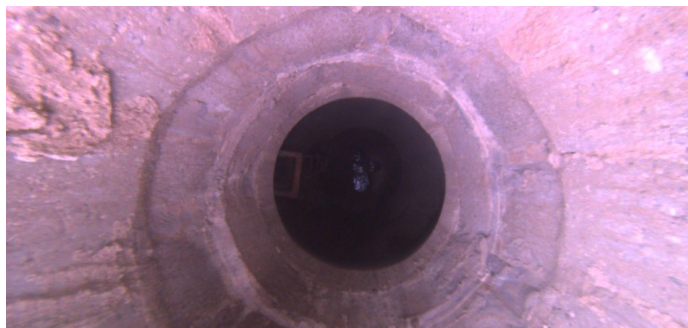
Code: **MGP**
Description: **General Photo**

Distance (ft): **.0**
Structural Grade: **0**
O&M Grade: **0**
Clock Start/From:
Clock To:
1st Value:
2nd Value:
Value Percent:
Step: **NO**
Remarks:

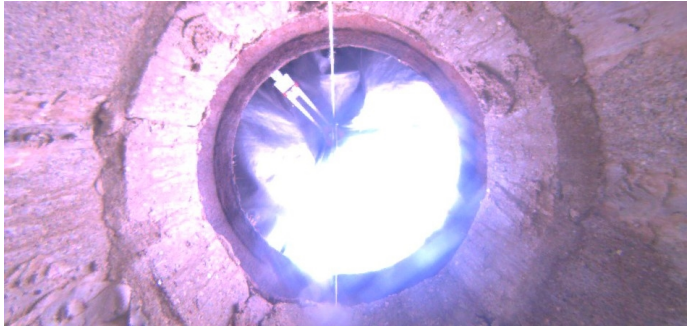
Code: **MGP**
Description: **General Photo**

Distance (ft): **2.6**
Structural Grade: **0**
O&M Grade: **0**
Clock Start/From:
Clock To:
1st Value:
2nd Value:
Value Percent:
Step: **NO**
Remarks:

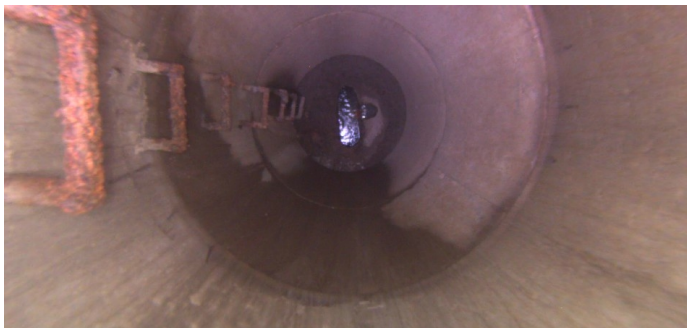
Code: **IS**
Description: **Infil Stain**

Distance (ft): **3.6**
Structural Grade: **0**
O&M Grade: **0**
Clock Start/From: **5**
Clock To: **10**
1st Value:
2nd Value:
Value Percent:
Step: **NO**
Remarks:

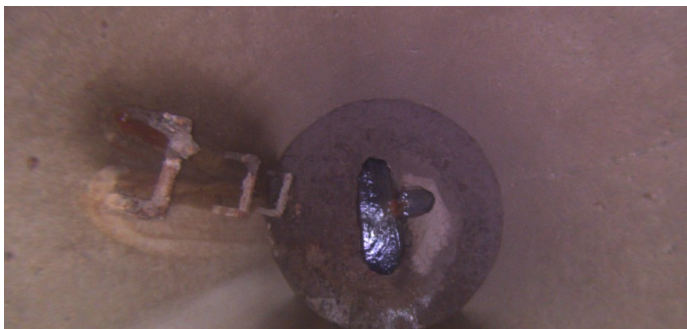
Code: **IS**
Description: **Infil Stain**

Distance (ft): **8.8**
Structural Grade: **0**
O&M Grade: **0**
Clock Start/From: **10**
Clock To:
1st Value:
2nd Value:
Value Percent:
Step: **NO**
Remarks:

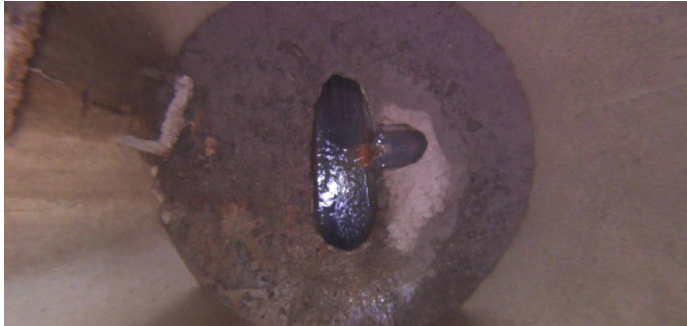
Code: **DSF**
Description: **Deposits Settled Fine**

Distance (ft): **10.7**
Structural Grade: **0**
O&M Grade: **2**
Clock Start/From: **12**
Clock To: **12**
1st Value:
2nd Value:
Value Percent: **10.000**
Step: **NO**
Remarks:

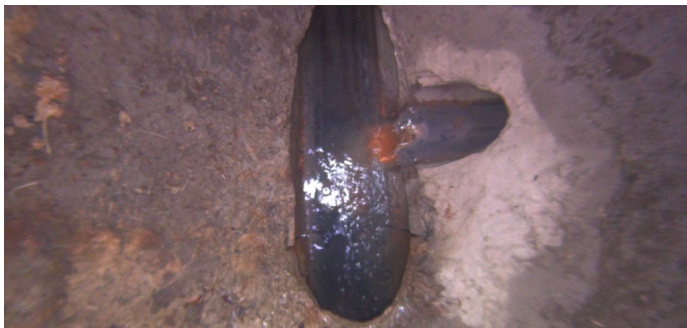
Code: **MGO**
Description: **General Observation**

Distance (ft): **12.5**
Structural Grade: **0**
O&M Grade: **0**
Clock Start/From:
Clock To:
1st Value:
2nd Value:
Value Percent:
Step: **NO**
Remarks: **Ins. Comp.**
