Manhole Inspection Report

Date:	03/26/2018	Weather:		Coding:	RZMACP
MH#:	M-208-016	Owner:	NA	Len. Surveyed:	10.5
P.O.#:		Surveyor:	John Kuglmaier	Rim to Invert:	10.6
Customer:		Cert. #:	U-1215-07002349	Wall Material:	Concrete (reinforced)

Street:	S 59th 337' W Minnesota	Project:	Hobart, IN
City:	Hobart, IN	GPS Northing:	0.0
Location:		GPS Easting:	0.0
Drain Area:	Southwest	GPS Accuracy:	Nearest Meter
Cover Shape:	Circular	Evidence of Surcharge:	No
Cover Size:	22.5	Potential for Runoff:	None
Comments:

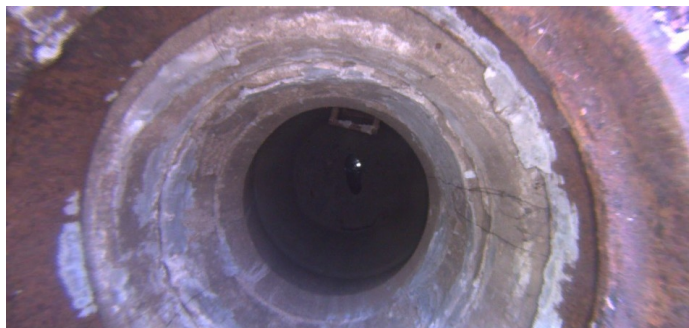
Code: **MGP**
Description: **General Photo**

Distance (ft): **.0**
Structural Grade: **0**
O&M Grade: **0**
Clock Start/From:
Clock To:
1st Value:
2nd Value:
Value Percent:
Step: **NO**
Remarks:

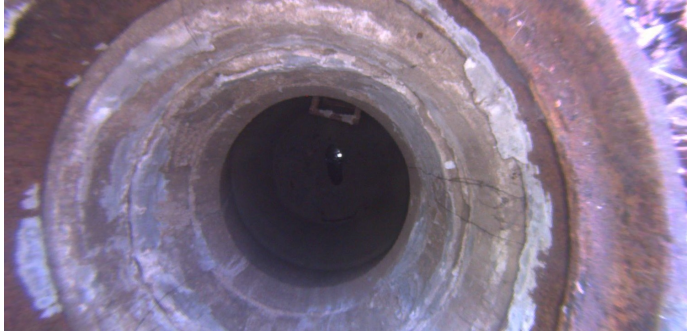
Code: **RFJ**
Description: **Roots Fine Joint**

Distance (ft): **.0**
Structural Grade: **0**
O&M Grade: **1**
Clock Start/From: **3**
Clock To: **8**
1st Value:
2nd Value:
Value Percent:
Step: **NO**
Remarks:

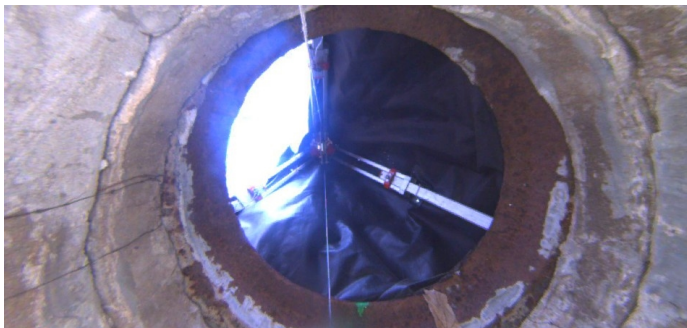
Code: **MGP**
Description: **General Photo**

Distance (ft): **2.8**
Structural Grade: **0**
O&M Grade: **0**
Clock Start/From:
Clock To:
1st Value:
2nd Value:
Value Percent:
Step: **NO**
Remarks:

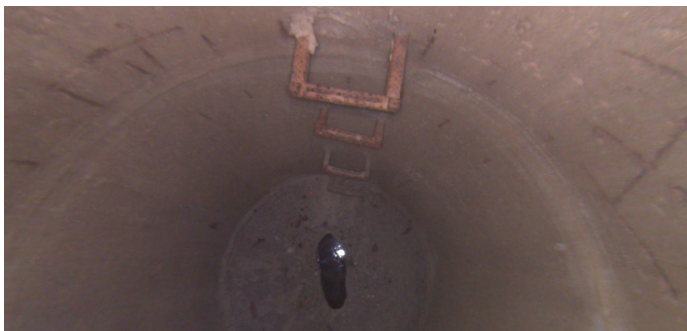
Code: **SRV**
Description: **Surface Reinforcement Visible**

Distance (ft): **4.2**
Structural Grade: **5**
O&M Grade: **0**
Clock Start/From: **9**
Clock To: **3**
1st Value:
2nd Value:
Value Percent:
Step: **NO**
Remarks:

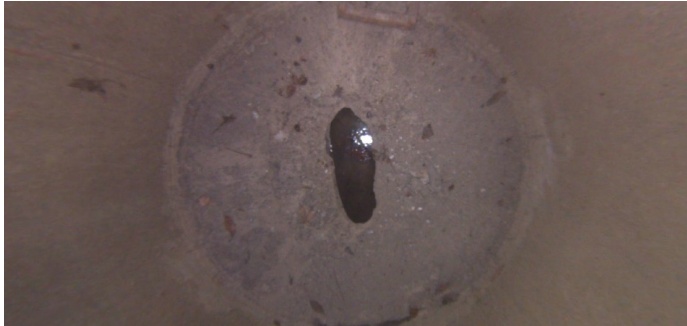
Code:	DSF
Description:	Deposits Settled Fine
Distance (ft):	7.3
Structural Grade:	0
O&M Grade:	2
Clock Start/From:	12
Clock To:	12
1st Value:	
2nd Value:	
Value Percent:	5.000
Step:	NO
Remarks:

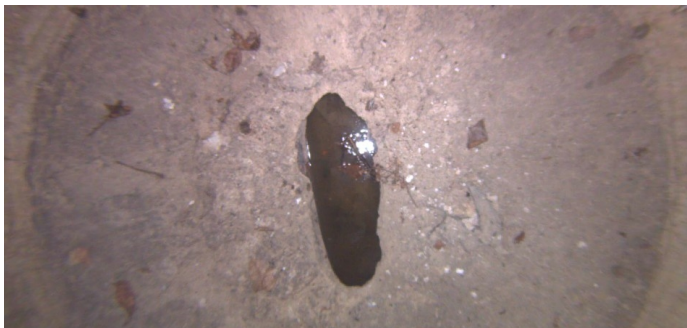
Code:	MGO
Description:	General Observation
Distance (ft):	8.8
Structural Grade:	0
O&M Grade:	0
Clock Start/From:	
Clock To:	
1st Value:	
2nd Value:	
Value Percent:	
Step:	NO
Remarks:	Ins. Comp.
