Manhole Inspection Report

Date:	03/22/2018	Weather:		Coding:	RZMACP
MH#:	M-208-023	Owner:	NA	Len. Surveyed:	6.2
P.O.#:		Surveyor:	John Kuglmaier	Rim to Invert:	8.6
Customer:		Cert. #:	U-1215-07002349	Wall Material:	Concrete (reinforced)

Street:	Liverpool Rd. 667' North of 61st Ave.	Project:	Hobart, IN
City:	Hobart, IN	GPS Northing:	0.0
Location:		GPS Easting:	0.0
Drain Area:	Southwest	GPS Accuracy:	Nearest Meter
Cover Shape:	Circular	Evidence of Surcharge:	Yes
Cover Size:	22.5	Potential for Runoff:	None
Comments:

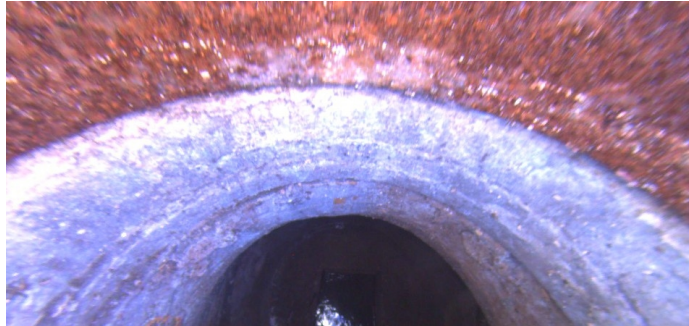
Code:	MGP
Description:	General Photo

Distance (ft):	.0
Structural Grade:	0
O&M Grade:	0
Clock Start/From:	
Clock To:	
1st Value:	
2nd Value:	
Value Percent:	
Step:	NO
Remarks:

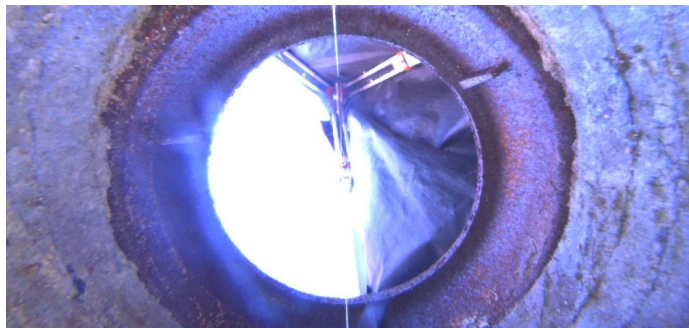
Code:	DAZ
Description:	Deposits Attached Other
Distance (ft):	.0
Structural Grade:	0
O&M Grade:	2
Clock Start/From:	12
Clock To:	12
1st Value:	
2nd Value:	
Value Percent:	5.000
Step:	NO
Remarks:	Mixed materials

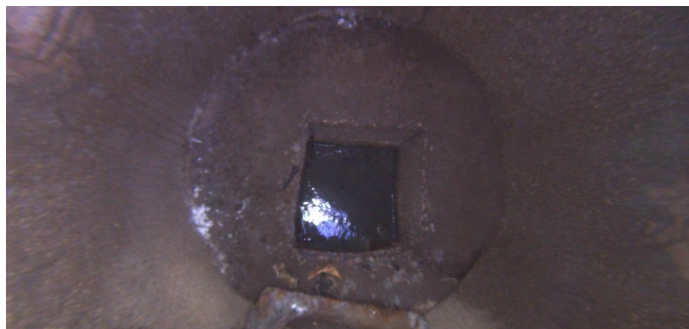
Code:	MGP
Description:	General Photo
Distance (ft):	2.2
Structural Grade:	0
O&M Grade:	0
Clock Start/From:	
Clock To:	
1st Value:	
2nd Value:	
Value Percent:	
Step:	NO
Remarks:

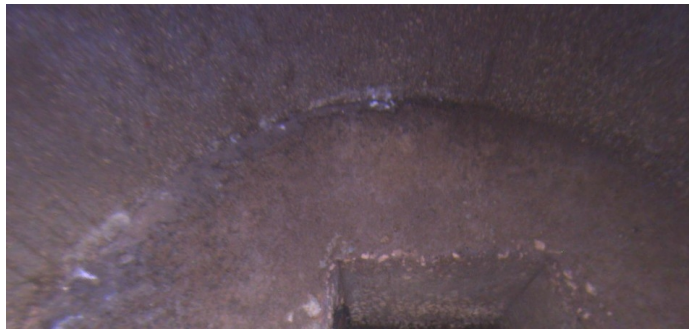
Code:	DSF
Description:	Deposits Settled Fine
Distance (ft):	4.0
Structural Grade:	0
O&M Grade:	3
Clock Start/From:	12
Clock To:	12
1st Value:	
2nd Value:	
Value Percent:	15.000
Step:	NO
Remarks:

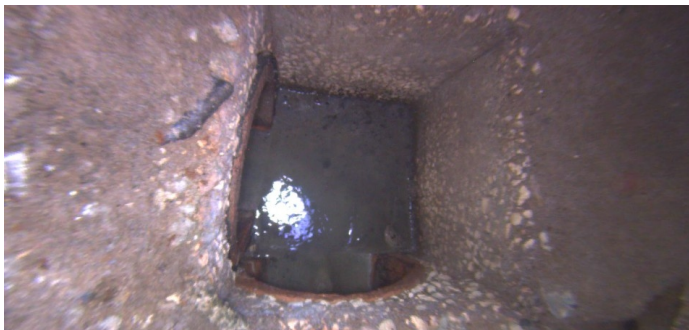
Code:	DAZ
Description:	Deposits Attached Other
Distance (ft):	5.6
Structural Grade:	0
O&M Grade:	2
Clock Start/From:	12
Clock To:	12
1st Value:	
2nd Value:	
Value Percent:	5.000
Step:	NO
Remarks:	Mixed materials
