# Manhole Inspection Report

Date:	<b>03/23/2018</b>	Weather:		Coding:	<b>RZMACP</b>
MH#:	<b>M-208-028</b>	Owner:	<b>NA</b>	Len. Surveyed:	<b>5.4</b>
P.O.#:		Surveyor:	<b>John Kuglmaier</b>	Rim to Invert:	<b>5.9</b>
Customer:		Cert. #:	<b>U-1215-07002349</b>	Wall Material:	<b>Concrete (reinforced)</b>

Street:	<b>North of 61st Ave. 267' East of Minn</b>	Project:	<b>Hobart, IN</b>
City:	<b>Hobart, IN</b>	GPS Northing:	<b>0.0</b>
Location:		GPS Easting:	<b>0.0</b>
Drain Area:	<b>Southwest</b>	GPS Accuracy:	<b>Nearest Meter</b>
Cover Shape:	<b>Circular</b>	Evidence of Surcharge:	<b>No</b>
Cover Size:	<b>22.5</b>	Potential for Runoff:	<b>None</b>
Comments:

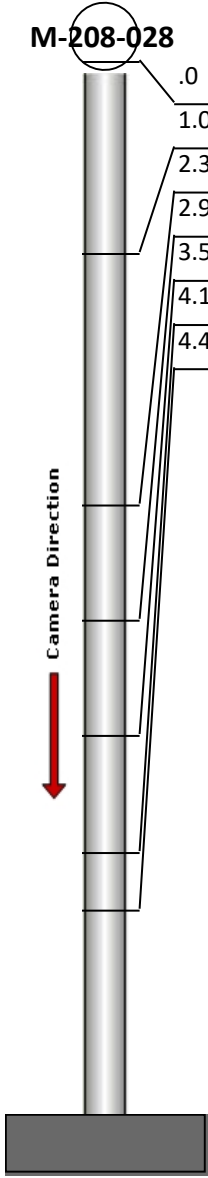
.0	MGP	General Photo	10	NA
	1.0	IS	Infil Stain	24	NA
	2.3	MGP	General Photo	40	NA
	2.9	IS	Infil Stain	55	NA
	3.5	IS	Infil Stain	68	NA
	4.1	RFC	Roots Fine Connection	80	M 1
	4.4	MGO	General Observation	93	NA

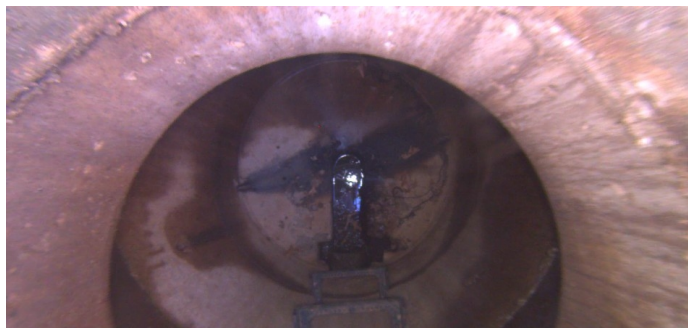
Code: **MGP**  
Description: **General Photo**

Distance (ft): **.0**  
Structural Grade: **0**  
O&M Grade: **0**  
Clock Start/From:  
Clock To:  
1st Value:  
2nd Value:  
Value Percent:  
Step: **NO**  
Remarks:

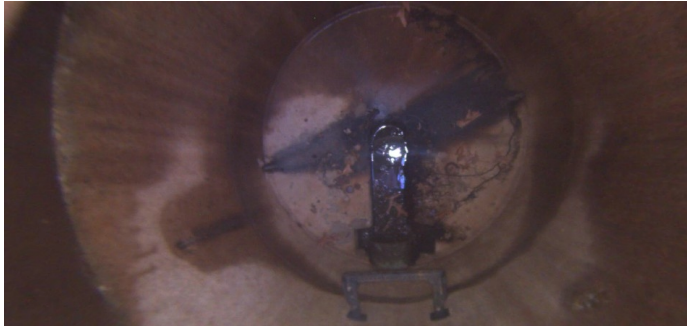
Code: **IS**  
Description: **Infil Stain**

Distance (ft): **1.0**  
Structural Grade: **0**  
O&M Grade: **0**  
Clock Start/From: **8**  
Clock To:  
1st Value:  
2nd Value:  
Value Percent:  
Step: **NO**  
Remarks:

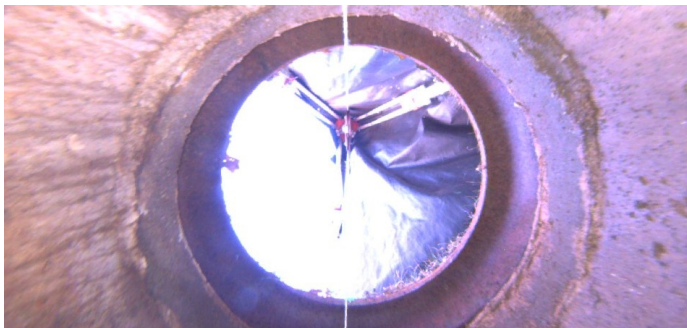
Code: **MGP**  
Description: **General Photo**

Distance (ft): **2.3**  
Structural Grade: **0**  
O&M Grade: **0**  
Clock Start/From:  
Clock To:  
1st Value:  
2nd Value:  
Value Percent:  
Step: **NO**  
Remarks:

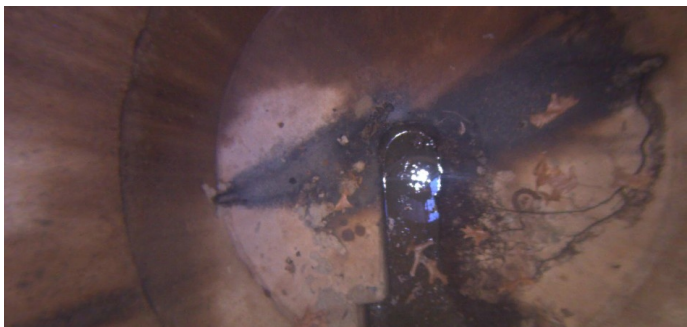
Code: **IS**  
Description: **Infil Stain**

Distance (ft): **2.9**  
Structural Grade: **0**  
O&M Grade: **0**  
Clock Start/From: **9**  
Clock To:  
1st Value:  
2nd Value:  
Value Percent:  
Step: **NO**  
Remarks:

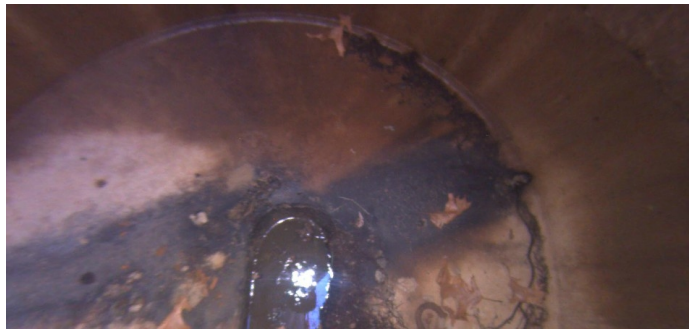
Code: **IS**  
Description: **Infil Stain**

Distance (ft): **3.5**  
Structural Grade: **0**  
O&M Grade: **0**  
Clock Start/From: **2**  
Clock To: **3**  
1st Value:  
2nd Value:  
Value Percent:  
Step: **NO**  
Remarks:

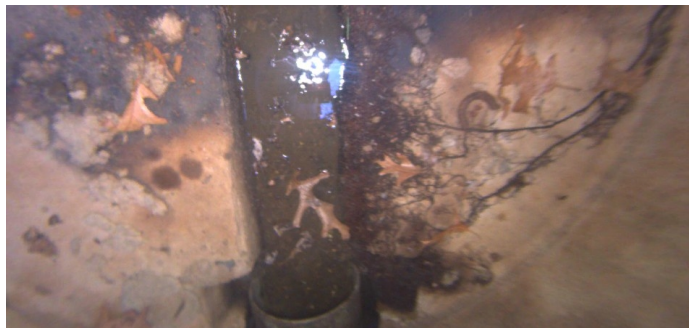
Code: **RFC**  
Description: **Roots Fine Connection**

Distance (ft): **4.1**  
Structural Grade: **0**  
O&M Grade: **1**  
Clock Start/From: **6**  
Clock To:  
1st Value:  
2nd Value:  
Value Percent:  
Step: **NO**  
Remarks:

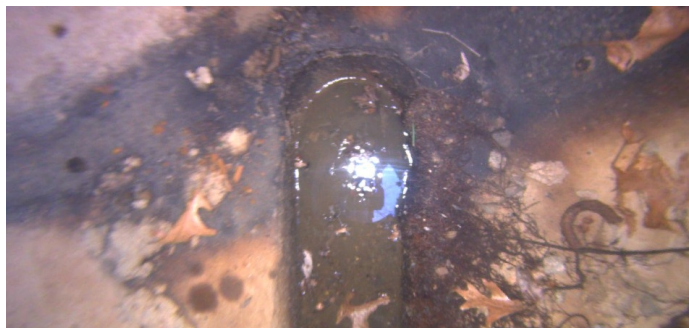
Code: **MGO**  
Description: **General Observation**

Distance (ft): **4.4**  
Structural Grade: **0**  
O&M Grade: **0**  
Clock Start/From:  
Clock To:  
1st Value:  
2nd Value:  
Value Percent:  
Step: **NO**  
Remarks: **Ins. Comp.**
