# Manhole Inspection Report

Date:	<b>03/25/2018</b>	Weather:		Coding:	<b>RZMACP</b>
MH#:	<b>M-209-001</b>	Owner:	<b>NA</b>	Len. Surveyed:	<b>4.3</b>
P.O.#:		Surveyor:	<b>John Kuglmaier</b>	Rim to Invert:	<b>4.9</b>
Customer:		Cert. #:	<b>U-1215-07002349</b>	Wall Material:	<b>Concrete (reinforced)</b>

Street:	<b>South of 61st Ln. 189' East of Orego</b>	Project:	<b>Hobart, IN</b>
City:	<b>Hobart, IN</b>	GPS Northing:	<b>0.0</b>
Location:		GPS Easting:	<b>0.0</b>
Drain Area:	<b>Southwest</b>	GPS Accuracy:	<b>Nearest Meter</b>
Cover Shape:	<b>Circular</b>	Evidence of Surcharge:	<b>No</b>
Cover Size:	<b>22.5</b>	Potential for Runoff:	<b>None</b>
Comments:

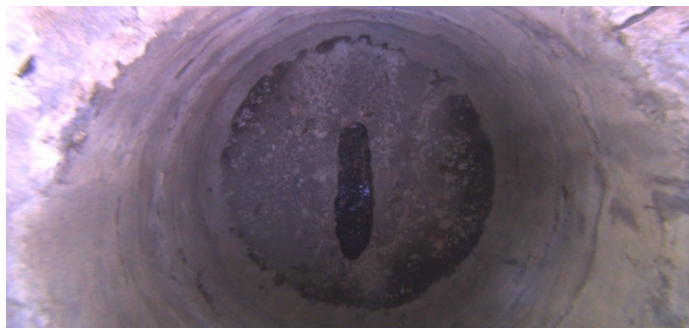
Code: **MGP**  
Description: **General Photo**

Distance (ft): **.0**  
Structural Grade: **0**  
O&M Grade: **0**  
Clock Start/From:  
Clock To:  
1st Value:  
2nd Value:  
Value Percent:  
Step: **NO**  
Remarks:

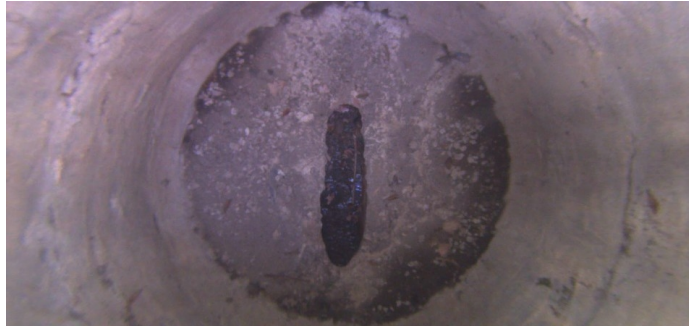
Code: **DSF**  
Description: **Deposits Settled Fine**

Distance (ft): **.8**  
Structural Grade: **0**  
O&M Grade: **2**  
Clock Start/From: **12**  
Clock To: **12**  
1st Value:  
2nd Value:  
Value Percent: **5.000**  
Step: **NO**  
Remarks:

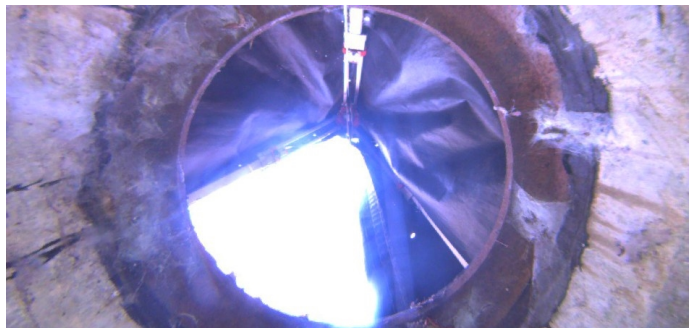
Code: **MGP**  
Description: **General Photo**

Distance (ft): **1.6**  
Structural Grade: **0**  
O&M Grade: **0**  
Clock Start/From:  
Clock To:  
1st Value:  
2nd Value:  
Value Percent:  
Step: **NO**  
Remarks:

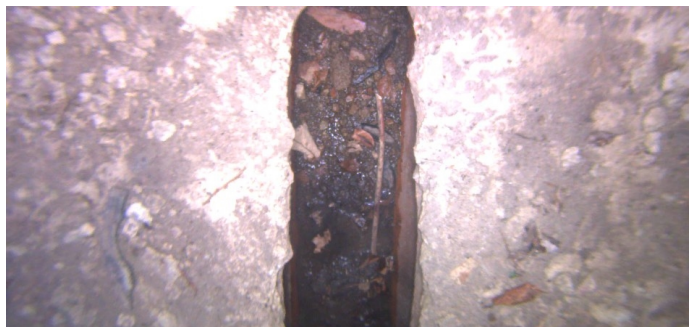
Code: **MGO**  
Description: **General Observation**

Distance (ft): **3.2**  
Structural Grade: **0**  
O&M Grade: **0**  
Clock Start/From:  
Clock To:  
1st Value:  
2nd Value:  
Value Percent:  
Step: **NO**  
Remarks: **Ins. Comp.**
