Manhole Inspection Report

Date:	03/25/2018	Weather:		Coding:	RZMACP
MH#:	M-209-002	Owner:	NA	Len. Surveyed:	7.2
P.O.#:		Surveyor:	John Kuglmaier	Rim to Invert:	8.5
Customer:		Cert. #:	U-1215-07002349	Wall Material:	Concrete (reinforced)

Street:	61st Ln. Oregon St. to the Southeast.	Project:	Hobart, IN
City:	Hobart, IN	GPS Northing:	0.0
Location:		GPS Easting:	0.0
Drain Area:	Southwest	GPS Accuracy:	Nearest Meter
Cover Shape:	Circular	Evidence of Surcharge:	No
Cover Size:	22.5	Potential for Runoff:	None
Comments:

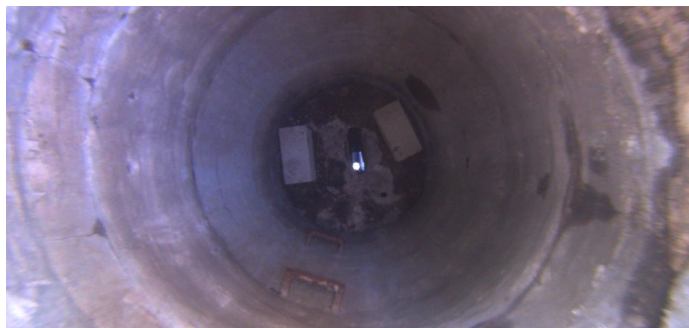
Code: **MGP**
 Description: **General Photo**

Distance (ft): **.0**
 Structural Grade: **0**
 O&M Grade: **0**
 Clock Start/From:
 Clock To:
 1st Value:
 2nd Value:
 Value Percent:
 Step: **NO**
 Remarks:

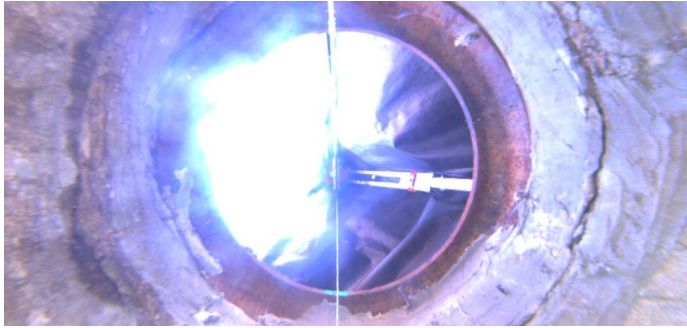
Code: **MGP**
Description: **General Photo**

Distance (ft): **2.1**
Structural Grade: **0**
O&M Grade: **0**
Clock Start/From:
Clock To:
1st Value:
2nd Value:
Value Percent:
Step: **NO**
Remarks:

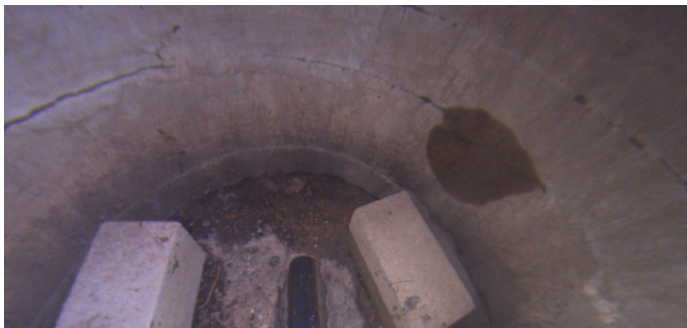
Code: **IS**
Description: **Infil Stain**

Distance (ft): **4.2**
Structural Grade: **0**
O&M Grade: **0**
Clock Start/From: **2**
Clock To:
1st Value:
2nd Value:
Value Percent:
Step: **NO**
Remarks:

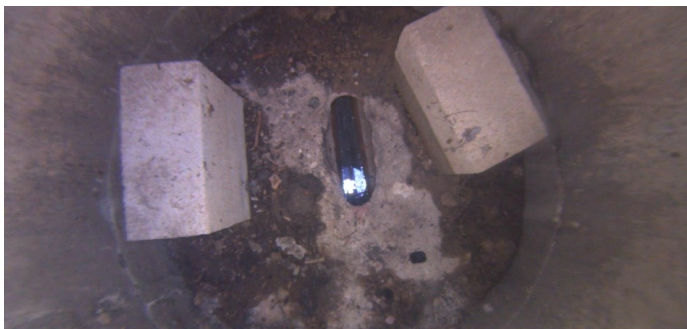
Code: **DSGV**
Description: **Deposits Settled Gravel**

Distance (ft): **4.5**
Structural Grade: **0**
O&M Grade: **2**
Clock Start/From: **12**
Clock To: **12**
1st Value:
2nd Value:
Value Percent: **5.000**
Step: **NO**
Remarks:

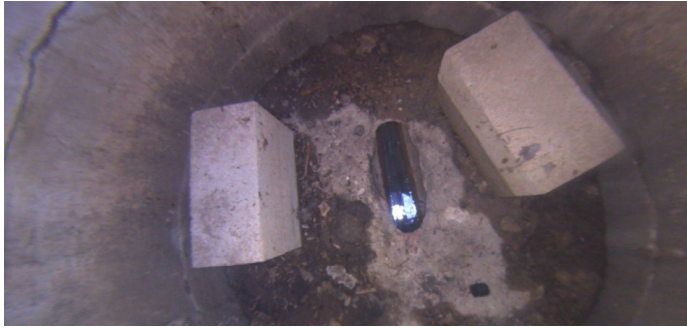
Code: **OBB**
Description: **Obstacle Brick**

Distance (ft): **4.5**
Structural Grade: **0**
O&M Grade: **2**
Clock Start/From: **8**
Clock To: **10**
1st Value:
2nd Value:
Value Percent: **10.000**
Step: **NO**
Remarks:

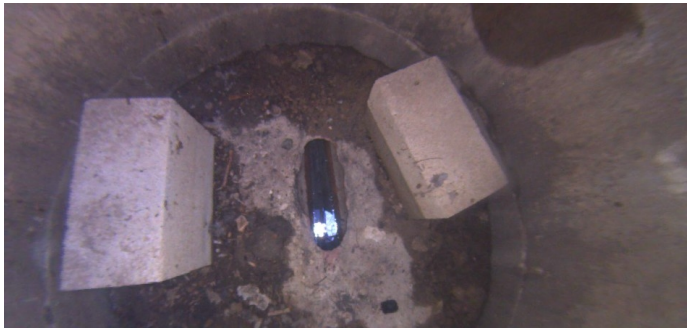
Code: **OBB**
Description: **Obstacle Brick**

Distance (ft): **4.5**
Structural Grade: **0**
O&M Grade: **2**
Clock Start/From: **2**
Clock To: **3**
1st Value:
2nd Value:
Value Percent: **10.000**
Step: **NO**
Remarks:

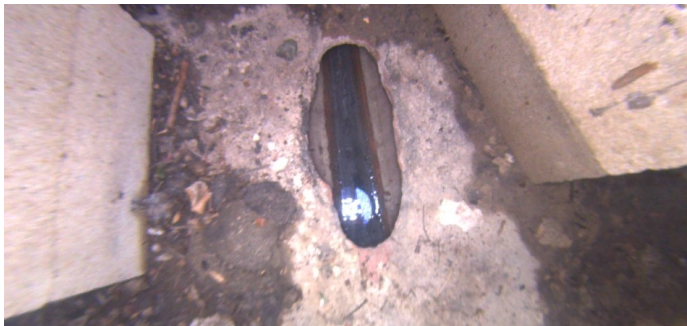
Code: **MGO**
Description: **General Observation**

Distance (ft): **6.1**
Structural Grade: **0**
O&M Grade: **0**
Clock Start/From:
Clock To:
1st Value:
2nd Value:
Value Percent:
Step: **NO**
Remarks: **Ins. Comp.**
