# Manhole Inspection Report

Date:	03/25/2018	Weather:		Coding:	RZMACP
MH#:	M-209-005	Owner:	NA	Len. Surveyed:	4.8
P.O.#:		Surveyor:	John Kuglmaier	Rim to Invert:	5.6
Customer:		Cert. #:	U-1215-07002349	Wall Material:	Concrete (reinforced)

Street:	62nd Pl. 87' East of Minnesota St.	Project:	Hobart, IN
City:	Hobart, IN	GPS Northing:	0.0
Location:		GPS Easting:	0.0
Drain Area:	Southwest	GPS Accuracy:	Nearest Meter
Cover Shape:	Circular	Evidence of Surcharge:	Yes
Cover Size:	22.5	Potential for Runoff:	None
Comments:

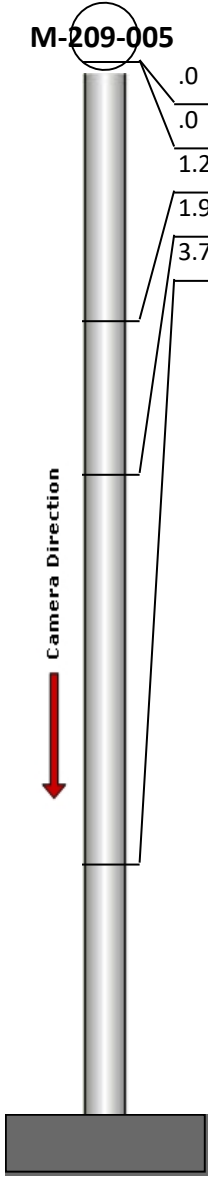
.0	MGP	General Photo	10	NA
	.0	FM	Fracture Multiple	22	S 4
	1.2	DAZ	Deposits Attached Other	36	M 3
	1.9	MGP	General Photo	51	NA
	3.7	MGO	General Observation	68	NA

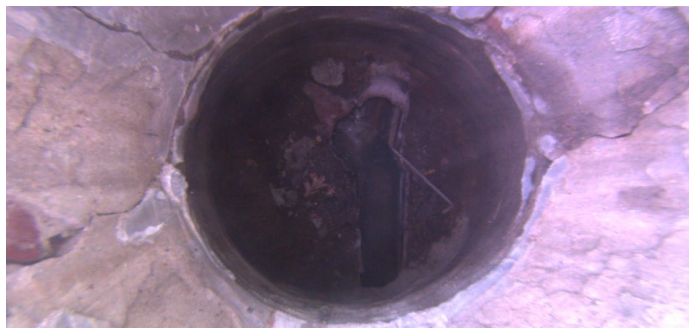
Code: **MGP**  
Description: **General Photo**

Distance (ft): **.0**  
Structural Grade: **0**  
O&M Grade: **0**  
Clock Start/From:  
Clock To:  
1st Value:  
2nd Value:  
Value Percent:  
Step: **NO**  
Remarks:

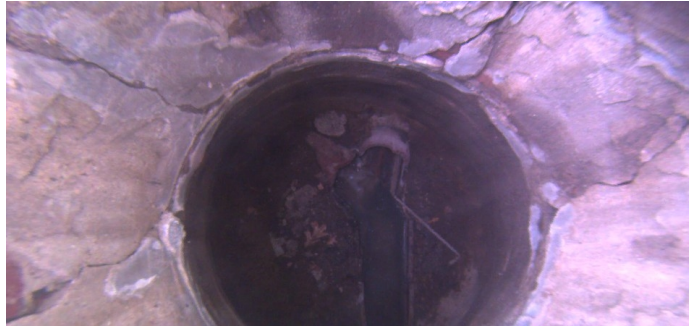
Code: **FM**  
Description: **Fracture Multiple**

Distance (ft): **.0**  
Structural Grade: **4**  
O&M Grade: **0**  
Clock Start/From: **8**  
Clock To: **3**  
1st Value:  
2nd Value:  
Value Percent:  
Step: **NO**  
Remarks:

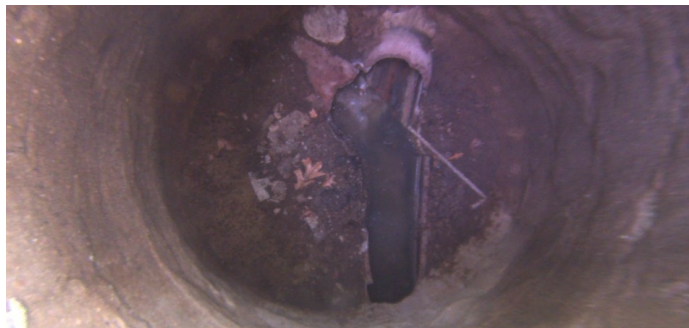
Code: **DAZ**  
Description: **Deposits Attached Other**

Distance (ft): **1.2**  
Structural Grade: **0**  
O&M Grade: **3**  
Clock Start/From: **12**  
Clock To: **12**  
1st Value:  
2nd Value:  
Value Percent: **15.000**  
Step: **NO**  
Remarks: **Mixed materials**

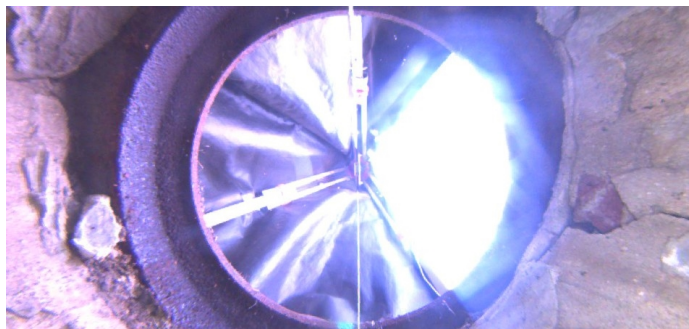
Code: **MGP**  
Description: **General Photo**

Distance (ft): **1.9**  
Structural Grade: **0**  
O&M Grade: **0**  
Clock Start/From:  
Clock To:  
1st Value:  
2nd Value:  
Value Percent:  
Step: **NO**  
Remarks:

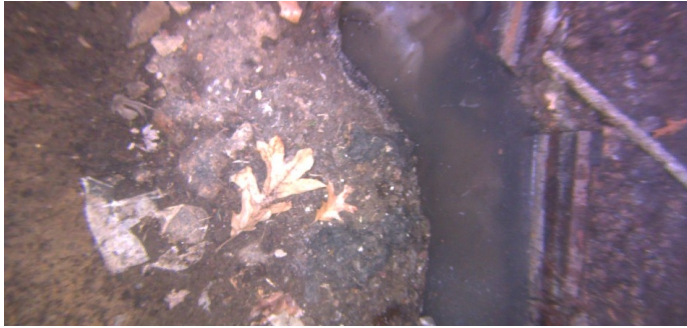
Code:	<b>MGO</b>
Description:	<b>General Observation</b>
Distance (ft):	<b>3.7</b>
Structural Grade:	<b>0</b>
O&M Grade:	<b>0</b>
Clock Start/From:	
Clock To:	
1st Value:	
2nd Value:	
Value Percent:	
Step:	<b>NO</b>
Remarks:	<b>Ins. Comp.</b>
