Manhole Inspection Report

Date:	03/24/2018	Weather:		Coding:	RZMACP
MH#:	M-209-016	Owner:	NA	Len. Surveyed:	4.6
P.O.#:		Surveyor:	John Kuglmaier	Rim to Invert:	6.8
Customer:		Cert. #:	U-1215-07002349	Wall Material:	Concrete (reinforced)

Street:	62nd Pl. California St. to the Southw	Project:	Hobart, IN
City:	Hobart, IN	GPS Northing:	0.0
Location:		GPS Easting:	0.0
Drain Area:	Southwest	GPS Accuracy:	Nearest Meter
Cover Shape:	Circular	Evidence of Surcharge:	Yes
Cover Size:	22.5	Potential for Runoff:	None
Comments:

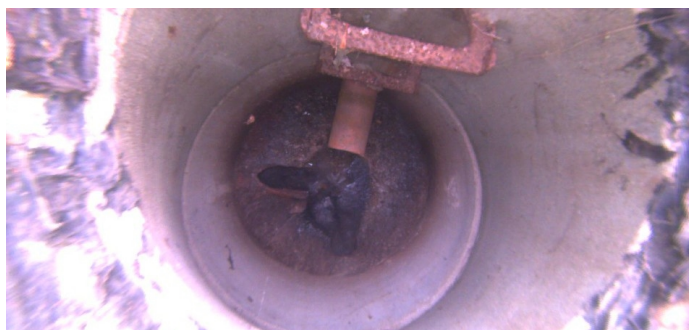
Code: **MGP**
Description: **General Photo**

Distance (ft): **.0**
Structural Grade: **0**
O&M Grade: **0**
Clock Start/From:
Clock To:
1st Value:
2nd Value:
Value Percent:
Step: **NO**
Remarks:

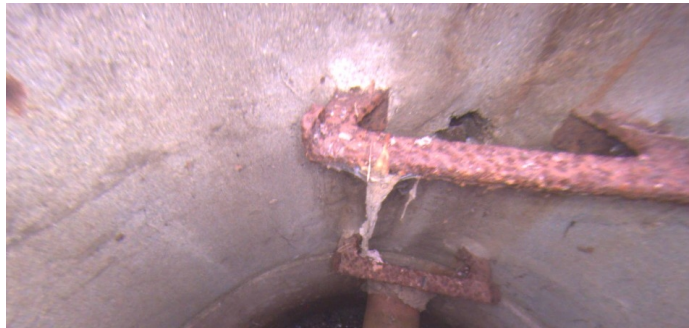
Code: **HSV**
Description: **Hole Soil Visible**

Distance (ft): **1.1**
Structural Grade: **5**
O&M Grade: **0**
Clock Start/From: **1**
Clock To:
1st Value:
2nd Value:
Value Percent:
Step: **NO**
Remarks:

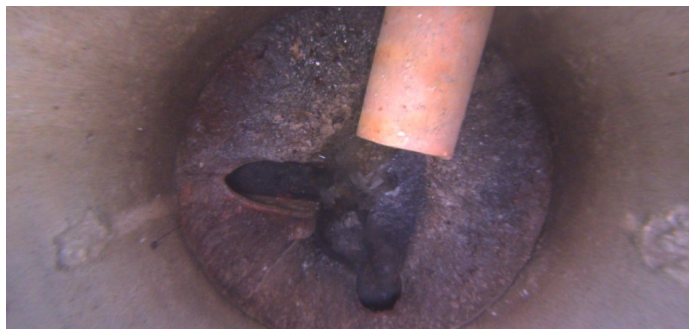
Code: **DAZ**
Description: **Deposits Attached Other**

Distance (ft): **3.1**
Structural Grade: **0**
O&M Grade: **2**
Clock Start/From: **12**
Clock To: **12**
1st Value:
2nd Value:
Value Percent: **10.000**
Step: **NO**
Remarks: **Mixed materials**

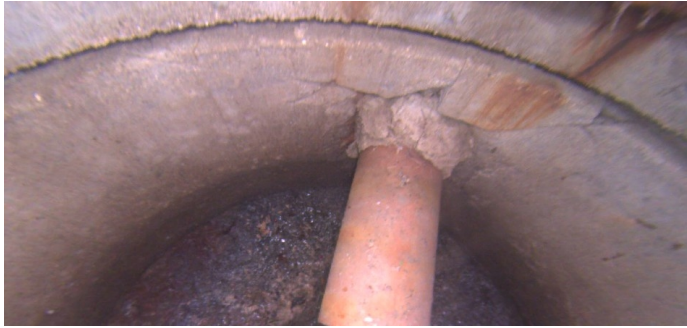
Code: **FM**
Description: **Fracture Multiple**

Distance (ft): **3.1**
Structural Grade: **4**
O&M Grade: **0**
Clock Start/From: **11**
Clock To: **1**
1st Value:
2nd Value:
Value Percent:
Step: **NO**
Remarks:

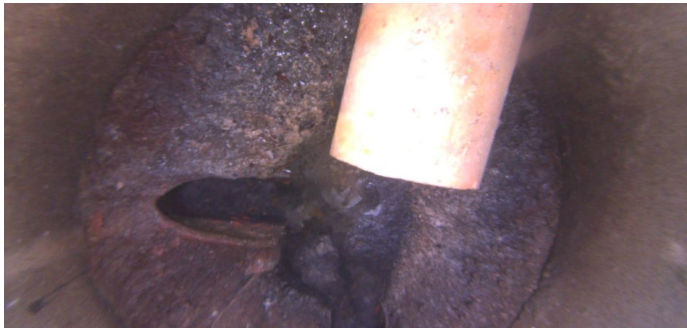
Code: **MGO**
Description: **General Observation**

Distance (ft): **3.8**
Structural Grade: **0**
O&M Grade: **0**
Clock Start/From:
Clock To:
1st Value:
2nd Value:
Value Percent:
Step: **NO**
Remarks: **Ins. Comp.**
