Manhole Inspection Report

Date:	03/25/2018	Weather:		Coding:	RZMACP
MH#:	M-209-022	Owner:	NA	Len. Surveyed:	10.7
P.O.#:		Surveyor:	John Kuglmaier	Rim to Invert:	11.0
Customer:		Cert. #:	U-1215-07002349	Wall Material:	Concrete (reinforced)

Street:	North of 62nd Pl. 141' West of Wisc	Project:	Hobart, IN
City:	Hobart, IN	GPS Northing:	0.0
Location:		GPS Easting:	0.0
Drain Area:	Southwest	GPS Accuracy:	Nearest Meter
Cover Shape:	Circular	Evidence of Surcharge:	Yes
Cover Size:	22.5	Potential for Runoff:	None
Comments:

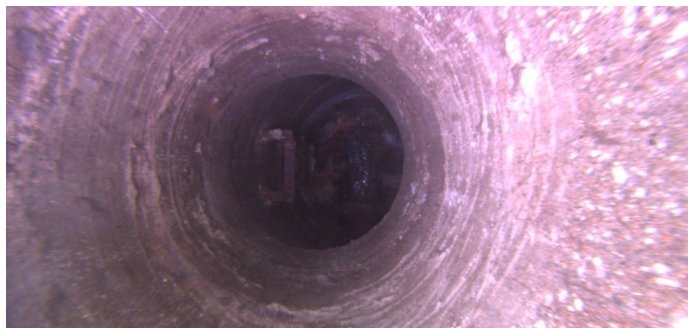
Code: **MGP**
Description: **General Photo**

Distance (ft): **.0**
Structural Grade: **0**
O&M Grade: **0**
Clock Start/From:
Clock To:
1st Value:
2nd Value:
Value Percent:
Step: **NO**
Remarks:

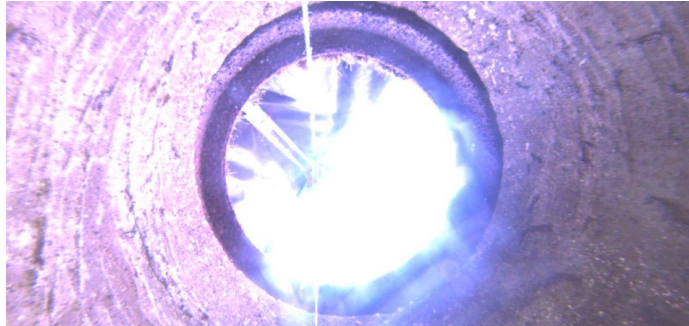
Code: **MGP**
Description: **General Photo**

Distance (ft): **2.6**
Structural Grade: **0**
O&M Grade: **0**
Clock Start/From:
Clock To:
1st Value:
2nd Value:
Value Percent:
Step: **NO**
Remarks:

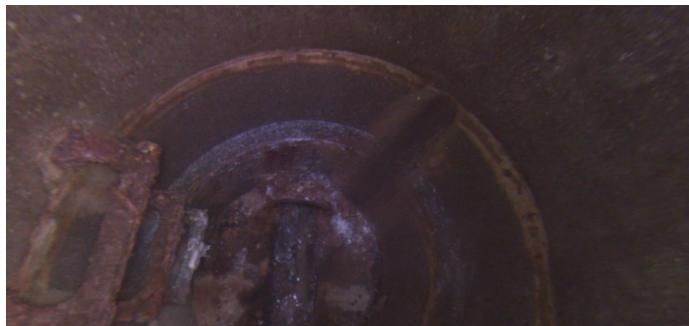
Code: **IS**
Description: **Infil Stain**

Distance (ft): **4.0**
Structural Grade: **0**
O&M Grade: **0**
Clock Start/From: **2**
Clock To:
1st Value:
2nd Value:
Value Percent:
Step: **NO**
Remarks:

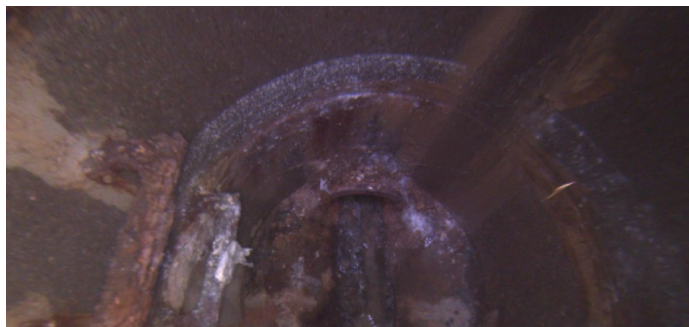
Code: **IS**
Description: **Infil Stain**

Distance (ft): **5.6**
Structural Grade: **0**
O&M Grade: **0**
Clock Start/From: **11**
Clock To:
1st Value:
2nd Value:
Value Percent:
Step: **NO**
Remarks:

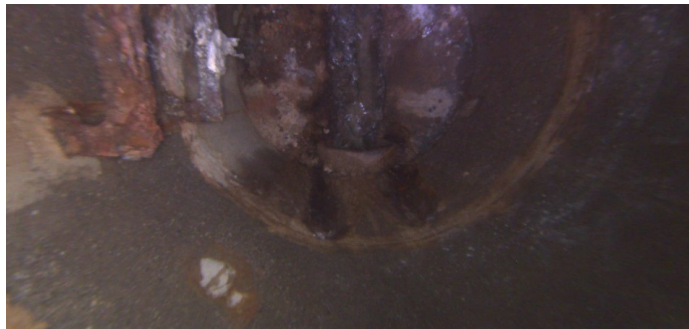
Code: **IS**
Description: **Infil Stain**

Distance (ft): **5.6**
Structural Grade: **0**
O&M Grade: **0**
Clock Start/From: **5**
Clock To: **7**
1st Value:
2nd Value:
Value Percent:
Step: **NO**
Remarks:

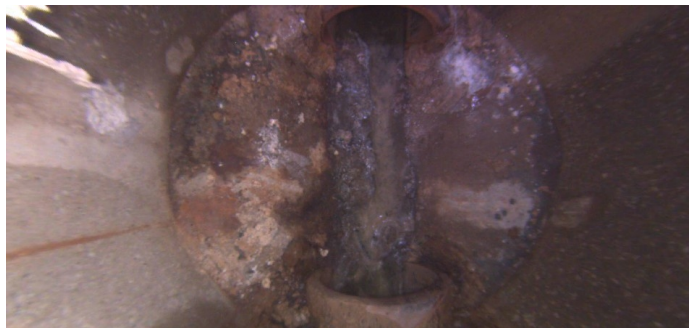
Code: **DAZ**
Description: **Deposits Attached Other**

Distance (ft): **7.8**
Structural Grade: **0**
O&M Grade: **2**
Clock Start/From: **12**
Clock To: **12**
1st Value:
2nd Value:
Value Percent: **5.000**
Step: **NO**
Remarks: **Mixed materials**

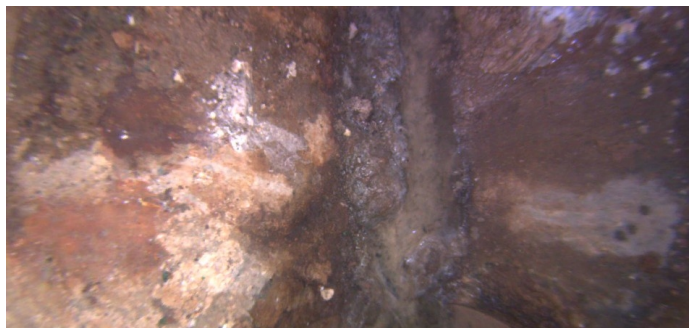
Code: **MGO**
Description: **General Observation**

Distance (ft): **9.0**
Structural Grade: **0**
O&M Grade: **0**
Clock Start/From:
Clock To:
1st Value:
2nd Value:
Value Percent:
Step: **NO**
Remarks: **Ins. Comp.**
