Manhole Inspection Report

Date:	04/12/2018	Weather:		Coding:	RZMACP
MH#:	M-303-004	Owner:	NA	Len. Surveyed:	5.6
P.O.#:		Surveyor:	John Kuglmaier	Rim to Invert:	6.6
Customer:		Cert. #:	U-1215-07002349	Wall Material:	Concrete (reinforced)

Street:	Ridgelawn St. and Ridge Road to the	Project:	Hobart, IN
City:	Hobart, IN	GPS Northing:	2895389.204
Location:		GPS Easting:	2895389.204
Drain Area:	Northwest	GPS Accuracy:	Sub-Meter
Cover Shape:	Circular	Evidence of Surcharge:	Yes
Cover Size:	23.0	Potential for Runoff:	None
Comments:

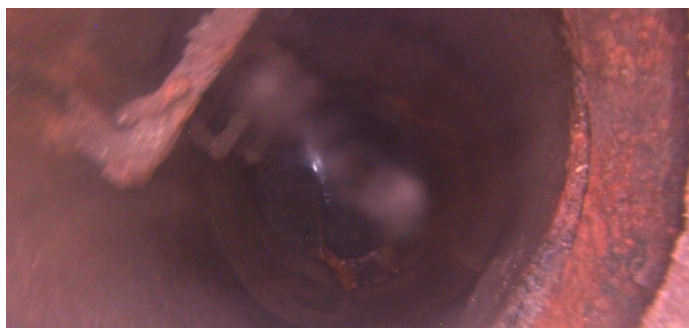
Code: **MGP**
Description: **General Photo**

Distance (ft): **.0**
Structural Grade: **0**
O&M Grade: **0**
Clock Start/From:
Clock To:
1st Value:
2nd Value:
Value Percent:
Step: **NO**
Remarks:

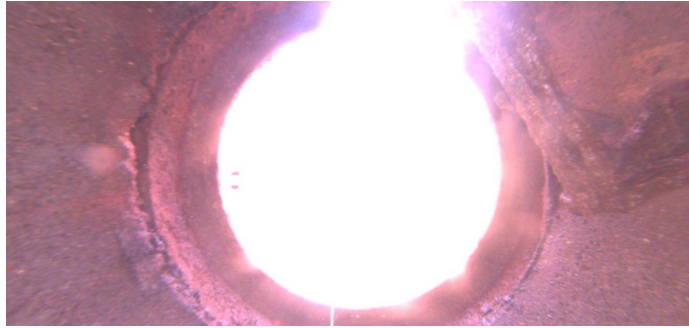
Code:	MGP
Description:	General Photo
Distance (ft):	2.2
Structural Grade:	0
O&M Grade:	0
Clock Start/From:	
Clock To:	
1st Value:	
2nd Value:	
Value Percent:	
Step:	NO
Remarks:

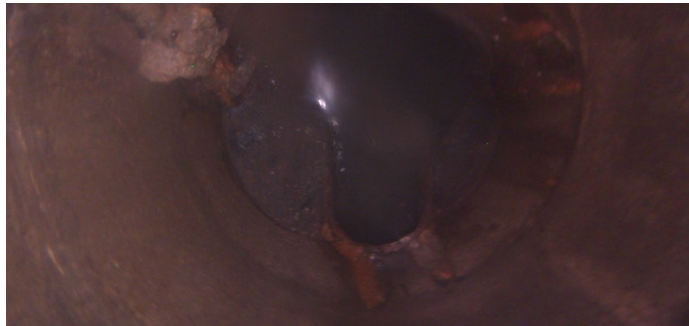
Code:	IS
Description:	Infil Stain
Distance (ft):	2.4
Structural Grade:	0
O&M Grade:	0
Clock Start/From:	5
Clock To:	6
1st Value:	
2nd Value:	
Value Percent:	
Step:	NO
Remarks:

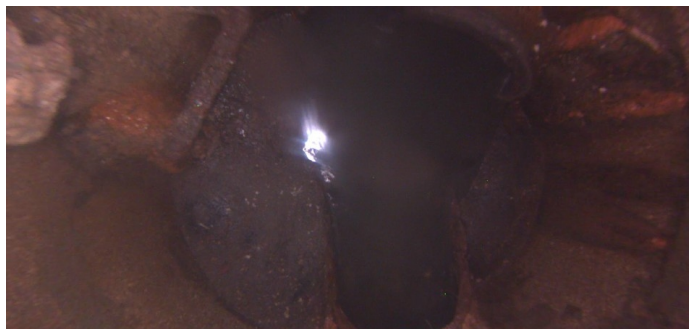
Code:	DSF
Description:	Deposits Settled Fine
Distance (ft):	3.3
Structural Grade:	0
O&M Grade:	2
Clock Start/From:	12
Clock To:	12
1st Value:	
2nd Value:	
Value Percent:	5.000
Step:	NO
Remarks:

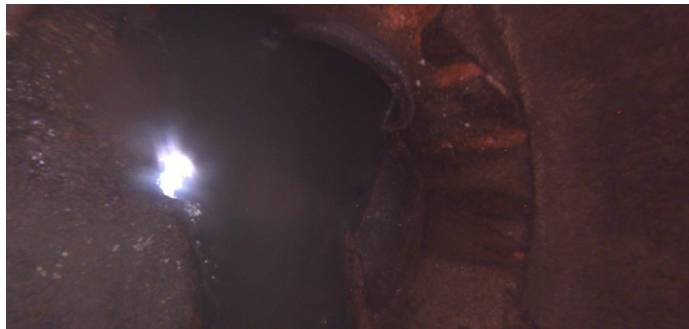
Code: **IS**
Description: **Infil Stain**

Distance (ft): **3.7**
Structural Grade: **0**
O&M Grade: **0**
Clock Start/From: **3**
Clock To: **4**
1st Value:
2nd Value:
Value Percent:
Step: **NO**
Remarks:

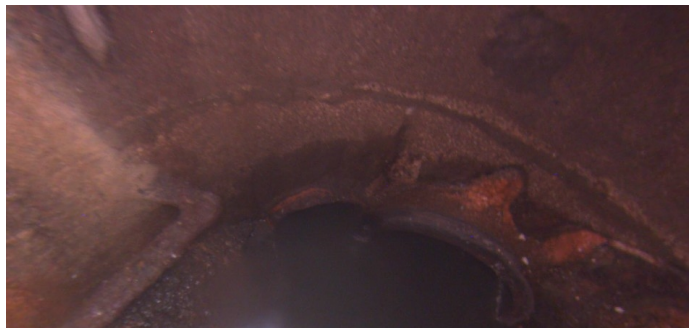
Code: **IS**
Description: **Infil Stain**

Distance (ft): **3.7**
Structural Grade: **0**
O&M Grade: **0**
Clock Start/From: **1**
Clock To: **2**
1st Value:
2nd Value:
Value Percent:
Step: **NO**
Remarks:

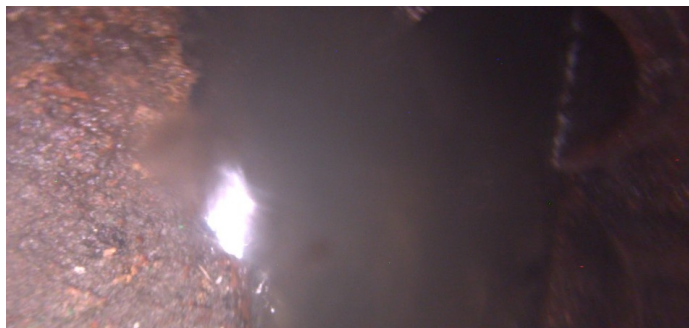
Code: **MGO**
Description: **General Observation**

Distance (ft): **5.1**
Structural Grade: **0**
O&M Grade: **0**
Clock Start/From:
Clock To:
1st Value:
2nd Value:
Value Percent:
Step: **NO**
Remarks: **Ins. Comp.**
