Manhole Inspection Report

Date:	05/16/2018	Weather:		Coding:	RZMACP
MH#:	M-303-005	Owner:	NA	Len. Surveyed:	6.0
P.O.#:		Surveyor:	Jen Costello	Rim to Invert:	5.8
Customer:		Cert. #:	U-907-5518	Wall Material:	Concrete (reinforced)

Street:	Id Ridge Rd. and 39th Ave. 156' East	Project:	Hobart, IN
City:	Hobart, IN	GPS Northing:	41.54634094
Location:		GPS Easting:	-87.29341125
Drain Area:	Northwest	GPS Accuracy:	Nearest Meter
Cover Shape:	Circular	Evidence of Surcharge:	No
Cover Size:	22.5	Potential for Runoff:	None
Comments:

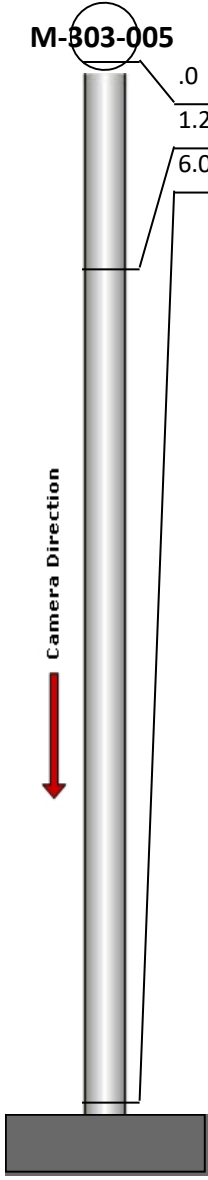
Position	Code	Observation	Video (sec)	Grade

.0	MGO	General Observation	10	NA
	1.2	IW	Infil Weeper	24	M 2
	6.0	MGO	General Observation	46	NA

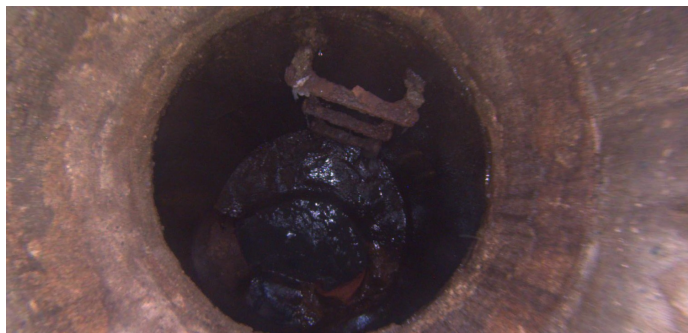
Code: **MGO**
Description: **General Observation**

Distance (ft): **.0**
Structural Grade: **0**
O&M Grade: **0**
Clock Start/From:
Clock To:
1st Value:
2nd Value:
Value Percent:
Step: **NO**
Remarks: **ACCESS MH**

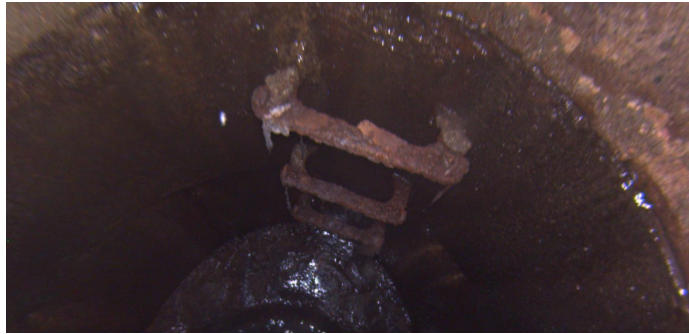
Code: **IW**
Description: **Infil Weeper**

Distance (ft): **1.2**
Structural Grade: **0**
O&M Grade: **2**
Clock Start/From: **12**
Clock To: **12**
1st Value:
2nd Value:
Value Percent:
Step: **NO**
Remarks:

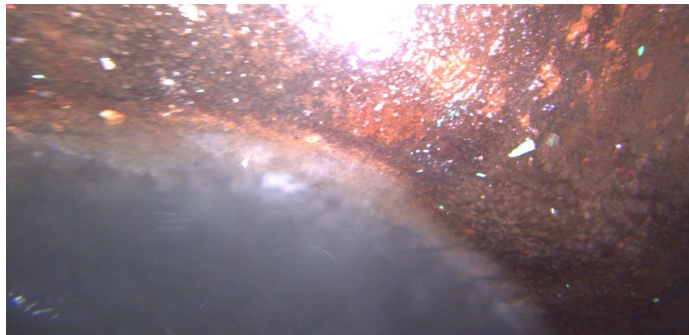
Code: **MGO**
Description: **General Observation**

Distance (ft): **6.0**
Structural Grade: **0**
O&M Grade: **0**
Clock Start/From:
Clock To:
1st Value:
2nd Value:
Value Percent:
Step: **NO**
Remarks: **END SURVEY**
