Manhole Inspection Report

Date:	05/16/2018	Weather:		Coding:	RZMACP
MH#:	M-303-006	Owner:	NA	Len. Surveyed:	7.1
P.O.#:		Surveyor:	Jen Costello	Rim to Invert:	8.2
Customer:		Cert. #:	U-907-5518	Wall Material:	Brick

Street:	Old Ridge Rd. 472' East of Ridge Pl.	Project:	Hobart, IN
City:	Hobart, IN	GPS Northing:	41.54605484
Location:		GPS Easting:	-87.29379272
Drain Area:	Northwest	GPS Accuracy:	Nearest Meter
Cover Shape:	Circular	Evidence of Surcharge:	No
Cover Size:	22.5	Potential for Runoff:	None
Comments:

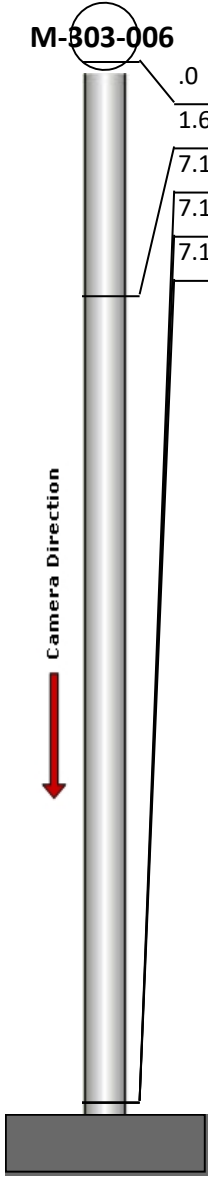
.0	MGO	General Observation	10	NA
	1.6	MGO	General Observation	26	NA
	7.1	DSF	Deposits Settled Fine	50	M 2
	7.1	DAR	Deposits Attached Ragging	60	M 2
	7.1	MGO	General Observation	70	NA

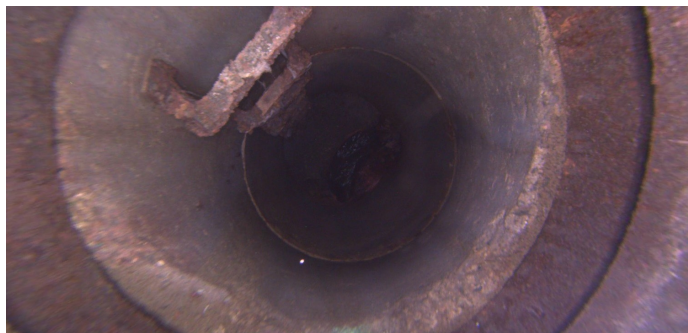
Code: **MGO**
 Description: **General Observation**

Distance (ft): **.0**
 Structural Grade: **0**
 O&M Grade: **0**
 Clock Start/From:
 Clock To:
 1st Value:
 2nd Value:
 Value Percent:
 Step: **NO**
 Remarks: **ACCESS MH**

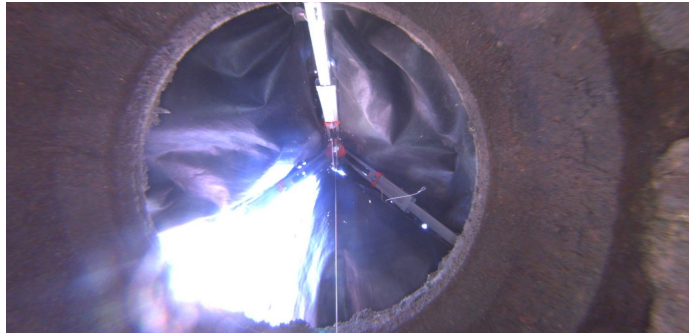
Code:	MGO
Description:	General Observation
Distance (ft):	1.6
Structural Grade:	0
O&M Grade:	0
Clock Start/From:	
Clock To:	
1st Value:	
2nd Value:	
Value Percent:	
Step:	NO
Remarks:	UNDERSIDE OF FRAME

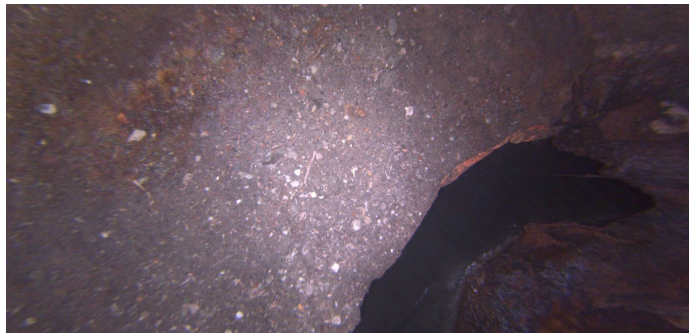
Code:	DSF
Description:	Deposits Settled Fine
Distance (ft):	7.1
Structural Grade:	0
O&M Grade:	2
Clock Start/From:	6
Clock To:	3
1st Value:	
2nd Value:	
Value Percent:	5.000
Step:	NO
Remarks:

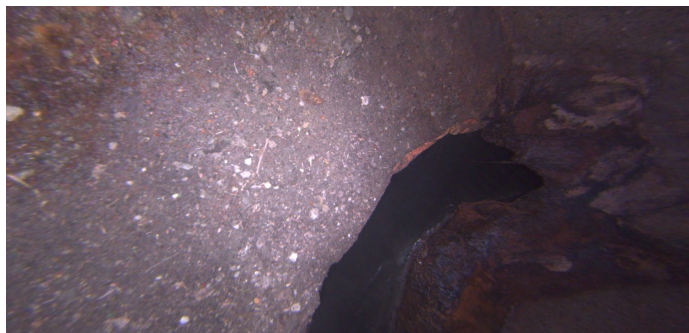
Code:	DAR
Description:	Deposits Attached Ragging
Distance (ft):	7.1
Structural Grade:	0
O&M Grade:	2
Clock Start/From:	3
Clock To:	4
1st Value:	
2nd Value:	
Value Percent:	10.000
Step:	NO
Remarks:	AROUND TAP

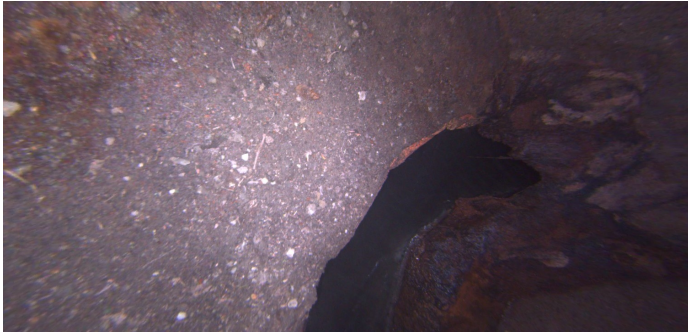
Code:	MGO
Description:	General Observation
Distance (ft):	7.1
Structural Grade:	0
O&M Grade:	0
Clock Start/From:	
Clock To:	
1st Value:	
2nd Value:	
Value Percent:	
Step:	NO
Remarks:	END SURVEY
