Manhole Inspection Report

Date:	10/05/2022	Weather:		Coding:	RZMACP
MH#:	M-303-016	Owner:	NA	Len. Surveyed:	7.5
P.O.#:		Surveyor:	Jen Costello	Rim to Invert:	8.2
Customer:		Cert. #:	U-907-5518	Wall Material:	Concrete (cast in place)

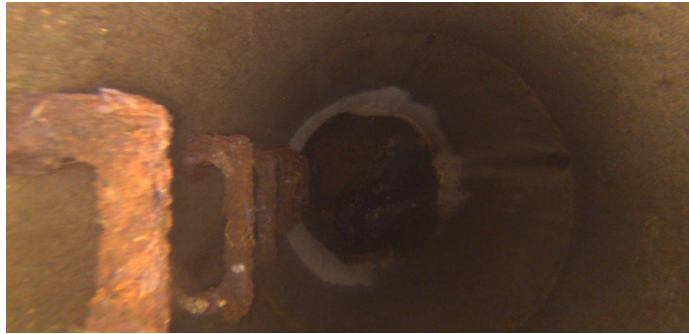
Code: **MGO**
Description: **General Observation**

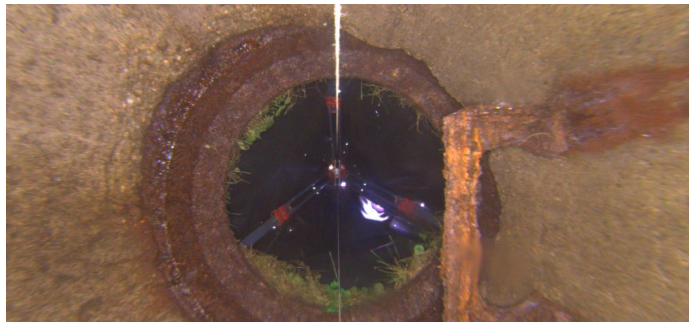
Code: **SRI**
Description: **Surface Roughness Increased**

Distance (ft): **.0**
Structural Grade: **1**
O&M Grade: **0**
Clock Start/From: **12**
Clock To: **12**
1st Value:
2nd Value:
Value Percent:
Step: **NO**
Remarks:

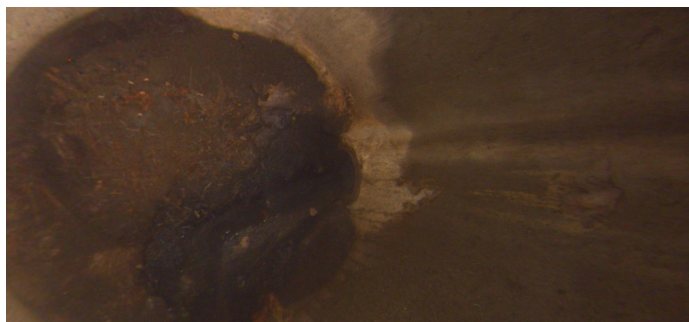
Code: **MGO**
Description: **General Observation**

Distance (ft): **2.1**
Structural Grade: **0**
O&M Grade: **0**
Clock Start/From:
Clock To:
1st Value:
2nd Value:
Value Percent:
Step: **NO**
Remarks: **underside of frame**

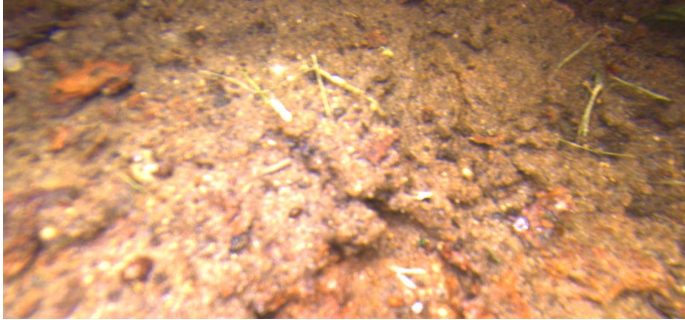
Code:	DSF
Description:	Deposits Settled Fine

Distance (ft):	7.5
Structural Grade:	0
O&M Grade:	2
Clock Start/From:	12
Clock To:	12
1st Value:	
2nd Value:	
Value Percent:	5.000
Step:	NO
Remarks:

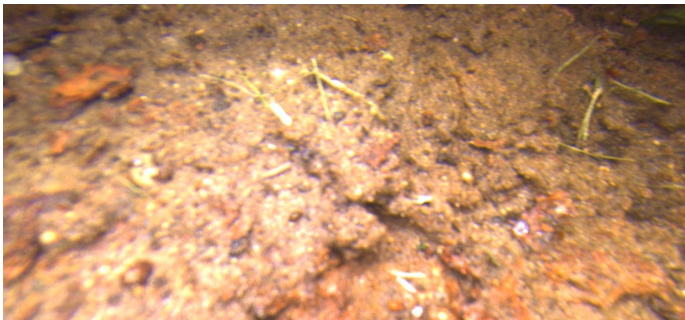
Code:	MGO
Description:	General Observation

Distance (ft):	7.5
Structural Grade:	0
O&M Grade:	0
Clock Start/From:	
Clock To:	
1st Value:	
2nd Value:	
Value Percent:	
Step:	NO
Remarks:	end of survey

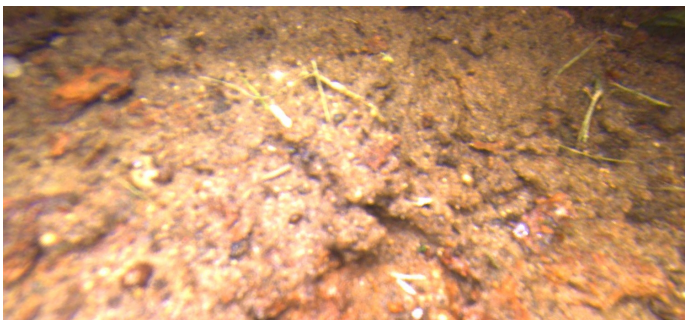
Code:	SRI
Description:	Surface Roughness Increased

Distance (ft):	7.5
Structural Grade:	1
O&M Grade:	0
Clock Start/From:	12
Clock To:	12
1st Value:	
2nd Value:	
Value Percent:	
Step:	NO
Remarks:
