Manhole Inspection Report

Date:	10/06/2022	Weather:		Coding:	RZMACP
MH#:	M-303-018	Owner:	NA	Len. Surveyed:	6.8
P.O.#:		Surveyor:	Todd Machine	Rim to Invert:	7.6
Customer:		Cert. #:	P0038859-082022	Wall Material:	Concrete (reinforced)

Street:	Alley between Ridge Rd. and 40th A	Project:	Missing GPS
City:	Hobart, IN	GPS Northing:	41.54645157
Location:		GPS Easting:	-3.963961601
Drain Area:	Northwest	GPS Accuracy:	
Cover Shape:	Circular	Evidence of Surcharge:	
Cover Size:	24.0	Potential for Runoff:	
Comments:

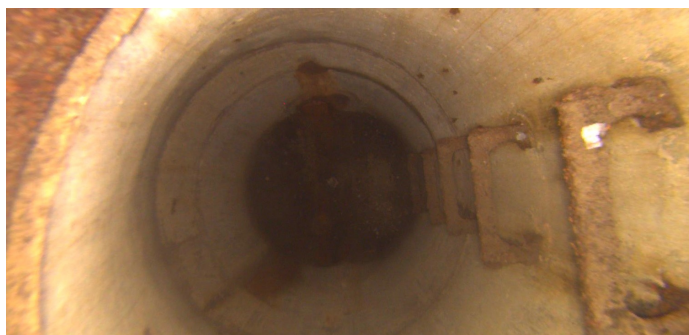
Code: **MGO**
Description: **General Observation**

Distance (ft): **.0**
Structural Grade: **0**
O&M Grade: **0**
Clock Start/From:
Clock To:
1st Value:
2nd Value:
Value Percent:
Step: **NO**
Remarks: **access mh**

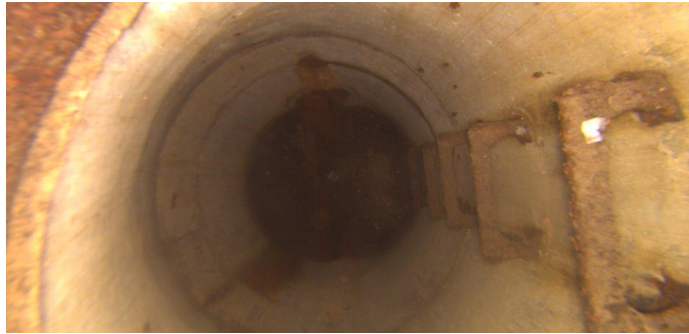
Code: **SRI**
Description: **Surface Roughness Increased**

Distance (ft): **.0**
Structural Grade: **1**
O&M Grade: **0**
Clock Start/From: **12**
Clock To: **12**
1st Value:
2nd Value:
Value Percent:
Step: **NO**
Remarks:

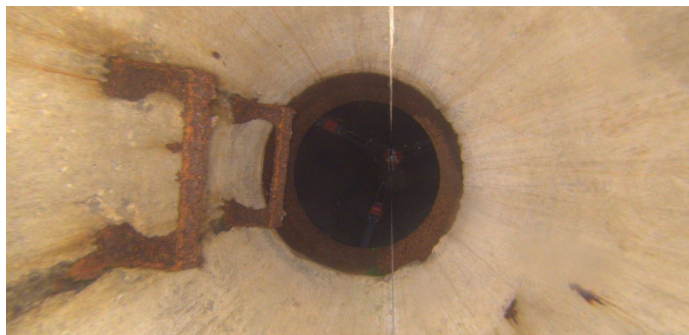
Code: **MGO**
Description: **General Observation**

Distance (ft): **3.5**
Structural Grade: **0**
O&M Grade: **0**
Clock Start/From:
Clock To:
1st Value:
2nd Value:
Value Percent:
Step: **NO**
Remarks: **underside of frame**

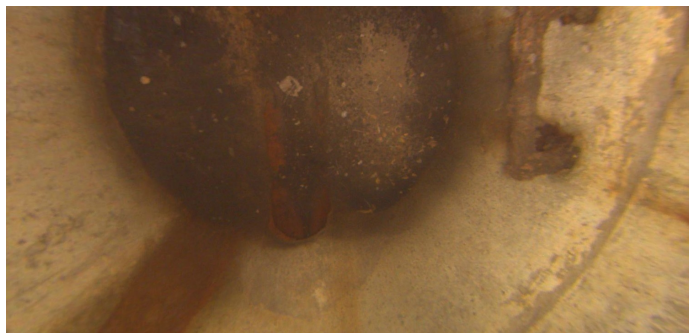
Code: **IW**
Description: **Infil Weeper**

Distance (ft): **3.5**
Structural Grade: **0**
O&M Grade: **2**
Clock Start/From: **7**
Clock To:
1st Value:
2nd Value:
Value Percent:
Step: **NO**
Remarks:

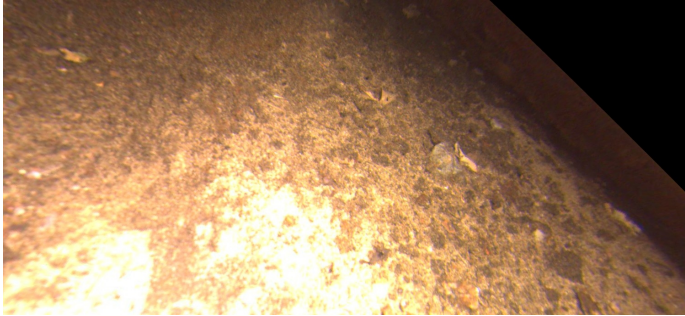
Code:	DSF
Description:	Deposits Settled Fine

Distance (ft):	6.8
Structural Grade:	0
O&M Grade:	2
Clock Start/From:	12
Clock To:	12
1st Value:	
2nd Value:	
Value Percent:	5.000
Step:	NO
Remarks:

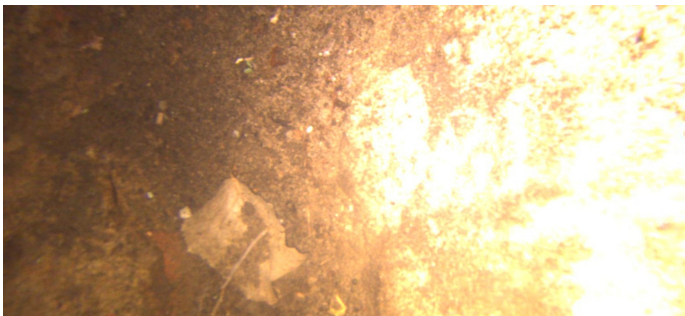
Code:	DSF
Description:	Deposits Settled Fine

Distance (ft):	6.8
Structural Grade:	0
O&M Grade:	2
Clock Start/From:	5
Clock To:	7
1st Value:	
2nd Value:	
Value Percent:	10.000
Step:	NO
Remarks:

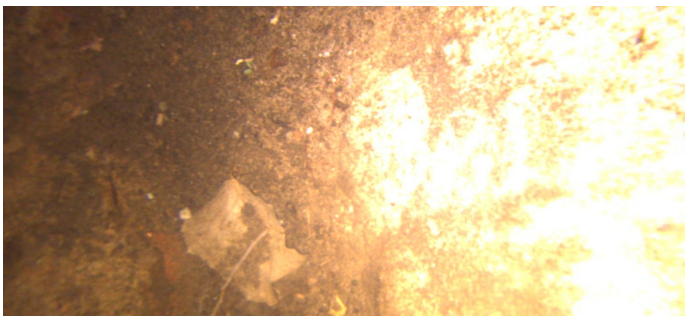
Code:	SRI
Description:	Surface Roughness Increased

Distance (ft):	6.8
Structural Grade:	1
O&M Grade:	0
Clock Start/From:	12
Clock To:	12
1st Value:	
2nd Value:	
Value Percent:	
Step:	NO
Remarks:

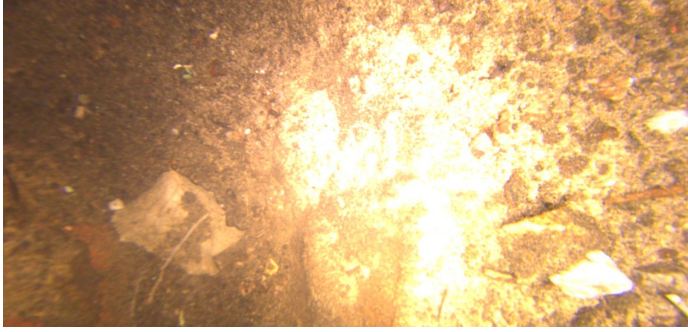
Code:	MGO
Description:	General Observation
Distance (ft):	6.8
Structural Grade:	0
O&M Grade:	0
Clock Start/From:	
Clock To:	
1st Value:	
2nd Value:	
Value Percent:	
Step:	NO
Remarks:	End Of Survey
