Manhole Inspection Report

Date:	04/13/2018	Weather:		Coding:	RZMACP
MH#:	M-303-021	Owner:	NA	Len. Surveyed:	8.2
P.O.#:		Surveyor:	Jen Costello	Rim to Invert:	12.5
Customer:		Cert. #:	U-907-5518	Wall Material:	Concrete (reinforced)

Street:	Ridgelawn St. between 38th Pl. and	Project:	Hobart, IN
City:	Hobart, IN	GPS Northing:	0.0
Location:		GPS Easting:	0.0
Drain Area:	Northwest	GPS Accuracy:	Nearest Meter
Cover Shape:	Circular	Evidence of Surcharge:	No
Cover Size:	23.0	Potential for Runoff:	None
Comments:

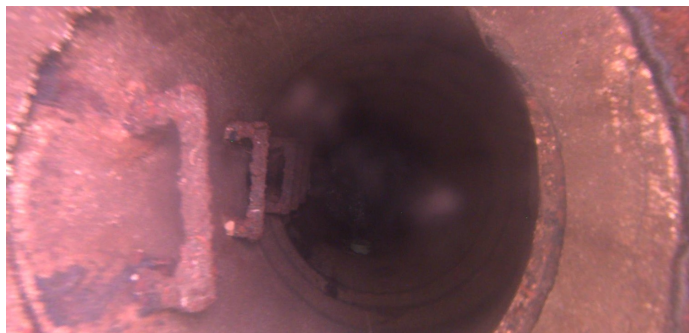
Code: **MGO**
Description: **General Observation**

Distance (ft): **.0**
Structural Grade: **0**
O&M Grade: **0**
Clock Start/From:
Clock To:
1st Value:
2nd Value:
Value Percent:
Step: **NO**
Remarks: **ACCESS MH**

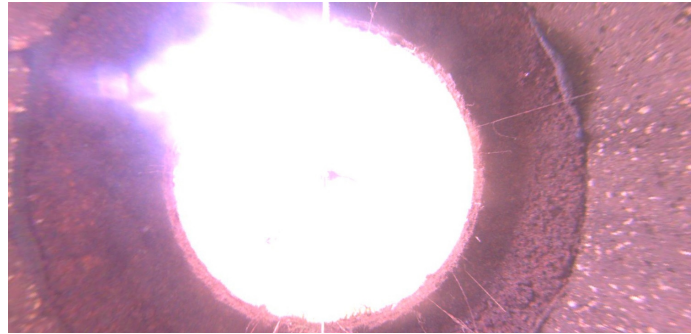
Code:	MGO
Description:	General Observation
Distance (ft):	1.3
Structural Grade:	0
O&M Grade:	0
Clock Start/From:	
Clock To:	
1st Value:	
2nd Value:	
Value Percent:	
Step:	NO
Remarks:	UNDERSIDE OF FRAME

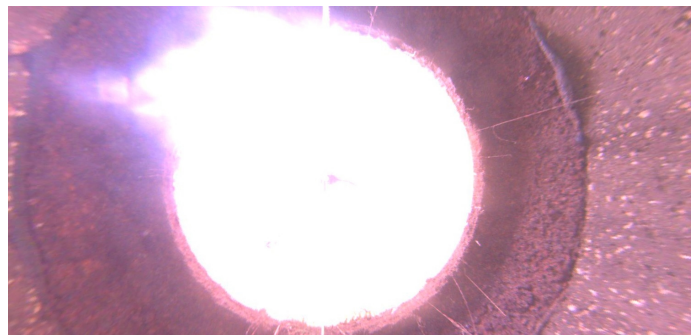
Code:	SAV
Description:	Surface Aggregate Visible
Distance (ft):	1.3
Structural Grade:	3
O&M Grade:	0
Clock Start/From:	12
Clock To:	12
1st Value:	
2nd Value:	
Value Percent:	
Step:	NO
Remarks:

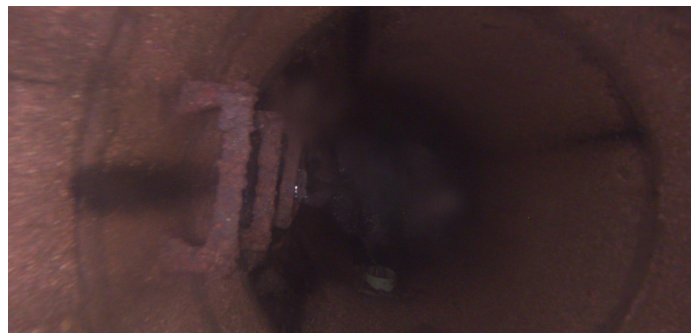
Code:	IW
Description:	Infil Weeper
Distance (ft):	2.6
Structural Grade:	0
O&M Grade:	2
Clock Start/From:	9
Clock To:	
1st Value:	
2nd Value:	
Value Percent:	
Step:	NO
Remarks:

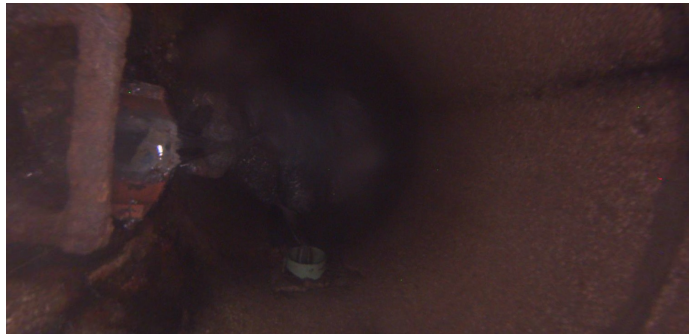
Code: **IW**
Description: **Infil Weeper**

Distance (ft): **4.1**
Structural Grade: **0**
O&M Grade: **2**
Clock Start/From: **3**
Clock To:
1st Value:
2nd Value:
Value Percent:
Step: **NO**
Remarks:

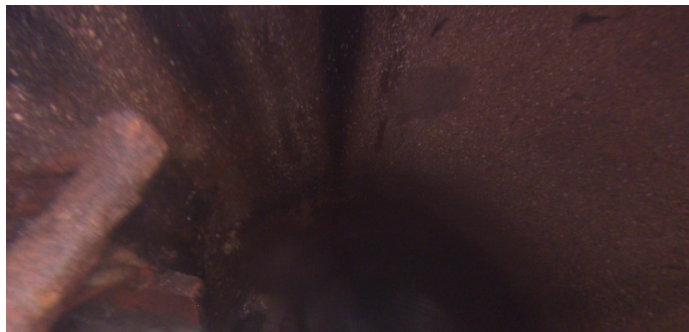
Code: **IW**
Description: **Infil Weeper**

Distance (ft): **4.8**
Structural Grade: **0**
O&M Grade: **2**
Clock Start/From: **11**
Clock To: **12**
1st Value:
2nd Value:
Value Percent:
Step: **NO**
Remarks:

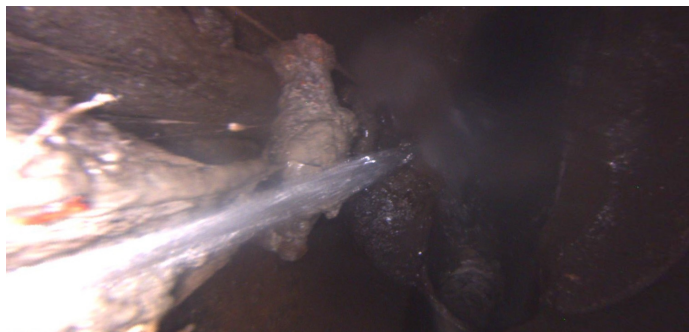
Code: **DAR**
Description: **Deposits Attached Ragging**

Distance (ft): **8.2**
Structural Grade: **0**
O&M Grade: **2**
Clock Start/From: **8**
Clock To: **9**
1st Value:
2nd Value:
Value Percent: **10.000**
Step: **YES**
Remarks:

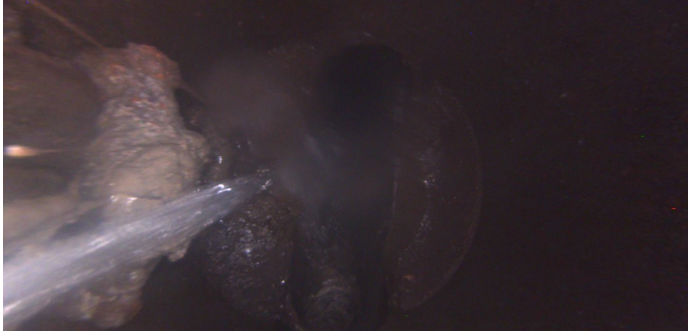
Code:	MSA
Description:	Abandoned Survey
Distance (ft):	8.2
Structural Grade:	0
O&M Grade:	0
Clock Start/From:	
Clock To:	
1st Value:	
2nd Value:	
Value Percent:	
Step:	NO
Remarks:	Caught on step
