Manhole Inspection Report

Date:	04/13/2018	Weather:		Coding:	RZMACP
MH#:	M-303-027	Owner:	NA	Len. Surveyed:	11.7
P.O.#:		Surveyor:	Jen Costello	Rim to Invert:	14.0
Customer:		Cert. #:	U-907-5518	Wall Material:	Concrete (reinforced)

Street:	Ridgelawn St. 164' South of 38th Av	Project:	Hobart, IN
City:	Hobart, IN	GPS Northing:	0.0
Location:		GPS Easting:	0.0
Drain Area:	Northwest	GPS Accuracy:	Nearest Meter
Cover Shape:	Circular	Evidence of Surcharge:	No
Cover Size:	23.0	Potential for Runoff:	None
Comments:

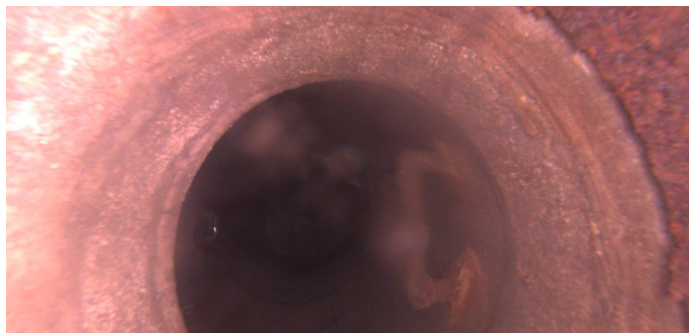
Code: **MGO**
Description: **General Observation**

Distance (ft): **.0**
Structural Grade: **0**
O&M Grade: **0**
Clock Start/From:
Clock To:
1st Value:
2nd Value:
Value Percent:
Step: **NO**
Remarks: **ACCESS MH**

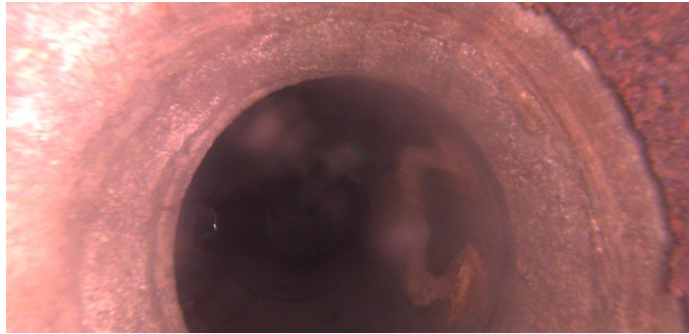
Code: **SAV**
Description: **Surface Aggregate Visible**

Distance (ft): **.0**
Structural Grade: **3**
O&M Grade: **0**
Clock Start/From: **12**
Clock To: **12**
1st Value:
2nd Value:
Value Percent:
Step: **NO**
Remarks:

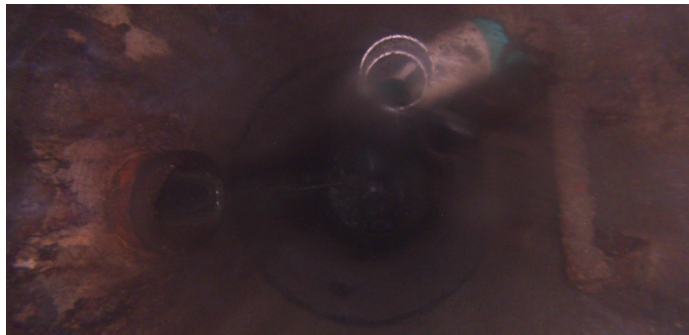
Code: **IW**
Description: **Infil Weeper**

Distance (ft): **2.9**
Structural Grade: **0**
O&M Grade: **2**
Clock Start/From: **8**
Clock To: **10**
1st Value:
2nd Value:
Value Percent:
Step: **NO**
Remarks:

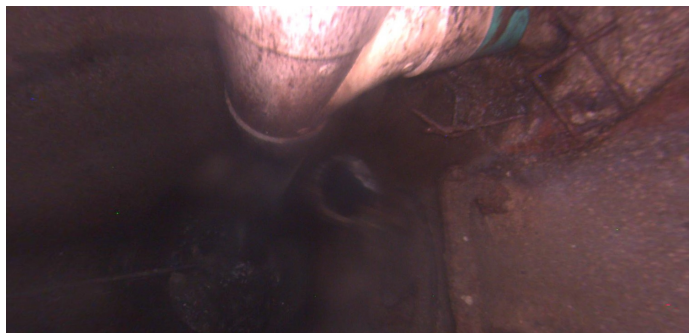
Code: **SRP**
Description: **Surface Reinforcement Projecting**

Distance (ft): **4.6**
Structural Grade: **3**
O&M Grade: **0**
Clock Start/From: **1**
Clock To: **2**
1st Value:
2nd Value:
Value Percent:
Step: **NO**
Remarks:

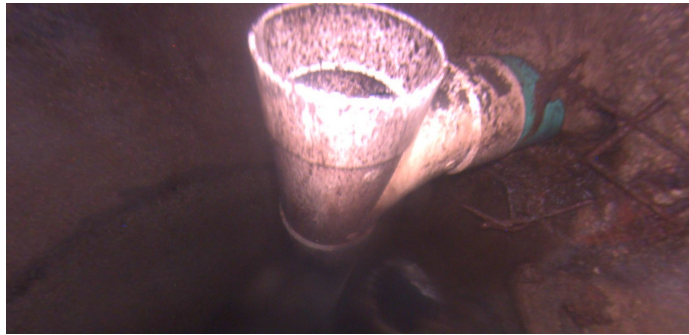
Code:	OBP
Description:	Obstacle External Pipe or Cable
Distance (ft):	4.6
Structural Grade:	0
O&M Grade:	2
Clock Start/From:	1
Clock To:	2
1st Value:	
2nd Value:	
Value Percent:	10.000
Step:	NO
Remarks:

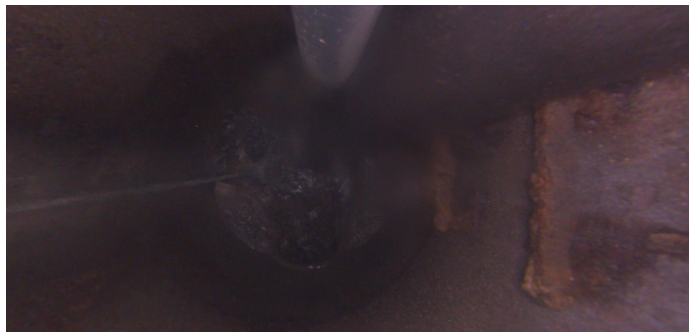
Code:	OBP
Description:	Obstacle External Pipe or Cable
Distance (ft):	7.2
Structural Grade:	0
O&M Grade:	2
Clock Start/From:	1
Clock To:	2
1st Value:	
2nd Value:	
Value Percent:	10.000
Step:	NO
Remarks:

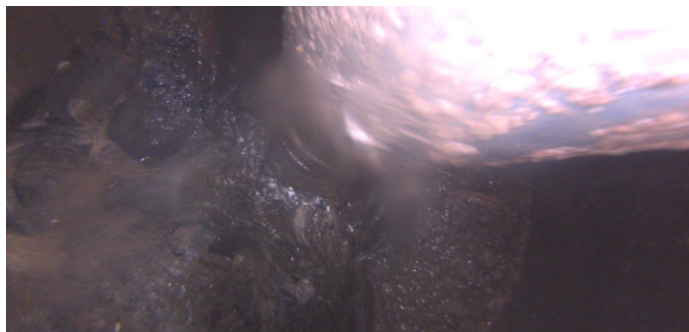
Code:	OBR
Description:	Obstacle Rocks
Distance (ft):	11.0
Structural Grade:	0
O&M Grade:	2
Clock Start/From:	12
Clock To:	12
1st Value:	
2nd Value:	
Value Percent:	10.000
Step:	NO
Remarks:

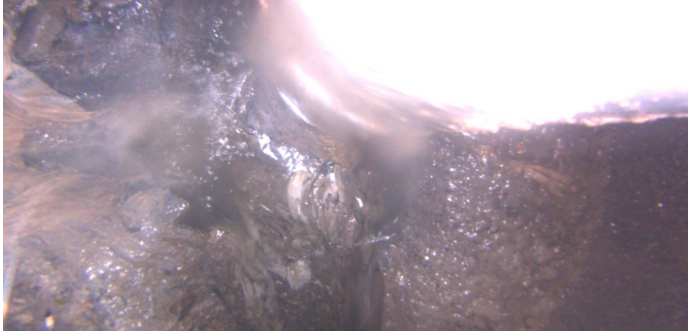
Code:	MGO
Description:	General Observation
Distance (ft):	11.7
Structural Grade:	0
O&M Grade:	0
Clock Start/From:	
Clock To:	
1st Value:	
2nd Value:	
Value Percent:	
Step:	NO
Remarks:	end survey
