Manhole Inspection Report

Date:	10/05/2022	Weather:		Coding:	RZMACP
MH#:	M-303-028	Owner:	NA	Len. Surveyed:	8.0
P.O.#:		Surveyor:	Jen Costello	Rim to Invert:	9.2
Customer:		Cert. #:	U-907-5518	Wall Material:	Concrete (cast in place)

Street:	Alley between 38th Ave. and 38th Pl	Project:	Hobart, IN
City:	Hobart, IN	GPS Northing:	2295015.976
Location:	Other	GPS Easting:	2895064.986
Drain Area:	Northwest	GPS Accuracy:	Sub-Meter
Cover Shape:	Circular	Evidence of Surcharge:	No
Cover Size:	24.0	Potential for Runoff:	None
Comments:

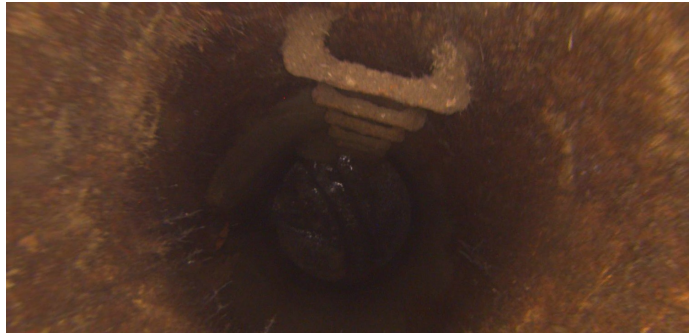
Code:	MGO
Description:	General Observation

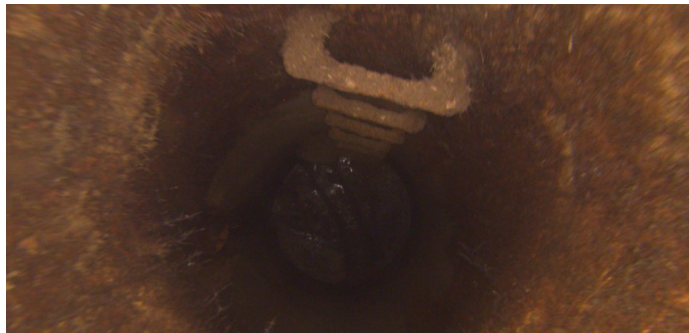
Code: **SRI**
Description: **Surface Roughness Increased**

Distance (ft): **.0**
Structural Grade: **1**
O&M Grade: **0**
Clock Start/From: **12**
Clock To: **12**
1st Value:
2nd Value:
Value Percent:
Step: **NO**
Remarks:

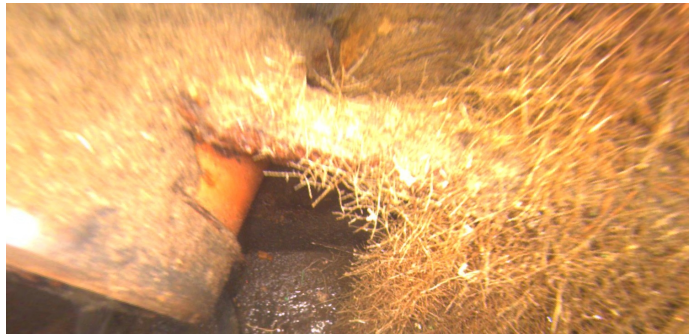
Code: **MGO**
Description: **General Observation**

Distance (ft): **2.2**
Structural Grade: **0**
O&M Grade: **0**
Clock Start/From:
Clock To:
1st Value:
2nd Value:
Value Percent:
Step: **NO**
Remarks: **access mh**

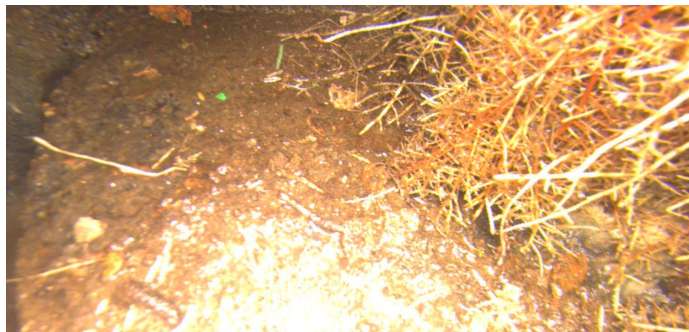
Code: **RMB**
Description: **Roots Medium Barrel**

Distance (ft): **6.3**
Structural Grade: **0**
O&M Grade: **4**
Clock Start/From: **10**
Clock To: **2**
1st Value:
2nd Value:
Value Percent: **20.000**
Step: **NO**
Remarks:

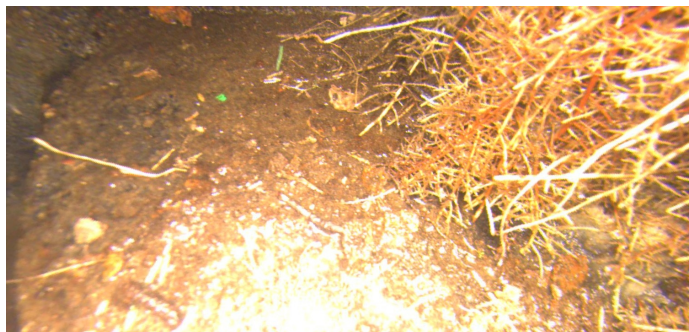
Code: **DSF**
Description: **Deposits Settled Fine**

Distance (ft): **8.0**
Structural Grade: **0**
O&M Grade: **2**
Clock Start/From: **12**
Clock To: **12**
1st Value:
2nd Value:
Value Percent: **5.000**
Step: **NO**
Remarks:

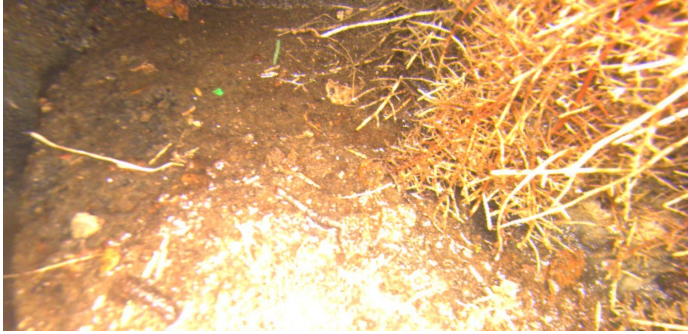
Code: **SRI**
Description: **Surface Roughness Increased**

Distance (ft): **8.0**
Structural Grade: **1**
O&M Grade: **0**
Clock Start/From: **12**
Clock To: **12**
1st Value:
2nd Value:
Value Percent:
Step: **NO**
Remarks:
