# Manhole Inspection Report

Date:	10/05/2022	Weather:		Coding:	RZMACP
MH#:	M-303-034	Owner:	NA	Len. Surveyed:	7.0
P.O.#:		Surveyor:	Jen Costello	Rim to Invert:	8.1
Customer:		Cert. #:	U-907-5518	Wall Material:	Other

Street:	Alley between 37th Pl. and 38th Ave	Project:	Hobart, IN
City:	Hobart, IN	GPS Northing:	2295360.995
Location:	Other	GPS Easting:	2895104.88
Drain Area:	Northwest	GPS Accuracy:	Sub-Meter
Cover Shape:	Circular	Evidence of Surcharge:	
Cover Size:	24.0	Potential for Runoff:	
Comments:

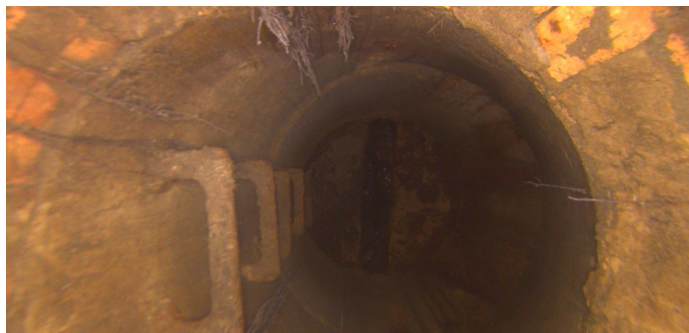
Code: **MGO**  
Description: **General Observation**

Distance (ft): **.0**  
Structural Grade: **0**  
O&M Grade: **0**  
Clock Start/From:  
Clock To:  
1st Value:  
2nd Value:  
Value Percent:  
Step: **NO**  
Remarks: **access mh**

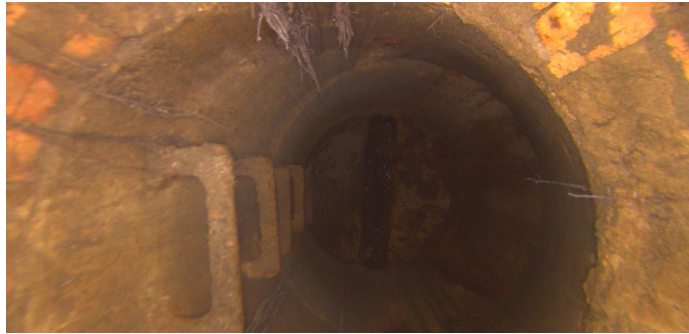
Code: **SRI**  
Description: **Surface Roughness Increased**

Distance (ft): **.0**  
Structural Grade: **1**  
O&M Grade: **0**  
Clock Start/From: **12**  
Clock To: **12**  
1st Value:  
2nd Value:  
Value Percent:  
Step: **NO**  
Remarks:

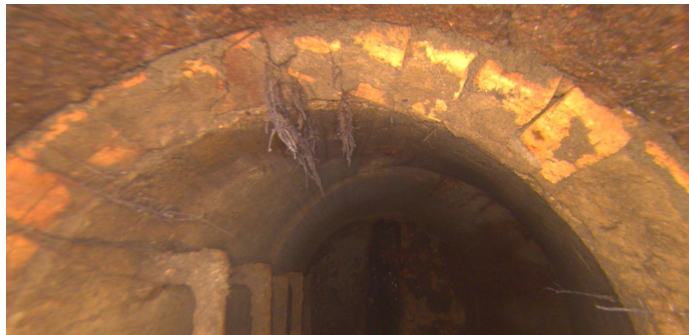
Code: **RFJ**  
Description: **Roots Fine Joint**

Distance (ft): **.0**  
Structural Grade: **0**  
O&M Grade: **1**  
Clock Start/From: **12**  
Clock To: **12**  
1st Value:  
2nd Value:  
Value Percent:  
Step: **NO**  
Remarks:

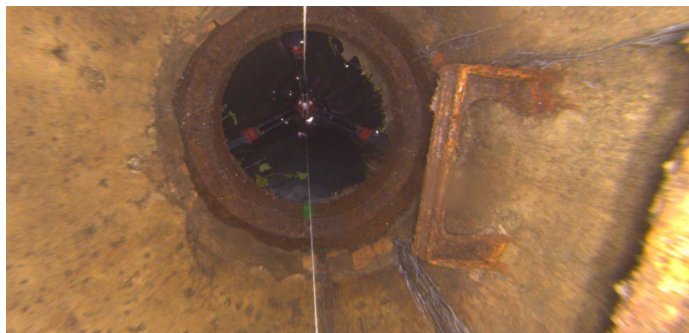
Code: **MGO**  
Description: **General Observation**

Distance (ft): **3.1**  
Structural Grade: **0**  
O&M Grade: **0**  
Clock Start/From:  
Clock To:  
1st Value:  
2nd Value:  
Value Percent:  
Step: **NO**  
Remarks: **underside of frame**

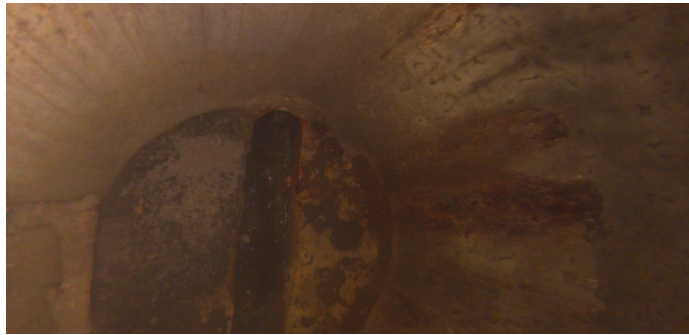
Code: **IW**  
Description: **Infil Weeper**

Distance (ft): **3.1**  
Structural Grade: **0**  
O&M Grade: **2**  
Clock Start/From: **2**  
Clock To: **4**  
1st Value:  
2nd Value:  
Value Percent:  
Step: **NO**  
Remarks:

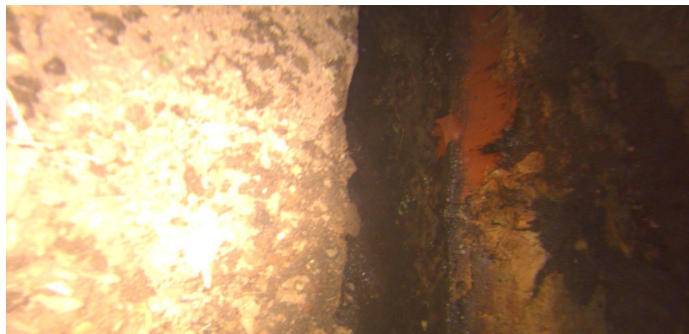
Code: **DSF**  
Description: **Deposits Settled Fine**

Distance (ft): **6.7**  
Structural Grade: **0**  
O&M Grade: **2**  
Clock Start/From: **12**  
Clock To: **12**  
1st Value:  
2nd Value:  
Value Percent: **5.000**  
Step: **NO**  
Remarks:

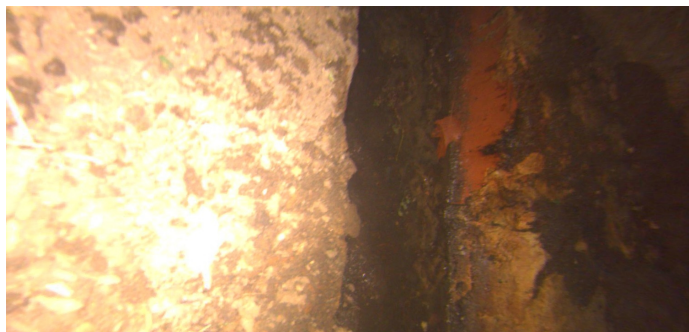
Code: **SRI**  
Description: **Surface Roughness Increased**

Distance (ft): **6.7**  
Structural Grade: **1**  
O&M Grade: **0**  
Clock Start/From: **12**  
Clock To: **12**  
1st Value:  
2nd Value:  
Value Percent:  
Step: **NO**  
Remarks:

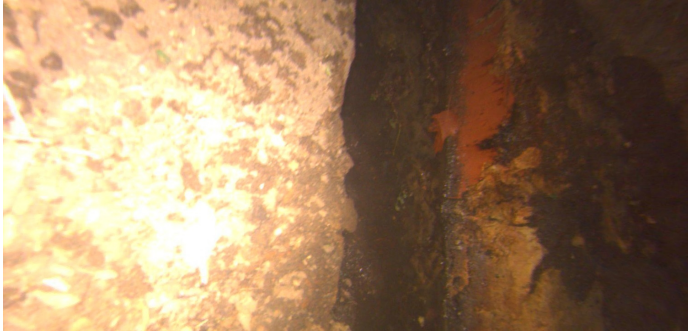
Code:	<b>MGO</b>
Description:	<b>General Observation</b>
Distance (ft):	<b>6.7</b>
Structural Grade:	<b>0</b>
O&M Grade:	<b>0</b>
Clock Start/From:	
Clock To:	
1st Value:	
2nd Value:	
Value Percent:	
Step:	<b>NO</b>
Remarks:	<b>end of survey</b>
