Manhole Inspection Report

Date:	10/05/2022	Weather:		Coding:	RZMACP
MH#:	M-303-035	Owner:	NA	Len. Surveyed:	8.1
P.O.#:		Surveyor:	Jen Costello	Rim to Invert:	9.4
Customer:		Cert. #:	U-907-5518	Wall Material:	Concrete (cast in place)

Street:	Alley between 37th Pl. and 38th Ave	Project:	Hobart, IN
City:	Hobart, IN	GPS Northing:	2295334.269
Location:	Other	GPS Easting:	2894802.06
Drain Area:	Northwest	GPS Accuracy:	Sub-Meter
Cover Shape:	Circular	Evidence of Surcharge:	No
Cover Size:	24.0	Potential for Runoff:	None
Comments:

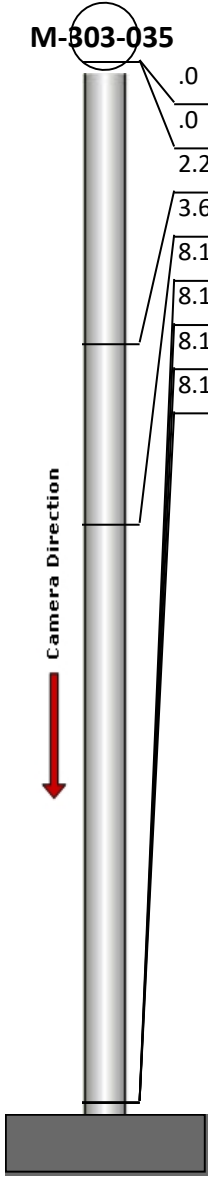
Position	Code	Observation	Video (sec)	Grade

.0	MGO	General Observation	10	NA
	.0	SRI	Surface Roughness Increased	21	S 1
	2.2	MGO	General Observation	39	NA
	3.6	IW	Infil Weeper	56	M 2
	8.1	DSF	Deposits Settled Fine	77	M 2
	8.1	DSF	Deposits Settled Fine	89	M 4
	8.1	SRI	Surface Roughness Increased	100	S 1
	8.1	MGO	General Observation	111	NA

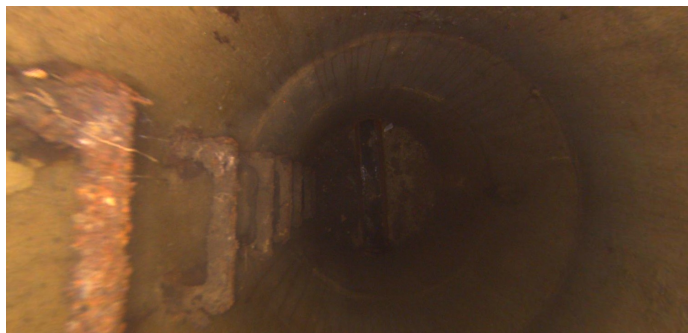
Code: **MGO**
Description: **General Observation**

Distance (ft): **.0**
Structural Grade: **0**
O&M Grade: **0**
Clock Start/From:
Clock To:
1st Value:
2nd Value:
Value Percent:
Step: **NO**
Remarks: **access mh**

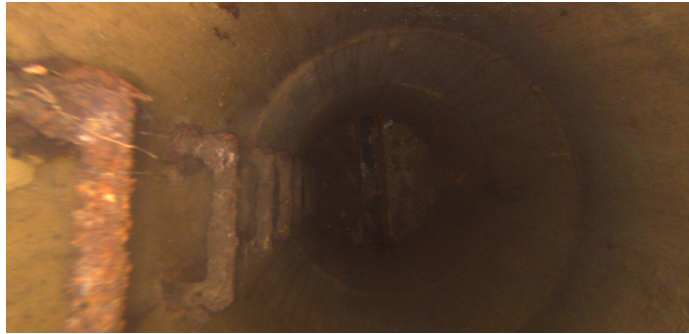
Code:	SRI
Description:	Surface Roughness Increased
Distance (ft):	.0
Structural Grade:	1
O&M Grade:	0
Clock Start/From:	12
Clock To:	12
1st Value:	
2nd Value:	
Value Percent:	
Step:	NO
Remarks:

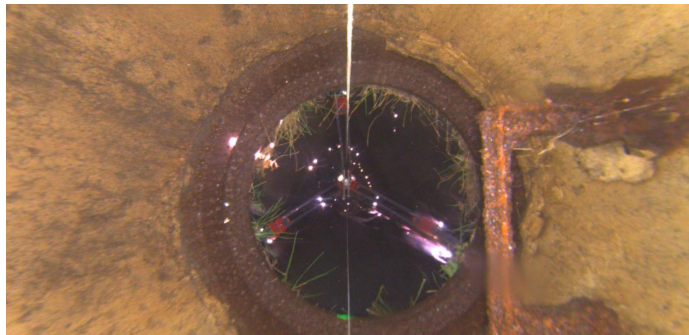
Code:	MGO
Description:	General Observation
Distance (ft):	2.2
Structural Grade:	0
O&M Grade:	0
Clock Start/From:	
Clock To:	
1st Value:	
2nd Value:	
Value Percent:	
Step:	NO
Remarks:	underside of frame

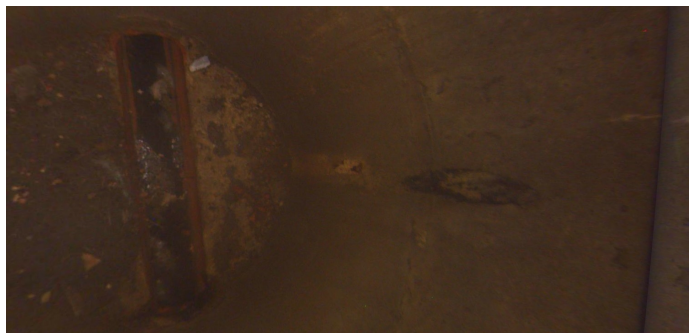
Code:	IW
Description:	Infil Weeper
Distance (ft):	3.6
Structural Grade:	0
O&M Grade:	2
Clock Start/From:	3
Clock To:	
1st Value:	
2nd Value:	
Value Percent:	
Step:	NO
Remarks:

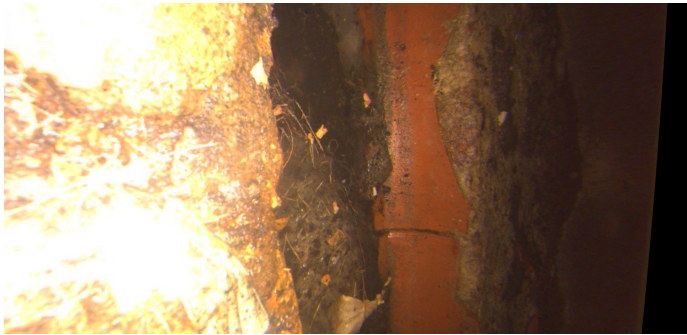
Code: **DSF**
Description: **Deposits Settled Fine**

Distance (ft): **8.1**
Structural Grade: **0**
O&M Grade: **2**
Clock Start/From: **12**
Clock To: **12**
1st Value:
2nd Value:
Value Percent: **5.000**
Step: **NO**
Remarks:

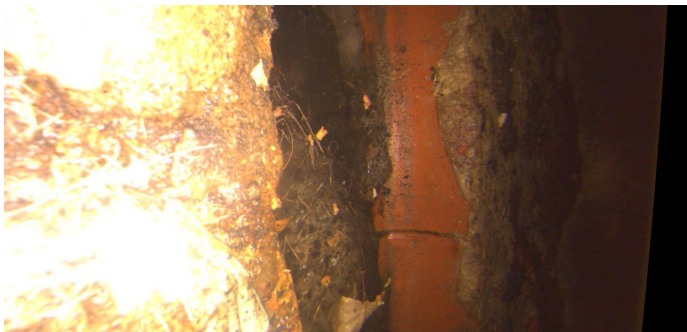
Code: **DSF**
Description: **Deposits Settled Fine**

Distance (ft): **8.1**
Structural Grade: **0**
O&M Grade: **4**
Clock Start/From: **4**
Clock To: **8**
1st Value:
2nd Value:
Value Percent: **30.000**
Step: **NO**
Remarks:

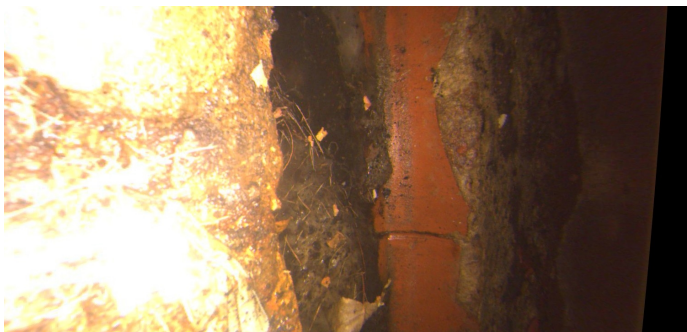
Code: **SRI**
Description: **Surface Roughness Increased**

Distance (ft): **8.1**
Structural Grade: **1**
O&M Grade: **0**
Clock Start/From: **12**
Clock To: **12**
1st Value:
2nd Value:
Value Percent:
Step: **NO**
Remarks:

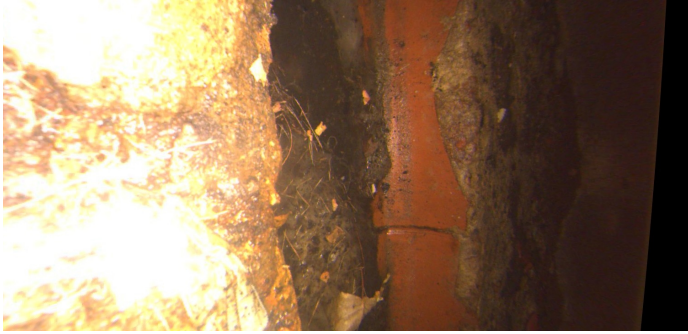
Code:	MGO
Description:	General Observation
Distance (ft):	8.1
Structural Grade:	0
O&M Grade:	0
Clock Start/From:	
Clock To:	
1st Value:	
2nd Value:	
Value Percent:	
Step:	NO
Remarks:	end of survey
