Manhole Inspection Report

Date:	09/20/2022	Weather:		Coding:	RZMACP
MH#:	M-303-044	Owner:	NA	Len. Surveyed:	12.8
P.O.#:		Surveyor:	Jen Costello	Rim to Invert:	14.2
Customer:		Cert. #:	U-907-5518	Wall Material:	Other

Street:	Brown St. 255' South of 37th Ave.	Project:	Hobart, IN
City:	Hobart, IN	GPS Northing:	2295589.497
Location:	Yard	GPS Easting:	2896052.866
Drain Area:	Northwest	GPS Accuracy:	Sub-Meter
Cover Shape:	Circular	Evidence of Surcharge:	
Cover Size:	24.0	Potential for Runoff:	
Comments:

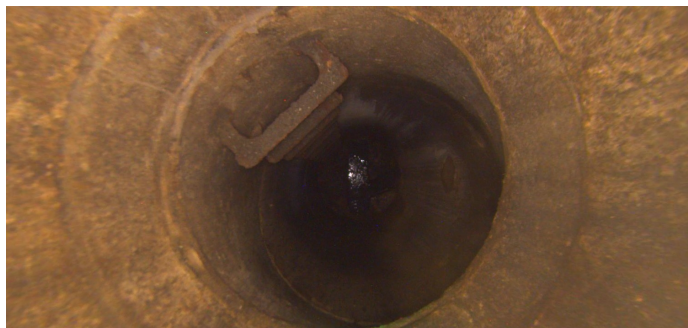
Code: **MGO**
Description: **General Observation**

Distance (ft): **.0**
Structural Grade: **0**
O&M Grade: **0**
Clock Start/From:
Clock To:
1st Value:
2nd Value:
Value Percent:
Step: **NO**
Remarks: **access mh**

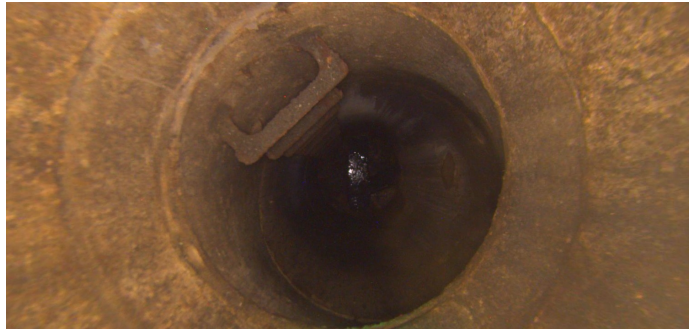
Code: **SRI**
Description: **Surface Roughness Increased**

Distance (ft): **.0**
Structural Grade: **1**
O&M Grade: **0**
Clock Start/From: **12**
Clock To: **12**
1st Value:
2nd Value:
Value Percent:
Step: **NO**
Remarks:

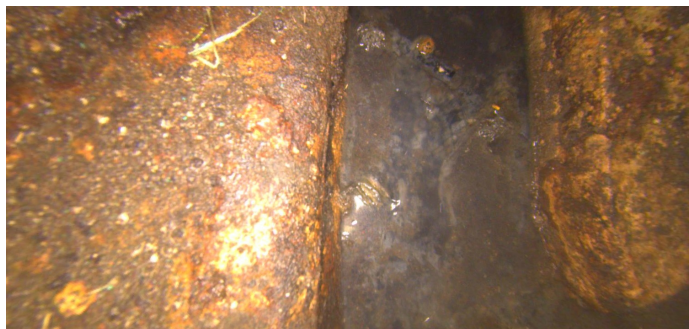
Code: **DSF**
Description: **Deposits Settled Fine**

Distance (ft): **12.8**
Structural Grade: **0**
O&M Grade: **2**
Clock Start/From: **12**
Clock To: **12**
1st Value:
2nd Value:
Value Percent: **5.000**
Step: **NO**
Remarks:

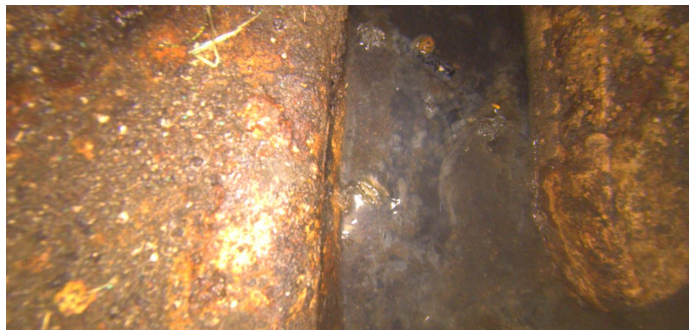
Code: **MGO**
Description: **General Observation**

Distance (ft): **12.8**
Structural Grade: **0**
O&M Grade: **0**
Clock Start/From:
Clock To:
1st Value:
2nd Value:
Value Percent:
Step: **NO**
Remarks: **end of survey**

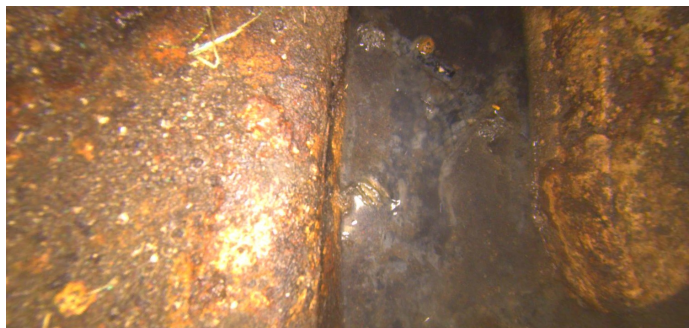
Code: **SRI**
Description: **Surface Roughness Increased**

Distance (ft): **12.8**
Structural Grade: **1**
O&M Grade: **0**
Clock Start/From: **12**
Clock To: **12**
1st Value:
2nd Value:
Value Percent:
Step: **NO**
Remarks:
