Manhole Inspection Report

Date:	04/12/2018	Weather:		Coding:	RZMACP
MH#:	M-303-049	Owner:	NA	Len. Surveyed:	5.4
P.O.#:		Surveyor:	John Kuglmaier	Rim to Invert:	6.1
Customer:		Cert. #:	U-1215-07002349	Wall Material:	Concrete (reinforced)

Street:	Northwest of L.S. #4.	Project:	Hobart, IN
City:	Hobart, IN	GPS Northing:	0.0
Location:		GPS Easting:	0.0
Drain Area:	Northwest	GPS Accuracy:	Nearest Meter
Cover Shape:	Circular	Evidence of Surcharge:	No
Cover Size:	23.0	Potential for Runoff:	None
Comments:

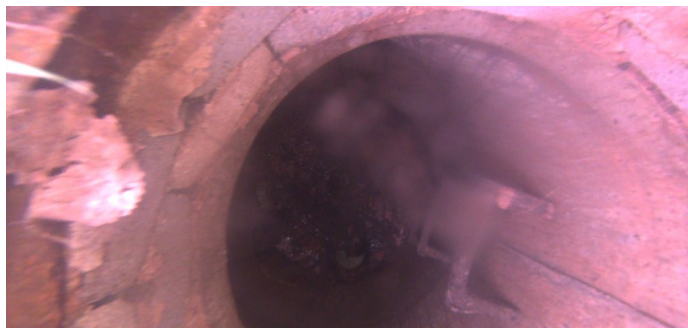
Code: **MGP**
Description: **General Photo**

Distance (ft): **.0**
Structural Grade: **0**
O&M Grade: **0**
Clock Start/From:
Clock To:
1st Value:
2nd Value:
Value Percent:
Step: **NO**
Remarks:

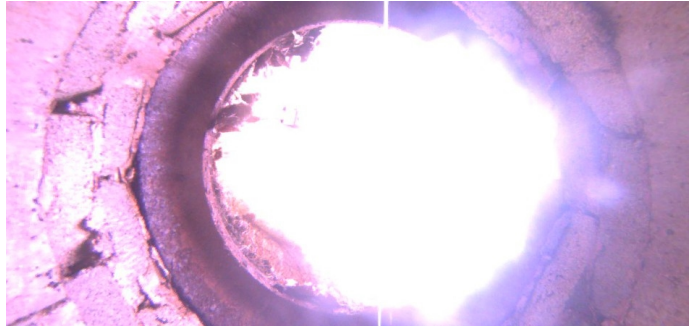
Code:	MGP
Description:	General Photo
Distance (ft):	2.1
Structural Grade:	0
O&M Grade:	0
Clock Start/From:	
Clock To:	
1st Value:	
2nd Value:	
Value Percent:	
Step:	NO
Remarks:

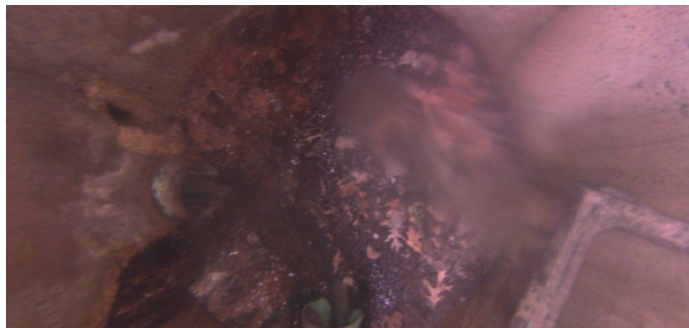
Code:	DAZ
Description:	Deposits Attached Other
Distance (ft):	3.2
Structural Grade:	0
O&M Grade:	2
Clock Start/From:	12
Clock To:	12
1st Value:	
2nd Value:	
Value Percent:	5.000
Step:	NO
Remarks:	Mixed materials

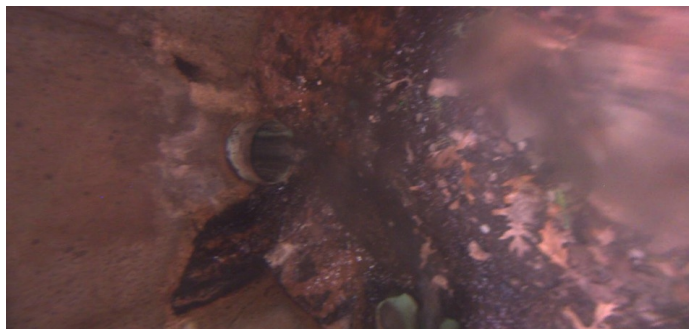
Code:	IS
Description:	Infil Stain
Distance (ft):	4.1
Structural Grade:	0
O&M Grade:	0
Clock Start/From:	8
Clock To:	
1st Value:	
2nd Value:	
Value Percent:	
Step:	NO
Remarks:

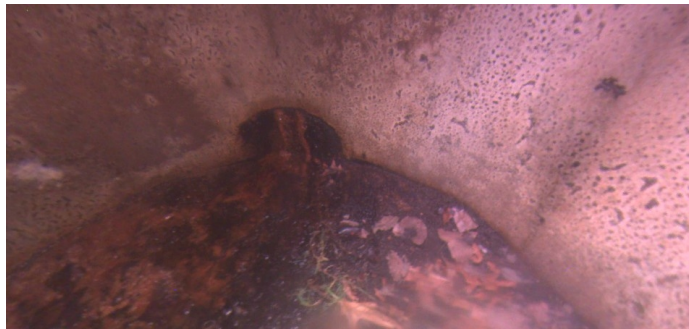
Code: **IS**
Description: **Infil Stain**

Distance (ft): **4.4**
Structural Grade: **0**
O&M Grade: **0**
Clock Start/From: **12**
Clock To:
1st Value:
2nd Value:
Value Percent:
Step: **NO**
Remarks:

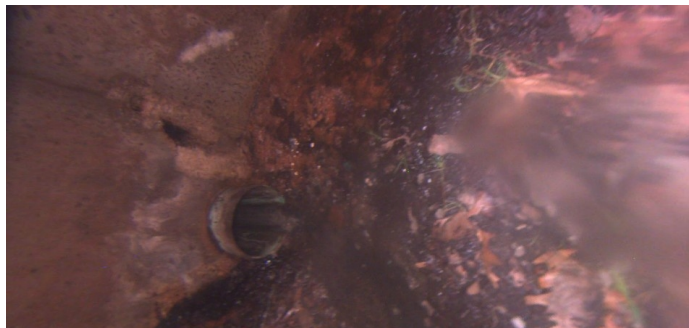
Code: **IS**
Description: **Infil Stain**

Distance (ft): **4.4**
Structural Grade: **0**
O&M Grade: **0**
Clock Start/From: **9**
Clock To:
1st Value:
2nd Value:
Value Percent:
Step: **NO**
Remarks:

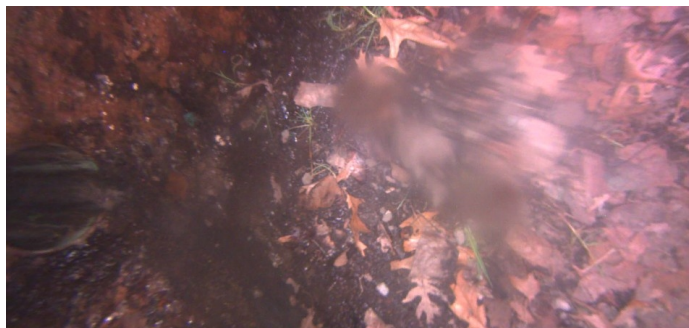
Code: **MGO**
Description: **General Observation**

Distance (ft): **4.7**
Structural Grade: **0**
O&M Grade: **0**
Clock Start/From:
Clock To:
1st Value:
2nd Value:
Value Percent:
Step: **NO**
Remarks: **Ins. Comp.**
