# Manhole Inspection Report

Date:	<b>04/17/2018</b>	Weather:		Coding:	<b>RZMACP</b>
MH#:	<b>M-303-052</b>	Owner:	<b>NA</b>	Len. Surveyed:	<b>5.1</b>
P.O.#:		Surveyor:	<b>Jen Costello</b>	Rim to Invert:	<b>6.1</b>
Customer:		Cert. #:	<b>U-907-5518</b>	Wall Material:	<b>Concrete (reinforced)</b>

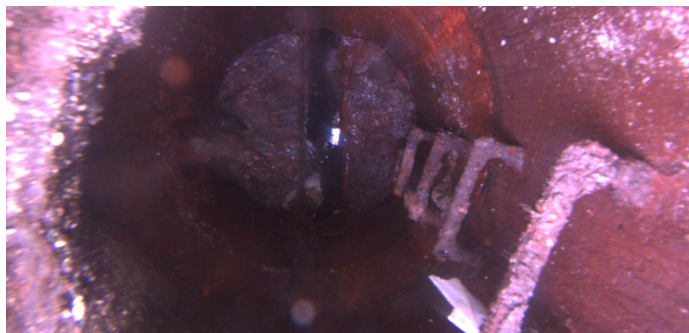
Code: **MGO**  
Description: **General Observation**

Distance (ft): **.0**  
Structural Grade: **0**  
O&M Grade: **0**  
Clock Start/From:  
Clock To:  
1st Value:  
2nd Value:  
Value Percent:  
Step: **NO**  
Remarks: **ACCESS MH**

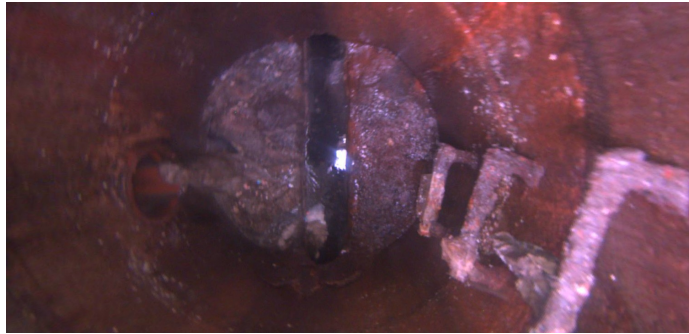
Code: **IS**  
Description: **Infil Stain**

Distance (ft): **.9**  
Structural Grade: **0**  
O&M Grade: **0**  
Clock Start/From: **12**  
Clock To: **12**  
1st Value:  
2nd Value:  
Value Percent:  
Step: **NO**  
Remarks:

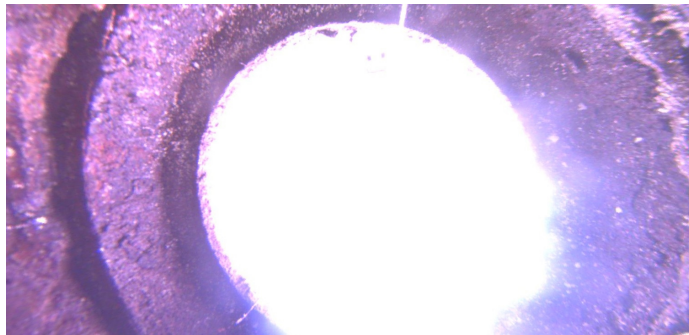
Code: **MGO**  
Description: **General Observation**

Distance (ft): **1.3**  
Structural Grade: **0**  
O&M Grade: **0**  
Clock Start/From:  
Clock To:  
1st Value:  
2nd Value:  
Value Percent:  
Step: **NO**  
Remarks: **UNDERSIDE OF FRAME**

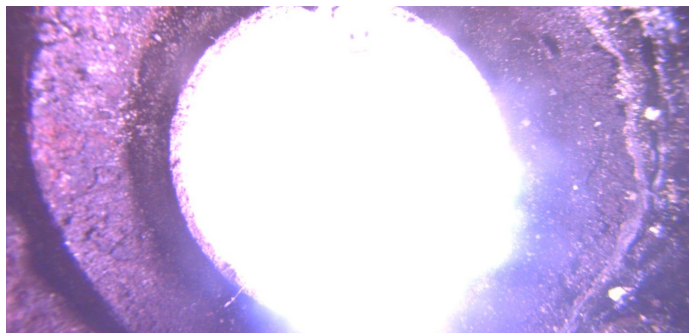
Code: **SAV**  
Description: **Surface Aggregate Visible**

Distance (ft): **1.3**  
Structural Grade: **3**  
O&M Grade: **0**  
Clock Start/From: **12**  
Clock To: **12**  
1st Value:  
2nd Value:  
Value Percent:  
Step: **NO**  
Remarks:

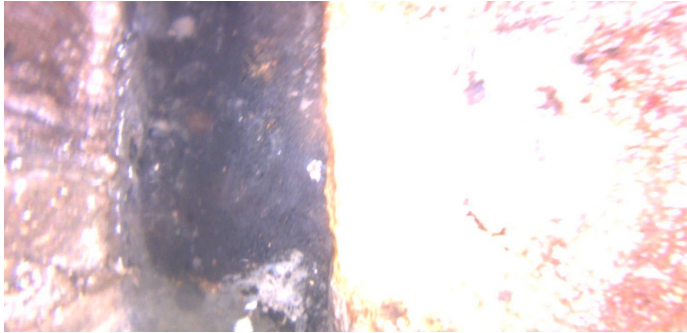
Code:	<b>MGO</b>
Description:	<b>General Observation</b>
Distance (ft):	<b>5.1</b>
Structural Grade:	<b>0</b>
O&M Grade:	<b>0</b>
Clock Start/From:	
Clock To:	
1st Value:	
2nd Value:	
Value Percent:	
Step:	<b>NO</b>
Remarks:	<b>END SURVEY</b>
