# Manhole Inspection Report

Date:	<b>04/18/2018</b>	Weather:		Coding:	<b>RZMACP</b>
MH#:	<b>M-303-053</b>	Owner:	<b>NA</b>	Len. Surveyed:	<b>5.3</b>
P.O.#:		Surveyor:	<b>Jen Costello</b>	Rim to Invert:	<b>6.8</b>
Customer:		Cert. #:	<b>U-907-5518</b>	Wall Material:	<b>Concrete (reinforced)</b>

Street:	<b>165' East of Maxwell St. 125' North</b>	Project:	<b>Hobart, IN</b>
City:	<b>Hobart, IN</b>	GPS Northing:	<b>0.0</b>
Location:		GPS Easting:	<b>0.0</b>
Drain Area:	<b>Northwest</b>	GPS Accuracy:	<b>Nearest Meter</b>
Cover Shape:	<b>Circular</b>	Evidence of Surcharge:	<b>No</b>
Cover Size:	<b>23.0</b>	Potential for Runoff:	<b>None</b>
Comments:

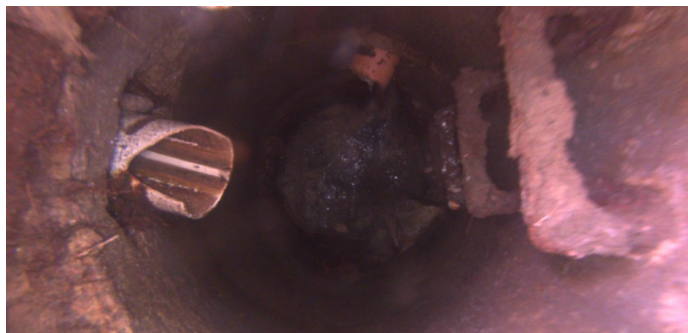
Code: **MGO**  
Description: **General Observation**

Distance (ft): **.0**  
Structural Grade: **0**  
O&M Grade: **0**  
Clock Start/From:  
Clock To:  
1st Value:  
2nd Value:  
Value Percent:  
Step: **NO**  
Remarks: **ACCESS MH**

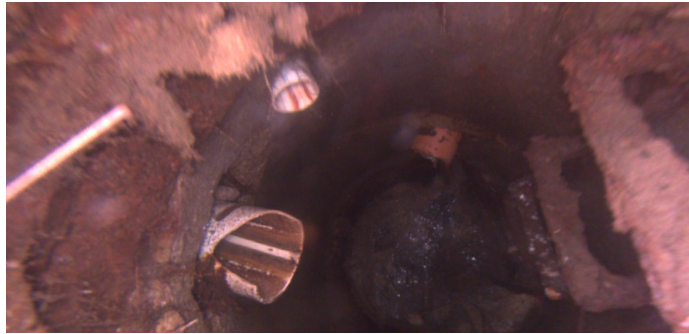
Code: **RMJ**  
Description: **Roots Medium Joint**

Distance (ft): **.0**  
Structural Grade: **0**  
O&M Grade: **3**  
Clock Start/From: **8**  
Clock To: **12**  
1st Value:  
2nd Value:  
Value Percent: **5.000**  
Step: **NO**  
Remarks:

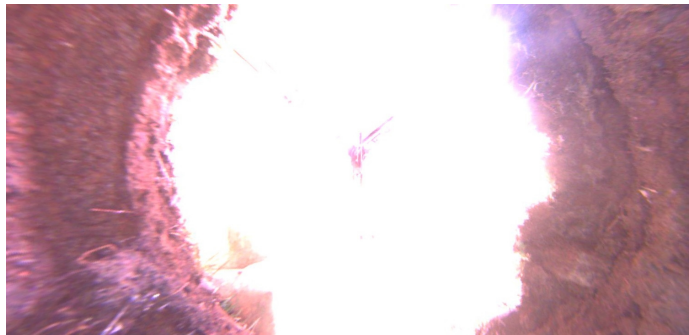
Code: **MGP**  
Description: **General Photo**

Distance (ft): **1.0**  
Structural Grade: **0**  
O&M Grade: **0**  
Clock Start/From:  
Clock To:  
1st Value:  
2nd Value:  
Value Percent:  
Step: **NO**  
Remarks: **UNDERSIDE OF FRAME**

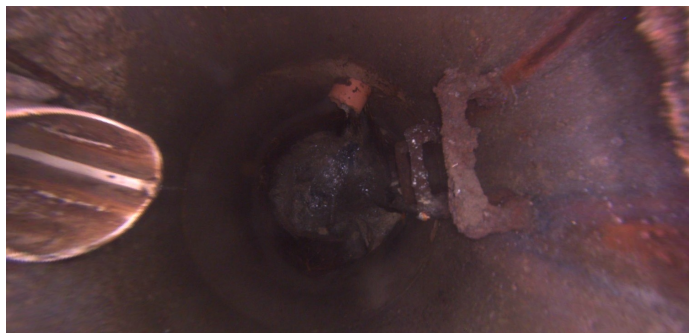
Code: **SRI**  
Description: **Surface Roughness Increased**

Distance (ft): **1.0**  
Structural Grade: **1**  
O&M Grade: **0**  
Clock Start/From: **12**  
Clock To: **12**  
1st Value:  
2nd Value:  
Value Percent:  
Step: **NO**  
Remarks:

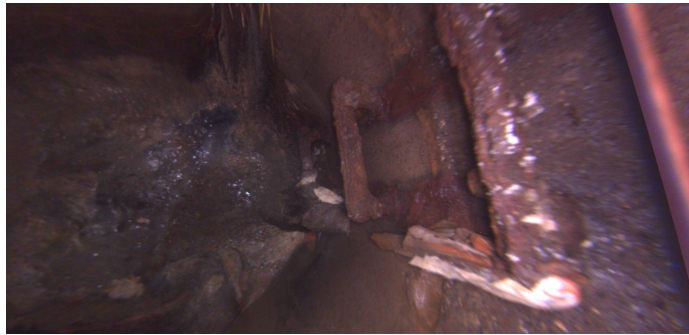
Code:	<b>DAR</b>
Description:	<b>Deposits Attached Ragging</b>
Distance (ft):	<b>2.9</b>
Structural Grade:	<b>0</b>
O&M Grade:	<b>2</b>
Clock Start/From:	<b>4</b>
Clock To:	
1st Value:	
2nd Value:	
Value Percent:	<b>5.000</b>
Step:	<b>YES</b>
Remarks:

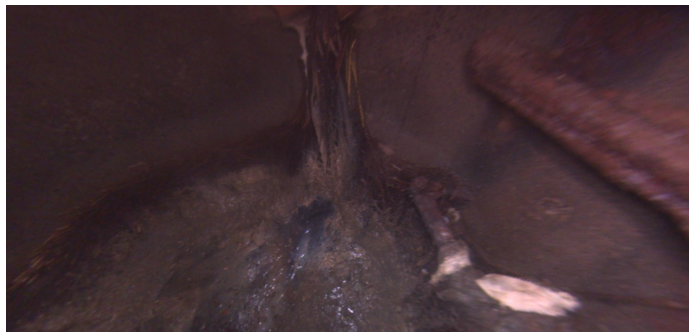
Code:	<b>RMC</b>
Description:	<b>Roots Medium Connection</b>
Distance (ft):	<b>3.9</b>
Structural Grade:	<b>0</b>
O&M Grade:	<b>3</b>
Clock Start/From:	<b>12</b>
Clock To:	
1st Value:	
2nd Value:	
Value Percent:	<b>10.000</b>
Step:	<b>NO</b>
Remarks:

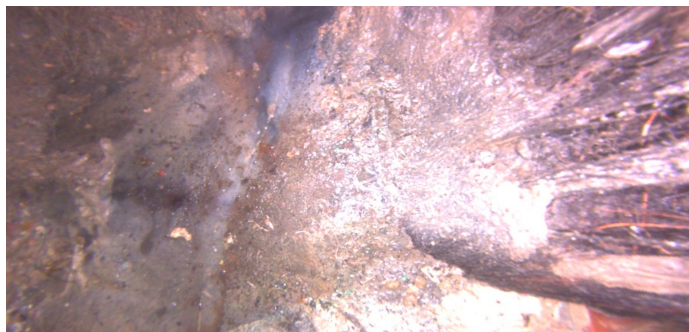
Code:	<b>MGO</b>
Description:	<b>General Observation</b>
Distance (ft):	<b>5.3</b>
Structural Grade:	<b>0</b>
O&M Grade:	<b>0</b>
Clock Start/From:	
Clock To:	
1st Value:	
2nd Value:	
Value Percent:	
Step:	<b>NO</b>
Remarks:	<b>END SURVEY</b>
