Manhole Inspection Report

Date:	04/13/2018	Weather:		Coding:	RZMACP
MH#:	M-303-058	Owner:	NA	Len. Surveyed:	4.3
P.O.#:		Surveyor:	Jen Costello	Rim to Invert:	5.6
Customer:		Cert. #:	U-907-5518	Wall Material:	Concrete (reinforced)

Street:	W. Hansen Blvd. 132' North of Ridge	Project:	Hobart, IN
City:	Hobart, IN	GPS Northing:	0.0
Location:		GPS Easting:	0.0
Drain Area:	Northwest	GPS Accuracy:	Nearest Meter
Cover Shape:	Circular	Evidence of Surcharge:	No
Cover Size:	23.0	Potential for Runoff:	None
Comments:

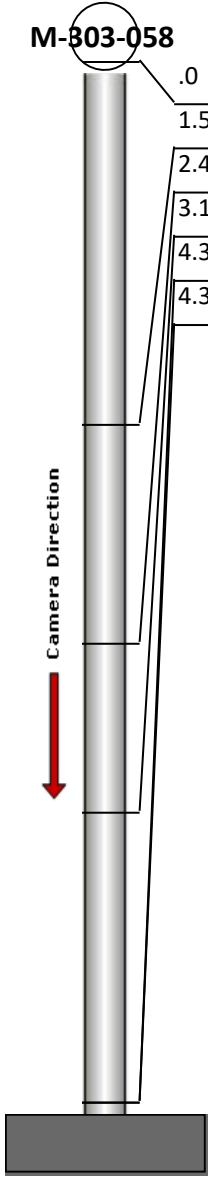
.0	MGO	General Observation	10	NA
	1.5	MGP	General Photo	26	NA
	2.4	IW	Infil Weeper	41	M 2
	3.1	OBR	Obstacle Rocks	54	M 2
	4.3	DSGV	Deposits Settled Gravel	68	M 2
	4.3	MGO	General Observation	79	NA

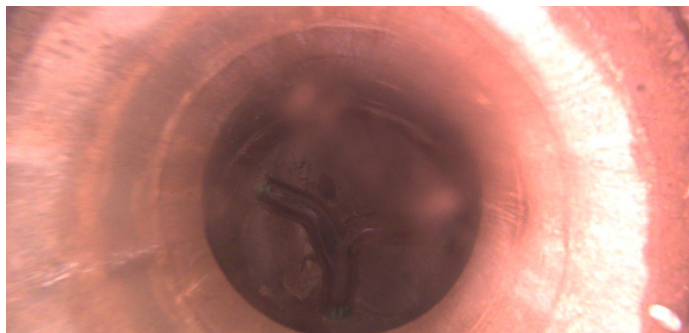
Code: **MGO**
Description: **General Observation**

Distance (ft): **.0**
Structural Grade: **0**
O&M Grade: **0**
Clock Start/From:
Clock To:
1st Value:
2nd Value:
Value Percent:
Step: **NO**
Remarks: **ACCESS MH**

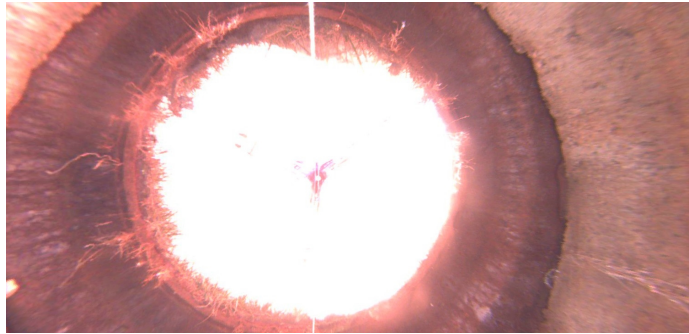
Code:	MGP
Description:	General Photo
Distance (ft):	1.5
Structural Grade:	0
O&M Grade:	0
Clock Start/From:	
Clock To:	
1st Value:	
2nd Value:	
Value Percent:	
Step:	NO
Remarks:	UNDERSIDE OF FRAME

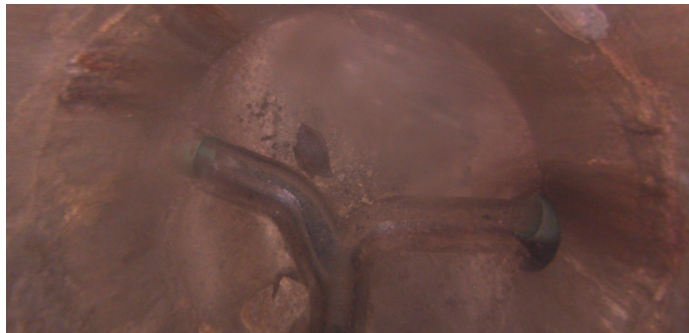
Code:	IW
Description:	Infil Weeper
Distance (ft):	2.4
Structural Grade:	0
O&M Grade:	2
Clock Start/From:	12
Clock To:	12
1st Value:	
2nd Value:	
Value Percent:	
Step:	NO
Remarks:

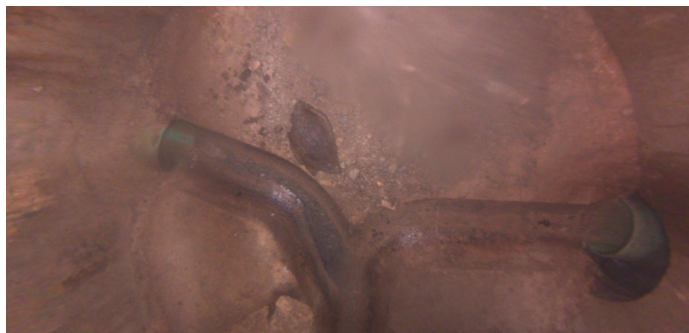
Code:	OBR
Description:	Obstacle Rocks
Distance (ft):	3.1
Structural Grade:	0
O&M Grade:	2
Clock Start/From:	6
Clock To:	
1st Value:	
2nd Value:	
Value Percent:	5.000
Step:	NO
Remarks:

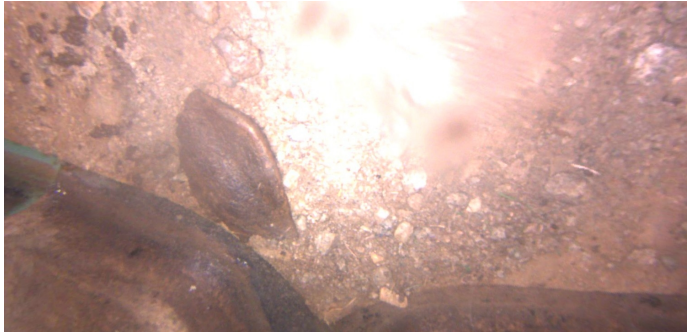
Code:	DSGV
Description:	Deposits Settled Gravel
Distance (ft):	4.3
Structural Grade:	0
O&M Grade:	2
Clock Start/From:	9
Clock To:	3
1st Value:	
2nd Value:	
Value Percent:	5.000
Step:	NO
Remarks:

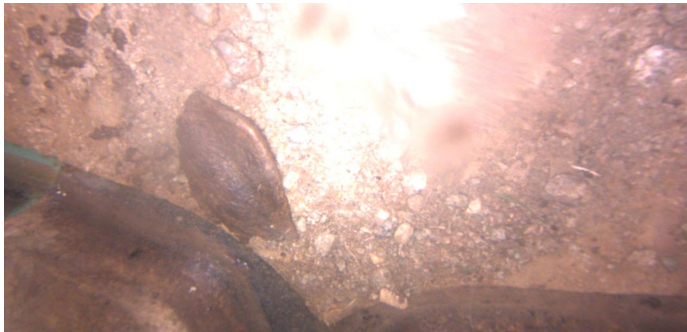
Code:	MGO
Description:	General Observation
Distance (ft):	4.3
Structural Grade:	0
O&M Grade:	0
Clock Start/From:	
Clock To:	
1st Value:	
2nd Value:	
Value Percent:	
Step:	NO
Remarks:	END SURVEY
