# Manhole Inspection Report

Date:	<b>04/13/2018</b>	Weather:		Coding:	<b>RZMACP</b>
MH#:	<b>M-303-061</b>	Owner:	<b>NA</b>	Len. Surveyed:	<b>3.6</b>
P.O.#:		Surveyor:	<b>Jen Costello</b>	Rim to Invert:	<b>4.5</b>
Customer:		Cert. #:	<b>U-907-5518</b>	Wall Material:	<b>Concrete (reinforced)</b>

Street:	<b>W. Hansen Blvd. 324' South of N. Ha</b>	Project:	<b>Hobart, IN</b>
City:	<b>Hobart, IN</b>	GPS Northing:	<b>0.0</b>
Location:		GPS Easting:	<b>0.0</b>
Drain Area:	<b>Northwest</b>	GPS Accuracy:	<b>Nearest Meter</b>
Cover Shape:	<b>Circular</b>	Evidence of Surcharge:	<b>No</b>
Cover Size:	<b>23.0</b>	Potential for Runoff:	<b>None</b>
Comments:

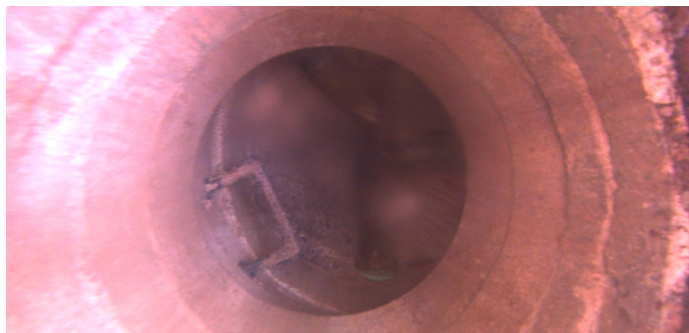
Code: **MGO**  
Description: **General Observation**

Distance (ft): **.0**  
Structural Grade: **0**  
O&M Grade: **0**  
Clock Start/From:  
Clock To:  
1st Value:  
2nd Value:  
Value Percent:  
Step: **NO**  
Remarks: **ACCESS MH**

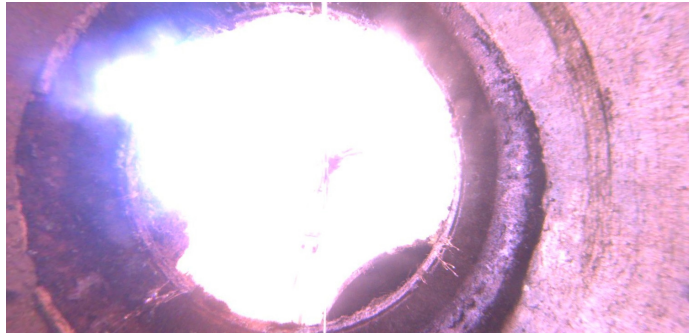
Code:	<b>MGP</b>
Description:	<b>General Photo</b>
Distance (ft):	<b>1.6</b>
Structural Grade:	<b>0</b>
O&M Grade:	<b>0</b>
Clock Start/From:	
Clock To:	
1st Value:	
2nd Value:	
Value Percent:	
Step:	<b>NO</b>
Remarks:	<b>UNDERSIDE OF FRAME</b>

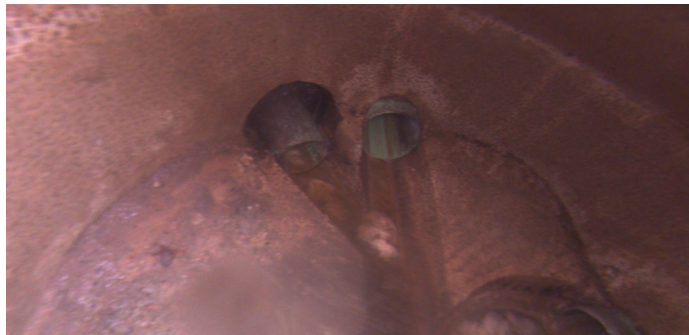
Code:	<b>SAV</b>
Description:	<b>Surface Aggregate Visible</b>
Distance (ft):	<b>2.5</b>
Structural Grade:	<b>3</b>
O&M Grade:	<b>0</b>
Clock Start/From:	<b>12</b>
Clock To:	<b>12</b>
1st Value:	
2nd Value:	
Value Percent:	
Step:	<b>NO</b>
Remarks:

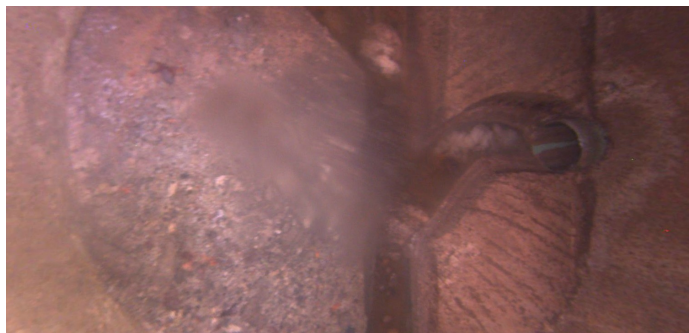
Code:	<b>SAP</b>
Description:	<b>Surface Aggregate Projecting</b>
Distance (ft):	<b>2.5</b>
Structural Grade:	<b>3</b>
O&M Grade:	<b>0</b>
Clock Start/From:	<b>12</b>
Clock To:	<b>12</b>
1st Value:	
2nd Value:	
Value Percent:	
Step:	<b>NO</b>
Remarks:

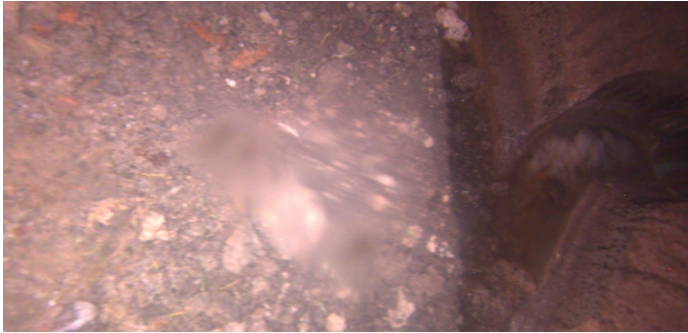
Code:	<b>MGO</b>
Description:	<b>General Observation</b>
Distance (ft):	<b>3.6</b>
Structural Grade:	<b>0</b>
O&M Grade:	<b>0</b>
Clock Start/From:	
Clock To:	
1st Value:	
2nd Value:	
Value Percent:	
Step:	<b>NO</b>
Remarks:	<b>END SURVEY</b>
