Manhole Inspection Report

Date:	10/06/2022	Weather:		Coding:	RZMACP
MH#:	M-303-069	Owner:	NA	Len. Surveyed:	5.4
P.O.#:		Surveyor:	Todd Machine	Rim to Invert:	6.4
Customer:		Cert. #:	P0038859-082022	Wall Material:	Concrete (precast)

Street:	39th Ave. and Ridgelawn St.	Project:	Hobart, IN
City:	Hobart, IN	GPS Northing:	2294563.427
Location:	Other	GPS Easting:	2895426
Drain Area:	Northwest	GPS Accuracy:	Sub-Meter
Cover Shape:	Circular	Evidence of Surcharge:	No
Cover Size:	24.0	Potential for Runoff:	None
Comments:

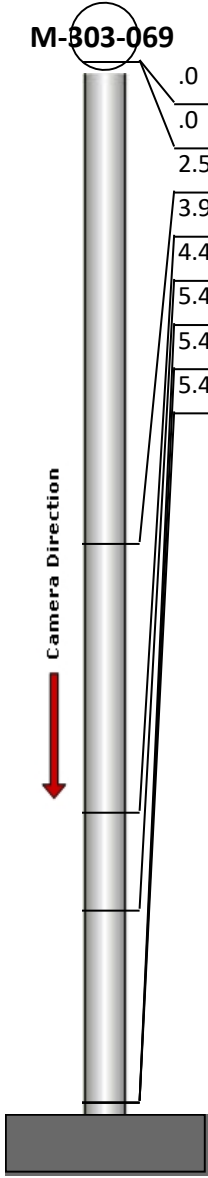
.0	MGO	General Observation	10	NA
	.0	SRI	Surface Roughness Increased	21	S 1
	2.5	MGO	General Observation	40	NA
	3.9	IW	Infil Weeper	56	M 2
	4.4	IW	Infil Weeper	69	M 2
	5.4	DSF	Deposits Settled Fine	83	M 2
	5.4	SRI	Surface Roughness Increased	94	S 1
	5.4	MGO	General Observation	105	NA

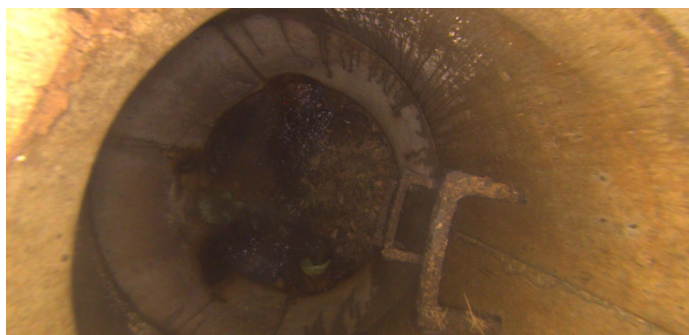
Code: **MGO**
Description: **General Observation**

Distance (ft): **.0**
Structural Grade: **0**
O&M Grade: **0**
Clock Start/From:
Clock To:
1st Value:
2nd Value:
Value Percent:
Step: **NO**
Remarks: **access mh**

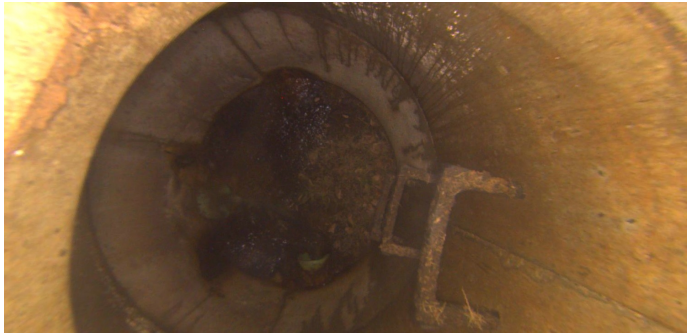
Code: **SRI**
Description: **Surface Roughness Increased**

Distance (ft): **.0**
Structural Grade: **1**
O&M Grade: **0**
Clock Start/From: **12**
Clock To: **12**
1st Value:
2nd Value:
Value Percent:
Step: **NO**
Remarks:

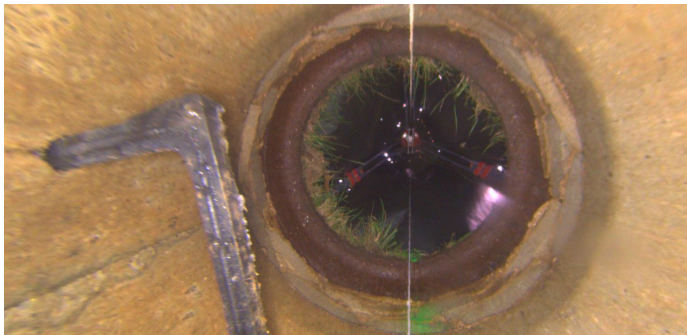
Code: **MGO**
Description: **General Observation**

Distance (ft): **2.5**
Structural Grade: **0**
O&M Grade: **0**
Clock Start/From:
Clock To:
1st Value:
2nd Value:
Value Percent:
Step: **NO**
Remarks: **underside of frame**

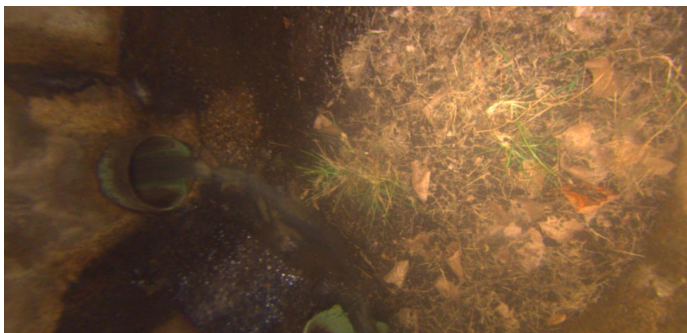
Code: **IW**
Description: **Infil Weeper**

Distance (ft): **3.9**
Structural Grade: **0**
O&M Grade: **2**
Clock Start/From: **6**
Clock To: **12**
1st Value:
2nd Value:
Value Percent:
Step: **NO**
Remarks:

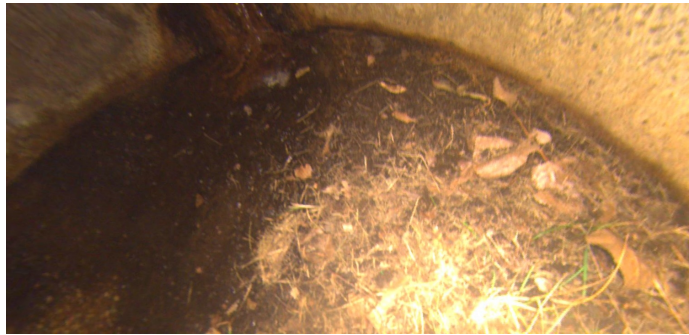
Code: **IW**
Description: **Infil Weeper**

Distance (ft): **4.4**
Structural Grade: **0**
O&M Grade: **2**
Clock Start/From: **12**
Clock To:
1st Value:
2nd Value:
Value Percent:
Step: **NO**
Remarks:

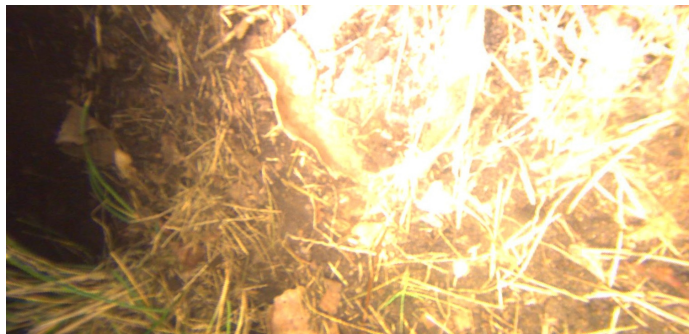
Code: **DSF**
Description: **Deposits Settled Fine**

Distance (ft): **5.4**
Structural Grade: **0**
O&M Grade: **2**
Clock Start/From: **12**
Clock To: **12**
1st Value:
2nd Value:
Value Percent: **5.000**
Step: **NO**
Remarks:

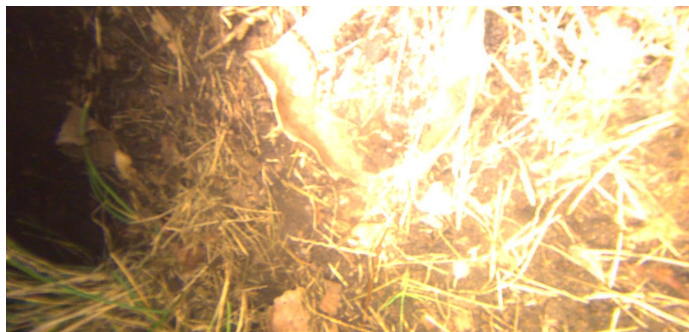
Code: **SRI**
Description: **Surface Roughness Increased**

Distance (ft): **5.4**
Structural Grade: **1**
O&M Grade: **0**
Clock Start/From: **12**
Clock To: **12**
1st Value:
2nd Value:
Value Percent:
Step: **NO**
Remarks:

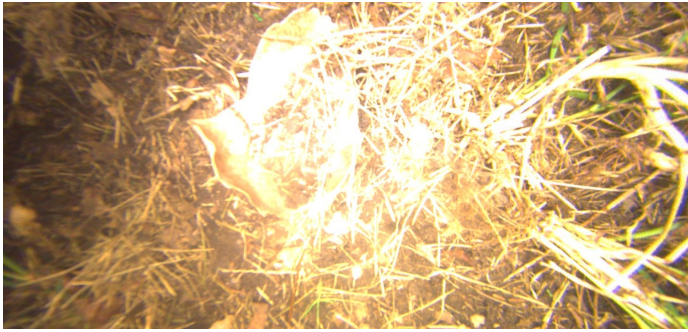
Code:	MGO
Description:	General Observation
Distance (ft):	5.4
Structural Grade:	0
O&M Grade:	0
Clock Start/From:	
Clock To:	
1st Value:	
2nd Value:	
Value Percent:	
Step:	NO
Remarks:	End Of Survey
