Manhole Inspection Report

Date:	04/12/2018	Weather:		Coding:	RZMACP
MH#:	M-303-073	Owner:	NA	Len. Surveyed:	6.3
P.O.#:		Surveyor:	John Kuglmaier	Rim to Invert:	7.9
Customer:		Cert. #:	U-1215-07002349	Wall Material:	Concrete (reinforced)

Street:	On Ridgelawn Dr. 189' South of 39th	Project:	Hobart, IN
City:	Hobart, IN	GPS Northing:	2895395.47
Location:		GPS Easting:	2895395.47
Drain Area:	Northwest	GPS Accuracy:	Sub-Meter
Cover Shape:	Circular	Evidence of Surcharge:	Yes
Cover Size:	23.0	Potential for Runoff:	None
Comments:

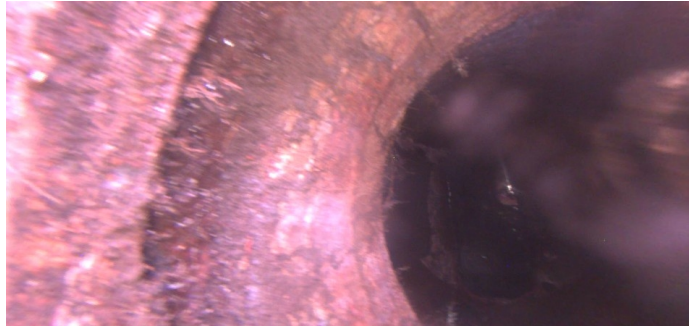
Code:	MGP
Description:	General Photo

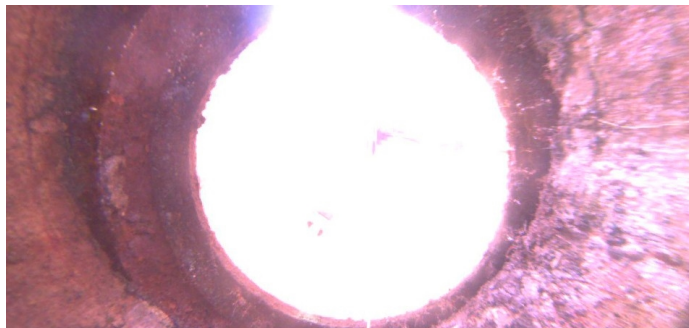
Code: **RFJ**
Description: **Roots Fine Joint**

Distance (ft): **.0**
Structural Grade: **0**
O&M Grade: **1**
Clock Start/From: **8**
Clock To: **11**
1st Value:
2nd Value:
Value Percent:
Step: **NO**
Remarks:

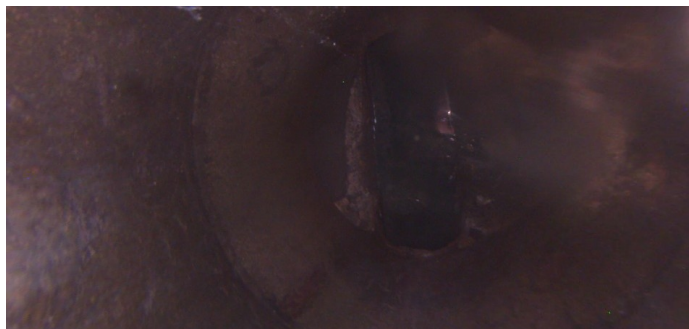
Code: **MGP**
Description: **General Photo**

Distance (ft): **1.8**
Structural Grade: **0**
O&M Grade: **0**
Clock Start/From:
Clock To:
1st Value:
2nd Value:
Value Percent:
Step: **NO**
Remarks:

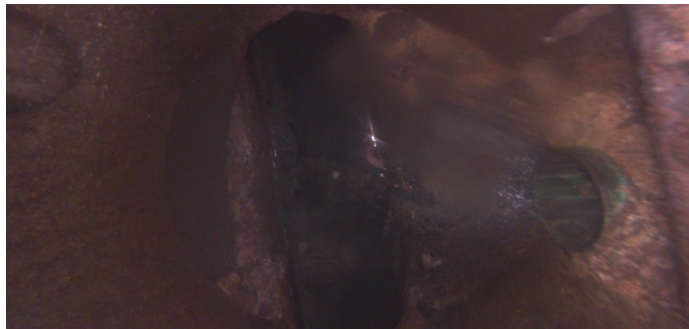
Code: **IS**
Description: **Infil Stain**

Distance (ft): **2.2**
Structural Grade: **0**
O&M Grade: **0**
Clock Start/From: **7**
Clock To:
1st Value:
2nd Value:
Value Percent:
Step: **NO**
Remarks:

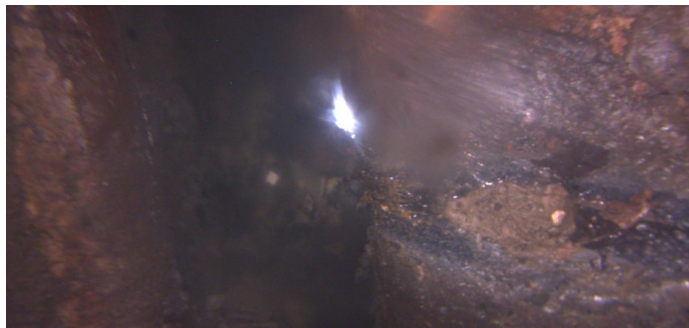
Code:	DSF
Description:	Deposits Settled Fine
Distance (ft):	3.9
Structural Grade:	0
O&M Grade:	2
Clock Start/From:	12
Clock To:	12
1st Value:	
2nd Value:	
Value Percent:	5.000
Step:	NO
Remarks:
