# Manhole Inspection Report

Date:	<b>05/17/2018</b>	Weather:		Coding:	<b>RZMACP</b>
MH#:	<b>M-305-001</b>	Owner:	<b>NA</b>	Len. Surveyed:	<b>7.3</b>
P.O.#:		Surveyor:	<b>Jen Costello</b>	Rim to Invert:	<b>7.8</b>
Customer:		Cert. #:	<b>U-907-5518</b>	Wall Material:	<b>Concrete (reinforced)</b>

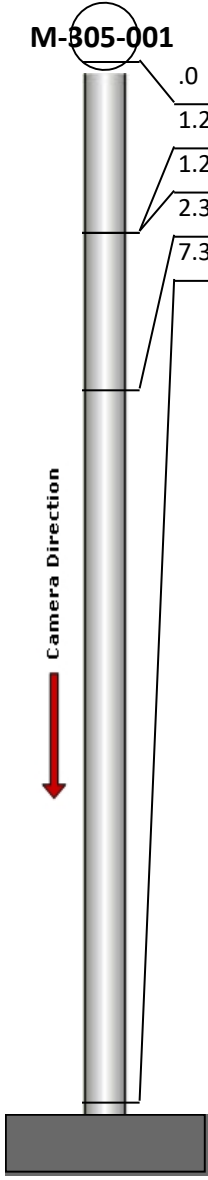
Position	Code	Observation	Video (sec)	Grade

.0	MGO	General Observation	10	NA
	1.2	MGO	General Observation	25	NA
	1.2	OBP	Obstacle External Pipe or Cable	38	M 2
	2.3	OBP	Obstacle External Pipe or Cable	53	M 2
	7.3	MGO	General Observation	75	NA

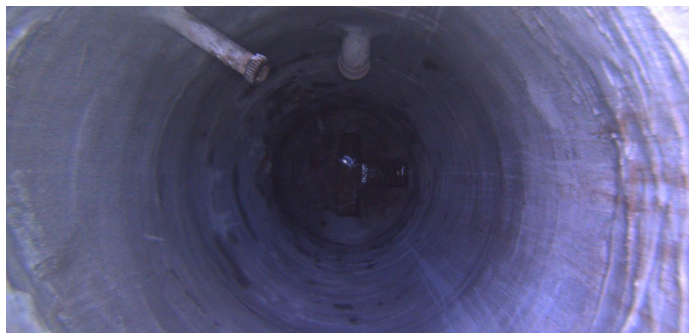
Code: **MGO**  
Description: **General Observation**

Distance (ft): **.0**  
Structural Grade: **0**  
O&M Grade: **0**  
Clock Start/From:  
Clock To:  
1st Value:  
2nd Value:  
Value Percent:  
Step: **NO**  
Remarks: **ACCESS MH**

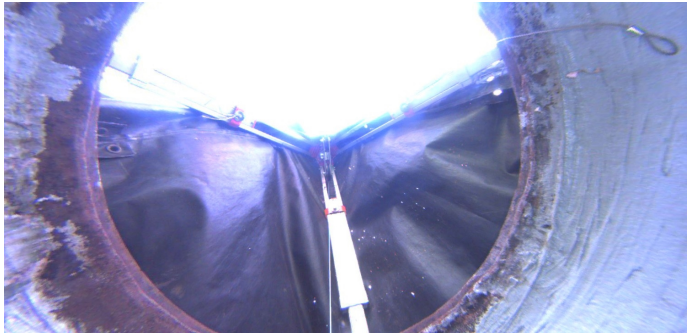
Code:	<b>MGO</b>
Description:	<b>General Observation</b>
Distance (ft):	<b>1.2</b>
Structural Grade:	<b>0</b>
O&M Grade:	<b>0</b>
Clock Start/From:	
Clock To:	
1st Value:	
2nd Value:	
Value Percent:	
Step:	<b>NO</b>
Remarks:	<b>UNDERSIDE OF FRAME</b>

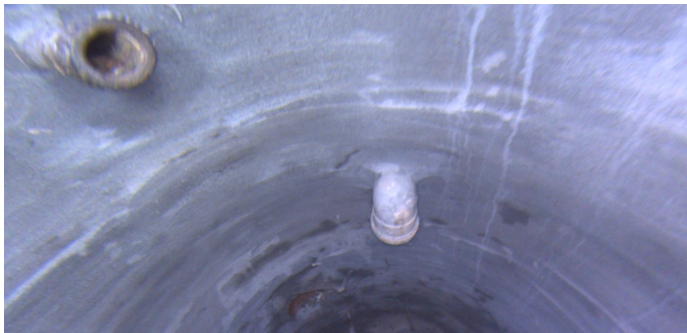
Code:	<b>OBP</b>
Description:	<b>Obstacle External Pipe or Cable</b>
Distance (ft):	<b>1.2</b>
Structural Grade:	<b>0</b>
O&M Grade:	<b>2</b>
Clock Start/From:	<b>11</b>
Clock To:	
1st Value:	
2nd Value:	
Value Percent:	<b>5.000</b>
Step:	<b>NO</b>
Remarks:

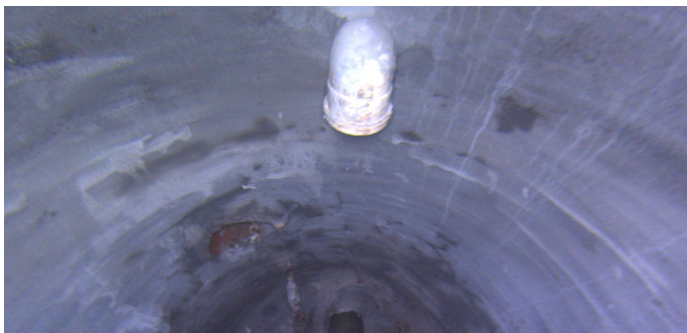
Code:	<b>OBP</b>
Description:	<b>Obstacle External Pipe or Cable</b>
Distance (ft):	<b>2.3</b>
Structural Grade:	<b>0</b>
O&M Grade:	<b>2</b>
Clock Start/From:	<b>12</b>
Clock To:	
1st Value:	
2nd Value:	
Value Percent:	<b>5.000</b>
Step:	<b>NO</b>
Remarks:

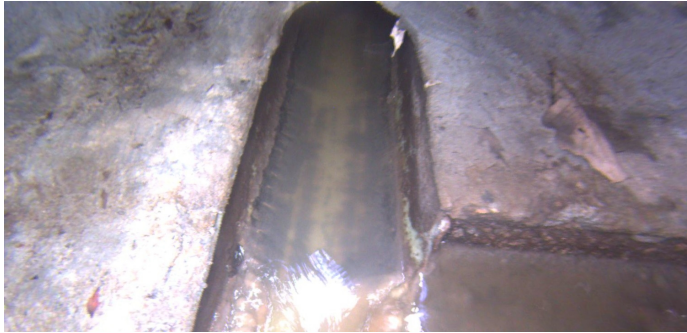
Code: **MGO**  
Description: **General Observation**

Distance (ft): **7.3**  
Structural Grade: **0**  
O&M Grade: **0**  
Clock Start/From:  
Clock To:  
1st Value:  
2nd Value:  
Value Percent:  
Step: **NO**  
Remarks: **END SURVEY**
