# Manhole Inspection Report

Date:	<b>09/28/2022</b>	Weather:		Coding:	<b>RZMACP</b>
MH#:	<b>M-305-002</b>	Owner:	<b>NA</b>	Len. Surveyed:	<b>5.7</b>
P.O.#:		Surveyor:	<b>Jen Costello</b>	Rim to Invert:	<b>6.5</b>
Customer:		Cert. #:	<b>U-907-5518</b>	Wall Material:	<b>Concrete (cast in place)</b>

Street:	<b>North of 49th Ave. 406' West of Cres</b>	Project:	<b>Hobart, IN</b>
City:	<b>Hobart, IN</b>	GPS Northing:	<b>2288044.84</b>
Location:	<b>Yard</b>	GPS Easting:	<b>2896499.515</b>
Drain Area:	<b>West</b>	GPS Accuracy:	<b>Sub-Meter</b>
Cover Shape:	<b>Circular</b>	Evidence of Surcharge:	<b>No</b>
Cover Size:	<b>24.0</b>	Potential for Runoff:	<b>None</b>
Comments:

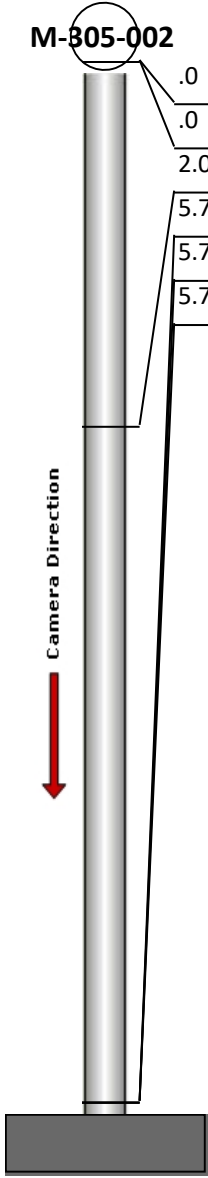
M-305-002				
	.0	MGO	General Observation	10	NA
	.0	SRI	Surface Roughness Increased	21	S 1
	2.0	MGO	General Observation	39	NA
	5.7	DSF	Deposits Settled Fine	60	M 2
	5.7	MGO	General Observation	71	NA
	5.7	SAV	Surface Aggregate Visible	82	S 3

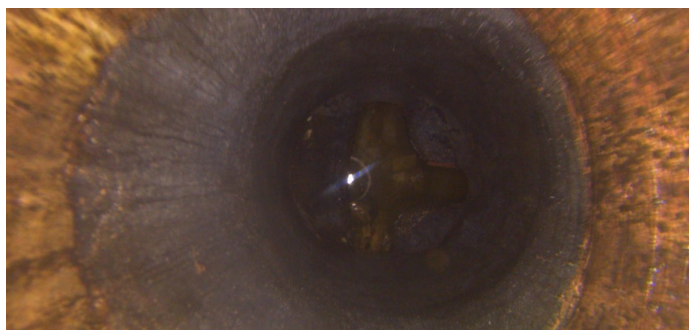
Code: **MGO**  
Description: **General Observation**

Distance (ft): **.0**  
Structural Grade: **0**  
O&M Grade: **0**  
Clock Start/From:  
Clock To:  
1st Value:  
2nd Value:  
Value Percent:  
Step: **NO**  
Remarks: **access mh**

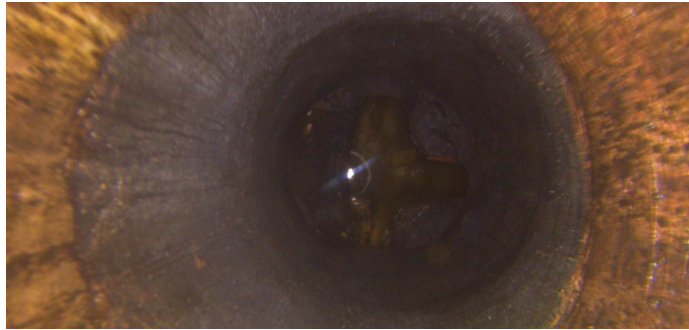
Code: **SRI**  
Description: **Surface Roughness Increased**

Distance (ft): **.0**  
Structural Grade: **1**  
O&M Grade: **0**  
Clock Start/From: **12**  
Clock To: **12**  
1st Value:  
2nd Value:  
Value Percent:  
Step: **NO**  
Remarks:

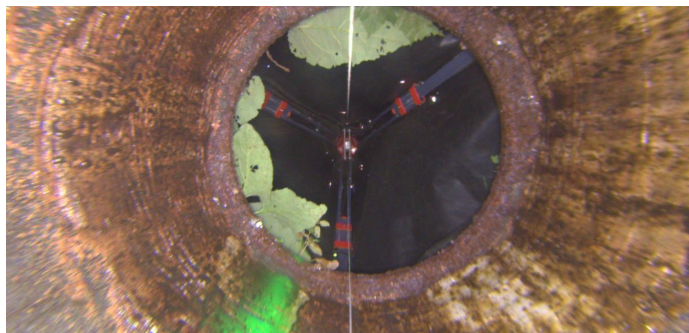
Code: **MGO**  
Description: **General Observation**

Distance (ft): **2.0**  
Structural Grade: **0**  
O&M Grade: **0**  
Clock Start/From:  
Clock To:  
1st Value:  
2nd Value:  
Value Percent:  
Step: **NO**  
Remarks: **underside of frame**

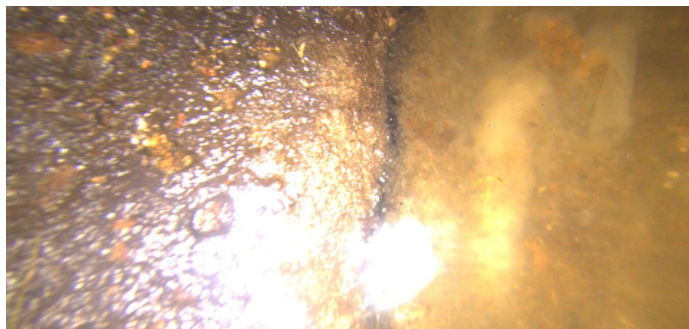
Code: **DSF**  
Description: **Deposits Settled Fine**

Distance (ft): **5.7**  
Structural Grade: **0**  
O&M Grade: **2**  
Clock Start/From: **12**  
Clock To: **12**  
1st Value:  
2nd Value:  
Value Percent: **5.000**  
Step: **NO**  
Remarks:

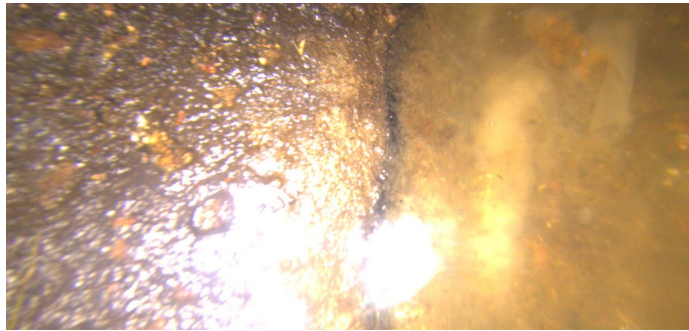
Code: **MGO**  
Description: **General Observation**

Distance (ft): **5.7**  
Structural Grade: **0**  
O&M Grade: **0**  
Clock Start/From:  
Clock To:  
1st Value:  
2nd Value:  
Value Percent:  
Step: **NO**  
Remarks: **end of survey**

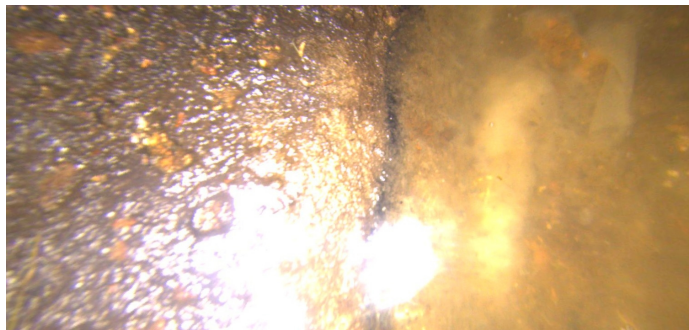
Code: **SAV**  
Description: **Surface Aggregate Visible**

Distance (ft): **5.7**  
Structural Grade: **3**  
O&M Grade: **0**  
Clock Start/From: **12**  
Clock To: **12**  
1st Value:  
2nd Value:  
Value Percent:  
Step: **NO**  
Remarks:
