# Manhole Inspection Report

Date:	<b>09/28/2022</b>	Weather:		Coding:	<b>RZMACP</b>
MH#:	<b>M-305-004</b>	Owner:	<b>NA</b>	Len. Surveyed:	<b>8.4</b>
P.O.#:		Surveyor:	<b>Jen Costello</b>	Rim to Invert:	<b>9.3</b>
Customer:		Cert. #:	<b>U-907-5518</b>	Wall Material:	<b>Concrete (cast in place)</b>

Street:	<b>North of 49th Ave. 519' East of Wild</b>	Project:	<b>Hobart, IN</b>
City:	<b>Hobart, IN</b>	GPS Northing:	<b>2288042.767</b>
Location:	<b>Yard</b>	GPS Easting:	<b>2895923.445</b>
Drain Area:	<b>West</b>	GPS Accuracy:	<b>Sub-Meter</b>
Cover Shape:	<b>Circular</b>	Evidence of Surcharge:	<b>No</b>
Cover Size:	<b>24.0</b>	Potential for Runoff:	<b>None</b>
Comments:

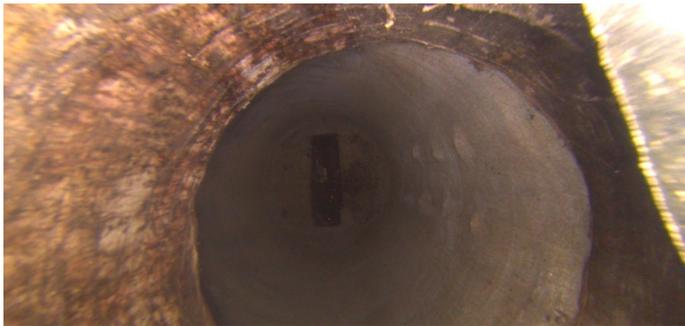
Code: **MGO**  
Description: **General Observation**

Distance (ft): **.0**  
Structural Grade: **0**  
O&M Grade: **0**  
Clock Start/From:  
Clock To:  
1st Value:  
2nd Value:  
Value Percent:  
Step: **NO**  
Remarks: **access mh**

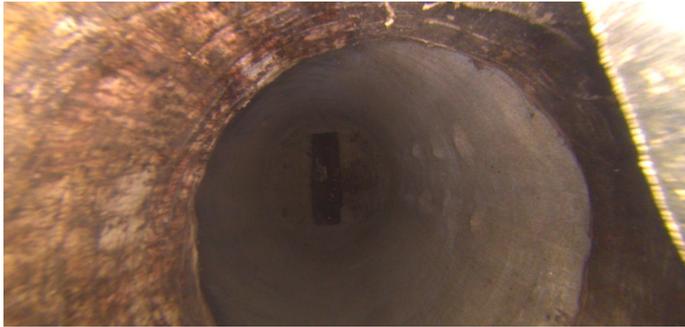
Code: **SRI**  
Description: **Surface Roughness Increased**

Distance (ft): **.0**  
Structural Grade: **1**  
O&M Grade: **0**  
Clock Start/From: **12**  
Clock To: **12**  
1st Value:  
2nd Value:  
Value Percent:  
Step: **NO**  
Remarks:

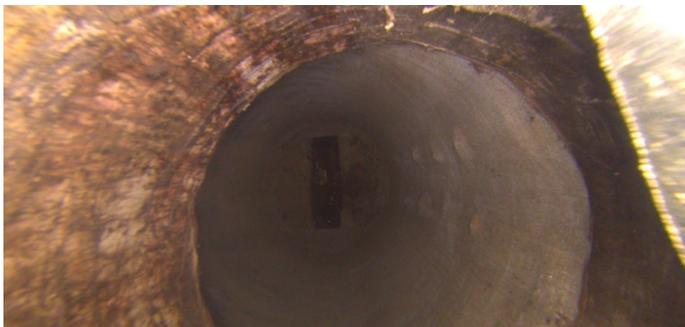
Code: **IW**  
Description: **Infil Weeper**

Distance (ft): **.0**  
Structural Grade: **0**  
O&M Grade: **2**  
Clock Start/From: **12**  
Clock To: **12**  
1st Value:  
2nd Value:  
Value Percent:  
Step: **NO**  
Remarks:

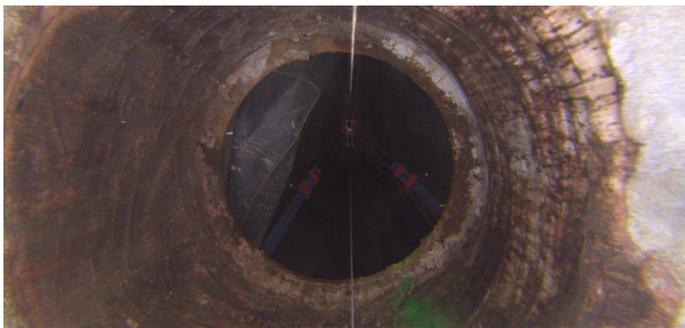
Code: **MGO**  
Description: **General Observation**

Distance (ft): **2.3**  
Structural Grade: **0**  
O&M Grade: **0**  
Clock Start/From:  
Clock To:  
1st Value:  
2nd Value:  
Value Percent:  
Step: **NO**  
Remarks: **underside of frame**

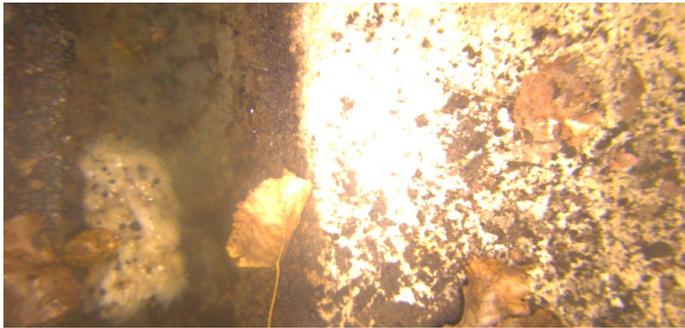
Code: **DSF**  
Description: **Deposits Settled Fine**

Distance (ft): **8.1**  
Structural Grade: **0**  
O&M Grade: **2**  
Clock Start/From: **12**  
Clock To: **12**  
1st Value:  
2nd Value:  
Value Percent: **5.000**  
Step: **NO**  
Remarks:

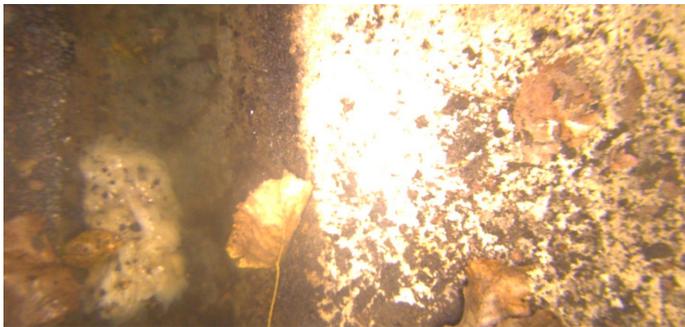
Code: **SRI**  
Description: **Surface Roughness Increased**

Distance (ft): **8.1**  
Structural Grade: **1**  
O&M Grade: **0**  
Clock Start/From: **3**  
Clock To: **9**  
1st Value:  
2nd Value:  
Value Percent:  
Step: **NO**  
Remarks:

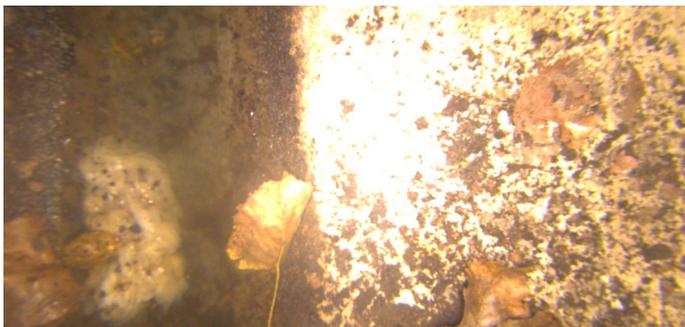
Code: **SRI**  
Description: **Surface Roughness Increased**

Distance (ft): **8.1**  
Structural Grade: **1**  
O&M Grade: **0**  
Clock Start/From: **12**  
Clock To: **12**  
1st Value:  
2nd Value:  
Value Percent:  
Step: **NO**  
Remarks:

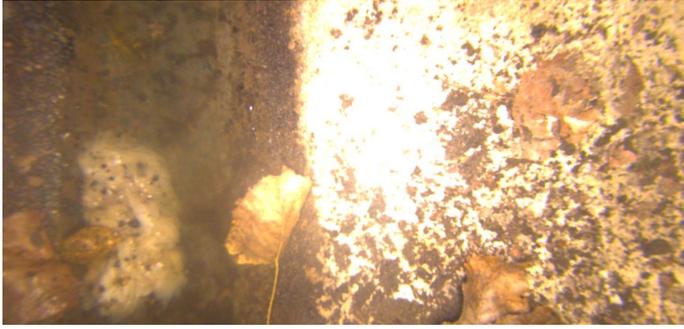
Code: **MGO**  
Description: **General Observation**

Distance (ft): **8.1**  
Structural Grade: **0**  
O&M Grade: **0**  
Clock Start/From:  
Clock To:  
1st Value:  
2nd Value:  
Value Percent:  
Step: **NO**  
Remarks: **end of survey**
