Manhole Inspection Report

Date:	05/06/2018	Weather:		Coding:	RZMACP
MH#:	M-305-005	Owner:	NA	Len. Surveyed:	6.3
P.O.#:		Surveyor:	Jen Costello	Rim to Invert:	7.7
Customer:		Cert. #:	U-907-5518	Wall Material:	Concrete (reinforced)

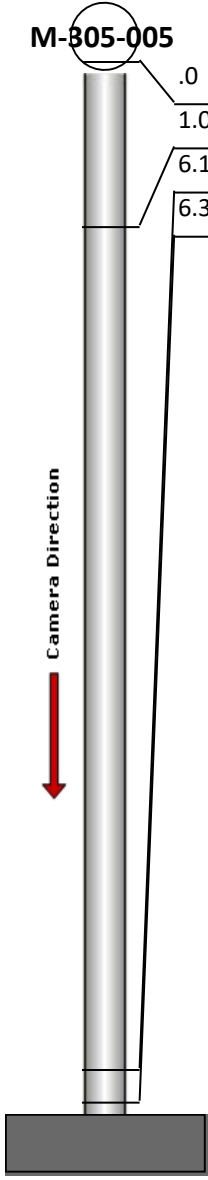
.0	MGO	General Observation	10	NA
	1.0	MGO	General Observation	25	NA
	6.1	DSF	Deposits Settled Fine	49	M 2
	6.3	MGO	General Observation	61	NA

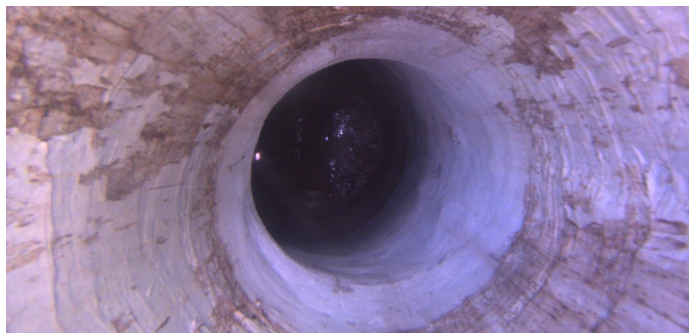
Code: **MGO**
Description: **General Observation**

Distance (ft): **.0**
Structural Grade: **0**
O&M Grade: **0**
Clock Start/From:
Clock To:
1st Value:
2nd Value:
Value Percent:
Step: **NO**
Remarks: **ACCESS MH**

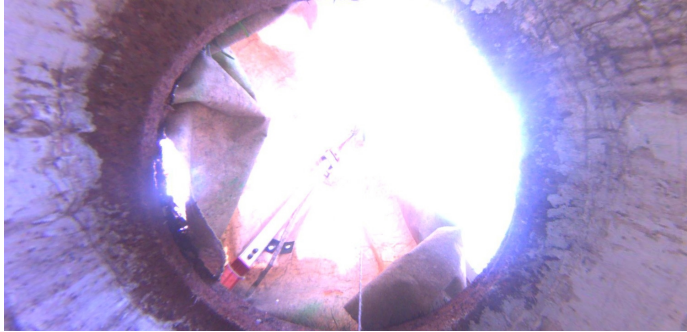
Code:	MGO
Description:	General Observation
Distance (ft):	1.0
Structural Grade:	0
O&M Grade:	0
Clock Start/From:	
Clock To:	
1st Value:	
2nd Value:	
Value Percent:	
Step:	NO
Remarks:	UNDERSIDE OF FRAME

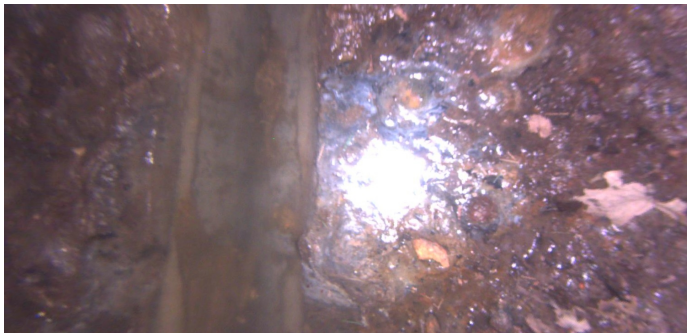
Code:	DSF
Description:	Deposits Settled Fine
Distance (ft):	6.1
Structural Grade:	0
O&M Grade:	2
Clock Start/From:	12
Clock To:	12
1st Value:	
2nd Value:	
Value Percent:	5.000
Step:	NO
Remarks:

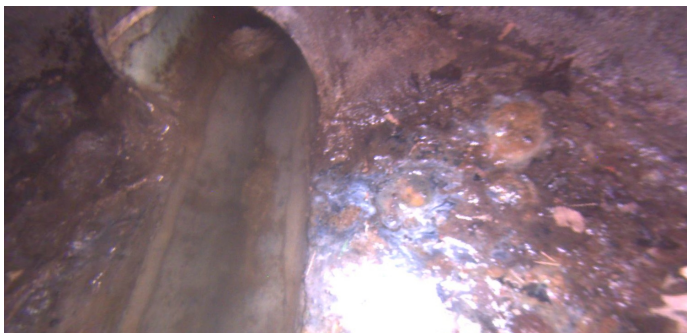
Code:	MGO
Description:	General Observation
Distance (ft):	6.3
Structural Grade:	0
O&M Grade:	0
Clock Start/From:	
Clock To:	
1st Value:	
2nd Value:	
Value Percent:	
Step:	NO
Remarks:	END SURVEY
