Manhole Inspection Report

Date:	05/06/2018	Weather:		Coding:	RZMACP
MH#:	M-305-006	Owner:	NA	Len. Surveyed:	5.6
P.O.#:		Surveyor:	Jen Costello	Rim to Invert:	8.8
Customer:		Cert. #:	U-907-5518	Wall Material:	Concrete (reinforced)

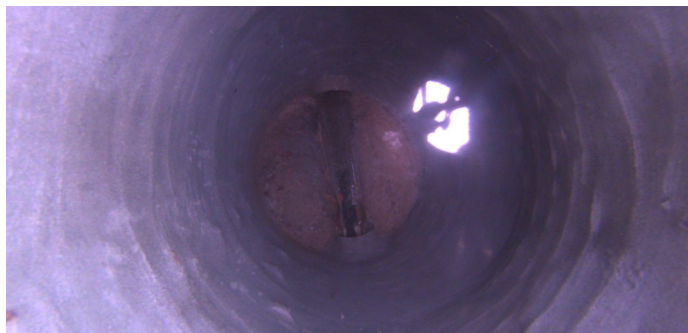
Code: **MGO**
Description: **General Observation**

Distance (ft): **.0**
Structural Grade: **0**
O&M Grade: **0**
Clock Start/From:
Clock To:
1st Value:
2nd Value:
Value Percent:
Step: **NO**
Remarks: **ACCESS MH**

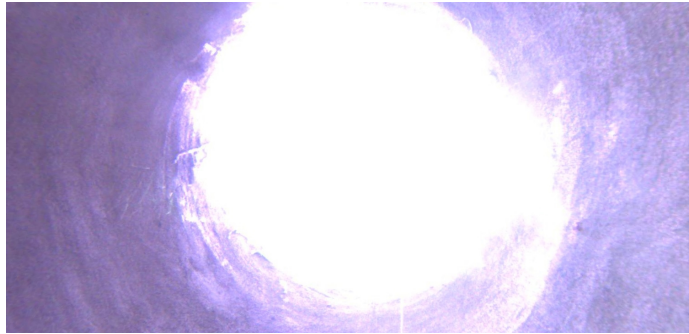
Code:	MGO
Description:	General Observation
Distance (ft):	1.8
Structural Grade:	0
O&M Grade:	0
Clock Start/From:	
Clock To:	
1st Value:	
2nd Value:	
Value Percent:	
Step:	NO
Remarks:	UNDERSIDE OF FRAME

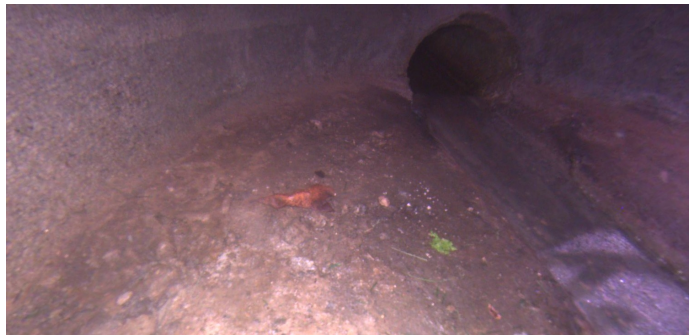
Code:	MGO
Description:	General Observation
Distance (ft):	5.6
Structural Grade:	0
O&M Grade:	0
Clock Start/From:	
Clock To:	
1st Value:	
2nd Value:	
Value Percent:	
Step:	NO
Remarks:	END SURVEY
