Manhole Inspection Report

Date:	09/28/2022	Weather:		Coding:	RZMACP
MH#:	M-305-007	Owner:	NA	Len. Surveyed:	8.4
P.O.#:		Surveyor:	Jen Costello	Rim to Invert:	8.8
Customer:		Cert. #:	U-907-5518	Wall Material:	Concrete (cast in place)

Street:	North of 49th Ave. 367' West of Wil	Project:	Hobart, IN
City:	Hobart, IN	GPS Northing:	2288047.984
Location:	Yard	GPS Easting:	2895036.31
Drain Area:	West	GPS Accuracy:	Sub-Meter
Cover Shape:	Circular	Evidence of Surcharge:	No
Cover Size:	24.0	Potential for Runoff:	None
Comments:

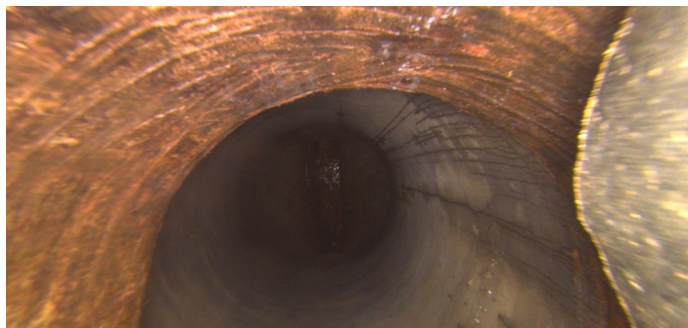
Code: **MGO**
Description: **General Observation**

Distance (ft): **.0**
Structural Grade: **0**
O&M Grade: **0**
Clock Start/From:
Clock To:
1st Value:
2nd Value:
Value Percent:
Step: **NO**
Remarks: **access mh**

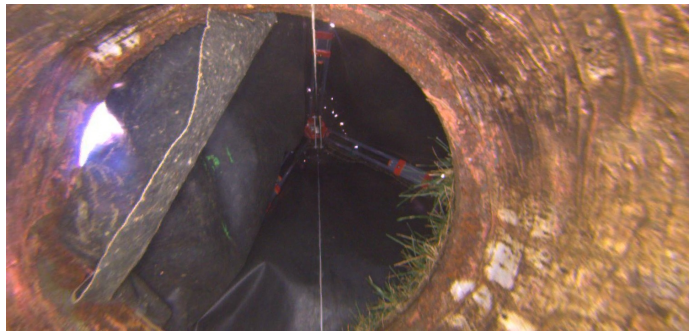
Code: **MGO**
Description: **General Observation**

Distance (ft): **1.6**
Structural Grade: **0**
O&M Grade: **0**
Clock Start/From:
Clock To:
1st Value:
2nd Value:
Value Percent:
Step: **NO**
Remarks: **underside of frame**
