Manhole Inspection Report

Date:	09/28/2022	Weather:		Coding:	RZMACP
MH#:	M-305-008	Owner:	NA	Len. Surveyed:	6.3
P.O.#:		Surveyor:	Jen Costello	Rim to Invert:	7.1
Customer:		Cert. #:	U-907-5518	Wall Material:	Concrete (cast in place)

Street:	North of 49th Ave. 606' West of Wil	Project:	Hobart, IN
City:	Hobart, IN	GPS Northing:	2288047.765
Location:	Yard	GPS Easting:	2894778.836
Drain Area:	West	GPS Accuracy:	Sub-Meter
Cover Shape:	Circular	Evidence of Surcharge:	No
Cover Size:	24.0	Potential for Runoff:	None
Comments:

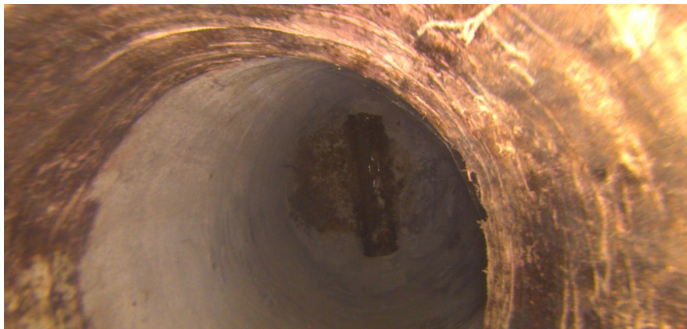
Code: **MGO**
Description: **General Observation**

Distance (ft): **.0**
Structural Grade: **0**
O&M Grade: **0**
Clock Start/From:
Clock To:
1st Value:
2nd Value:
Value Percent:
Step: **NO**
Remarks: **access mh**

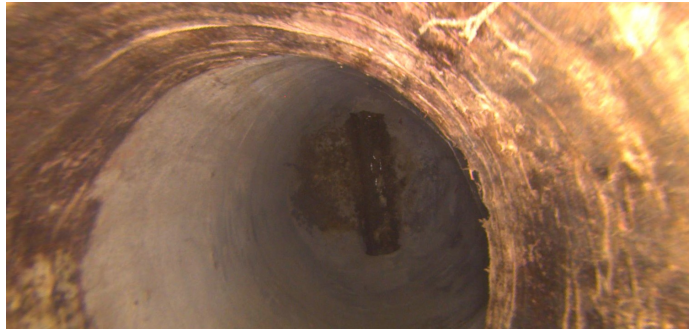
Code: **SRI**
Description: **Surface Roughness Increased**

Distance (ft): **.0**
Structural Grade: **1**
O&M Grade: **0**
Clock Start/From: **12**
Clock To: **12**
1st Value:
2nd Value:
Value Percent:
Step: **NO**
Remarks:

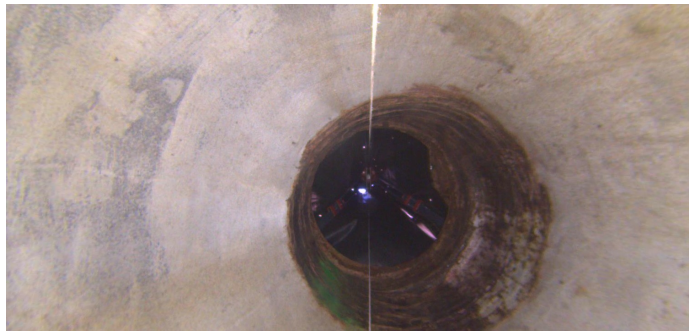
Code: **MGO**
Description: **General Observation**

Distance (ft): **3.8**
Structural Grade: **0**
O&M Grade: **0**
Clock Start/From:
Clock To:
1st Value:
2nd Value:
Value Percent:
Step: **NO**
Remarks: **underside of frame**

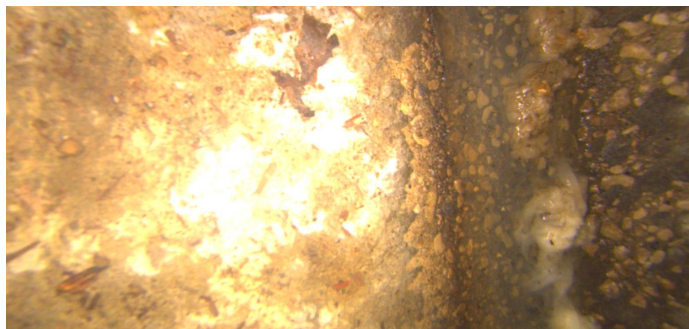
Code: **SRI**
Description: **Surface Roughness Increased**

Distance (ft): **6.2**
Structural Grade: **1**
O&M Grade: **0**
Clock Start/From: **12**
Clock To: **12**
1st Value:
2nd Value:
Value Percent:
Step: **NO**
Remarks:

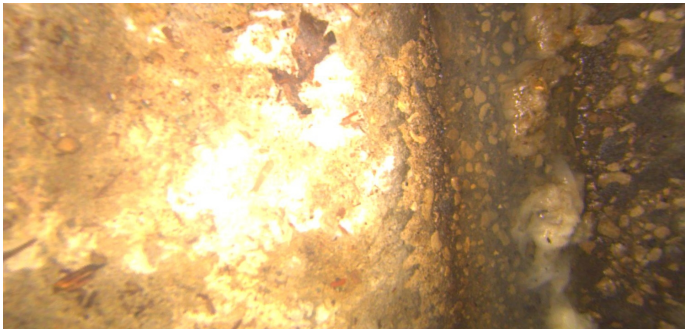
Code:	SAP
Description:	Surface Aggregate Projecting

Distance (ft):	6.2
Structural Grade:	3
O&M Grade:	0
Clock Start/From:	3
Clock To:	9
1st Value:	
2nd Value:	
Value Percent:	
Step:	NO
Remarks:

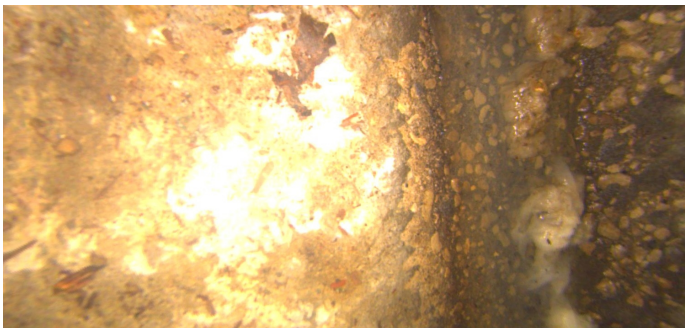
Code:	MGO
Description:	General Observation

Distance (ft):	6.2
Structural Grade:	0
O&M Grade:	0
Clock Start/From:	
Clock To:	
1st Value:	
2nd Value:	
Value Percent:	
Step:	NO
Remarks:	end of survey

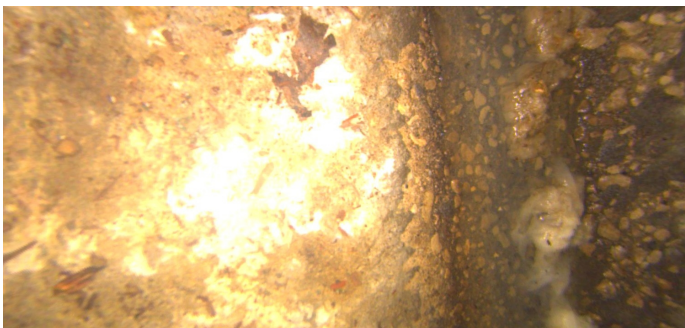
Code:	SRI
Description:	Surface Roughness Increased

Distance (ft):	6.2
Structural Grade:	1
O&M Grade:	0
Clock Start/From:	12
Clock To:	12
1st Value:	
2nd Value:	
Value Percent:	
Step:	NO
Remarks:
