Manhole Inspection Report

Date:	05/17/2018	Weather:		Coding:	RZMACP
MH#:	M-305-022	Owner:	NA	Len. Surveyed:	6.7
P.O.#:		Surveyor:	Jen Costello	Rim to Invert:	7.2
Customer:		Cert. #:	U-907-5518	Wall Material:	Concrete (reinforced)

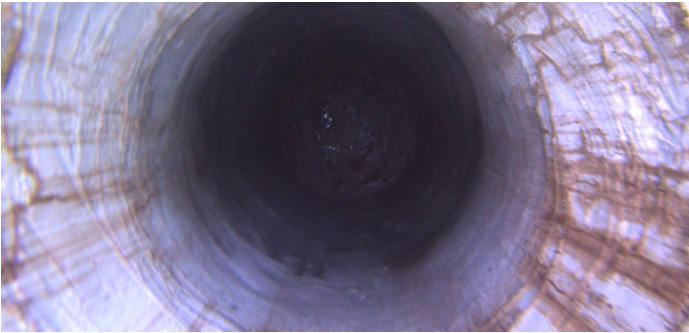
Code: **MGO**
Description: **General Observation**

Distance (ft): **.0**
Structural Grade: **0**
O&M Grade: **0**
Clock Start/From:
Clock To:
1st Value:
2nd Value:
Value Percent:
Step: **NO**
Remarks: **ACCESS MH**

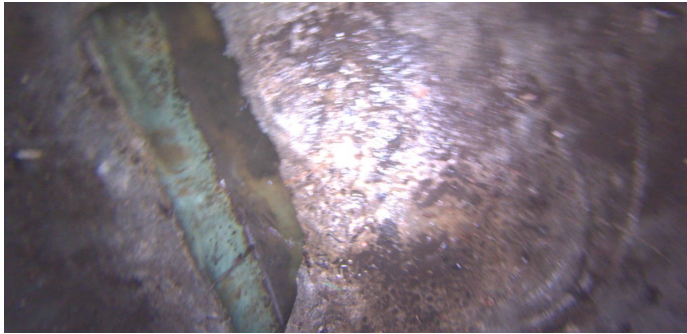
Code:	DSC
Description:	Deposits Settled Compacted
Distance (ft):	6.0
Structural Grade:	0
O&M Grade:	2
Clock Start/From:	12
Clock To:	12
1st Value:	
2nd Value:	
Value Percent:	5.000
Step:	NO
Remarks:

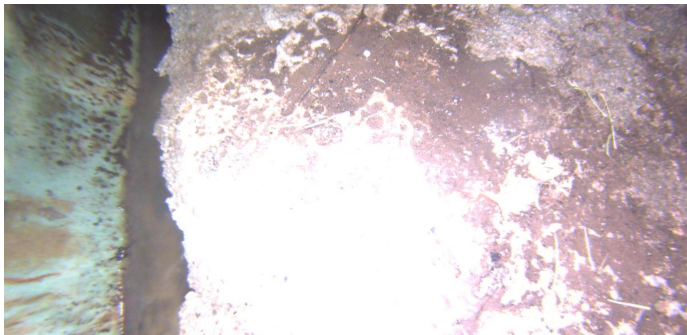
Code:	MGO
Description:	General Observation
Distance (ft):	6.7
Structural Grade:	0
O&M Grade:	0
Clock Start/From:	
Clock To:	
1st Value:	
2nd Value:	
Value Percent:	
Step:	NO
Remarks:	END SURVEY
