Manhole Inspection Report

Date:	05/16/2018	Weather:		Coding:	RZMACP
MH#:	M-305-023	Owner:	NA	Len. Surveyed:	7.3
P.O.#:		Surveyor:	Jen Costello	Rim to Invert:	8.6
Customer:		Cert. #:	U-907-5518	Wall Material:	Concrete (reinforced)

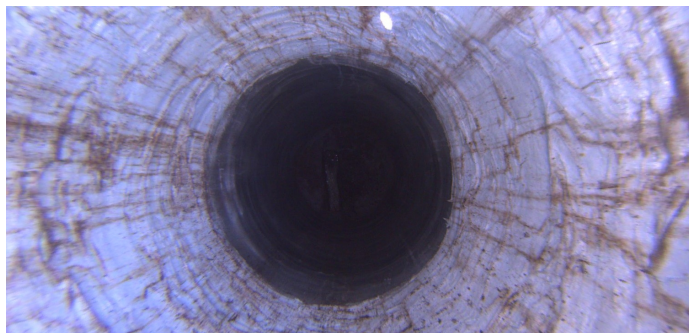
Code: **MGO**
Description: **General Observation**

Distance (ft): **.0**
Structural Grade: **0**
O&M Grade: **0**
Clock Start/From:
Clock To:
1st Value:
2nd Value:
Value Percent:
Step: **NO**
Remarks: **access mh**

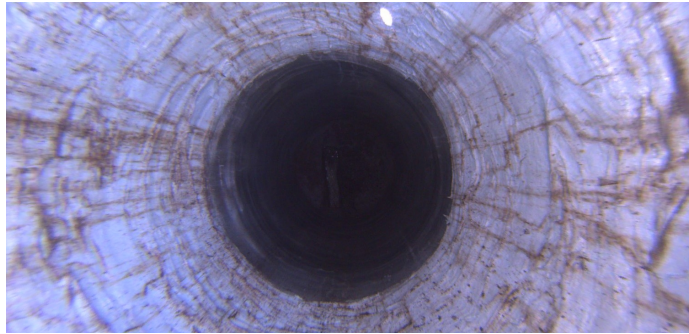
Code: **CM**
Description: **Crack Multiple**

Distance (ft): **.0**
Structural Grade: **3**
O&M Grade: **0**
Clock Start/From: **12**
Clock To: **12**
1st Value:
2nd Value:
Value Percent:
Step: **NO**
Remarks:

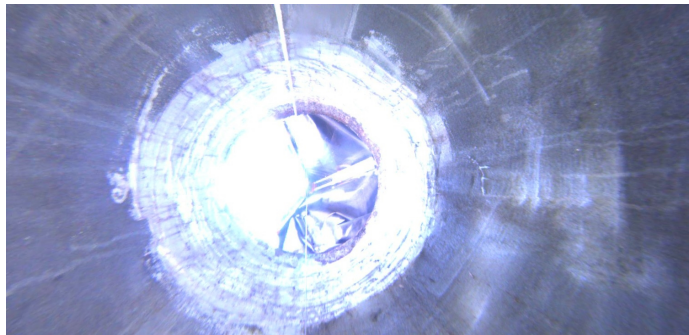
Code: **MGO**
Description: **General Observation**

Distance (ft): **3.1**
Structural Grade: **0**
O&M Grade: **0**
Clock Start/From:
Clock To:
1st Value:
2nd Value:
Value Percent:
Step: **NO**
Remarks: **underside of frame**

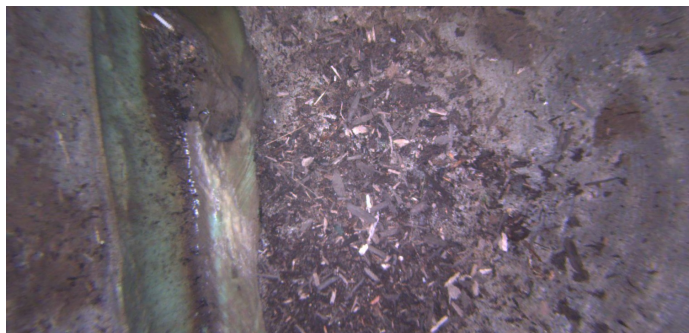
Code: **DSF**
Description: **Deposits Settled Fine**

Distance (ft): **6.9**
Structural Grade: **0**
O&M Grade: **2**
Clock Start/From: **12**
Clock To: **12**
1st Value:
2nd Value:
Value Percent: **5.000**
Step: **NO**
Remarks:

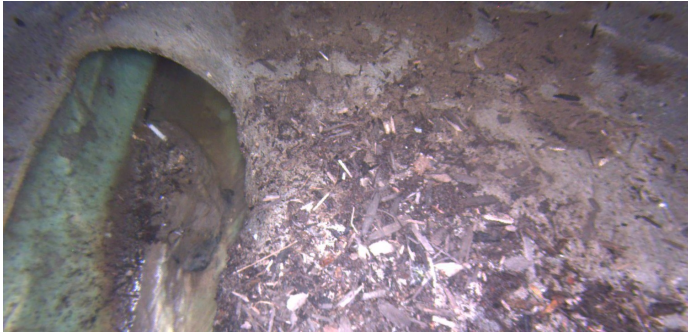
Code:	MGO
Description:	General Observation
Distance (ft):	7.3
Structural Grade:	0
O&M Grade:	0
Clock Start/From:	
Clock To:	
1st Value:	
2nd Value:	
Value Percent:	
Step:	NO
Remarks:	end survey
