Manhole Inspection Report

Date:	09/28/2022	Weather:		Coding:	RZMACP
MH#:	M-305-026	Owner:	NA	Len. Surveyed:	9.2
P.O.#:		Surveyor:	Todd Machine	Rim to Invert:	10.0
Customer:		Cert. #:	P0038859-082022	Wall Material:	Concrete (cast in place)

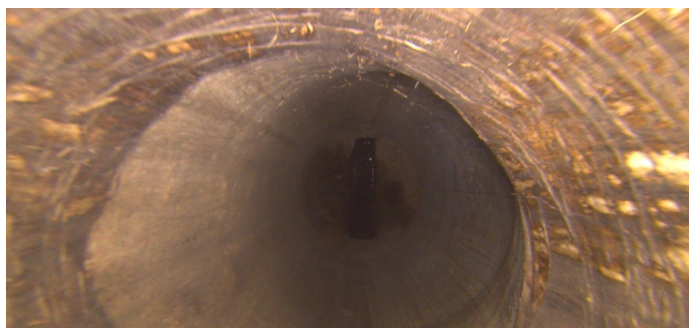
Code: **MGO**
Description: **General Observation**

Distance (ft): **.0**
Structural Grade: **0**
O&M Grade: **0**
Clock Start/From:
Clock To:
1st Value:
2nd Value:
Value Percent:
Step: **NO**
Remarks: **access mh**

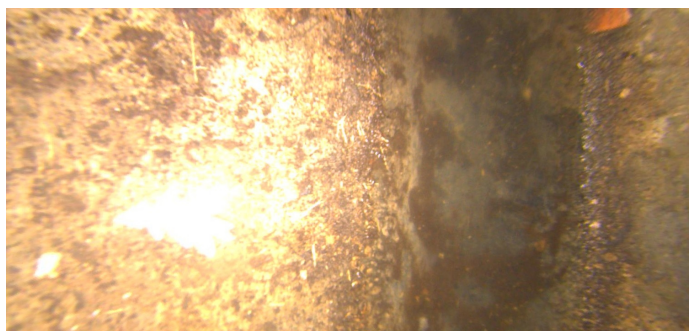
Code: **DSF**
Description: **Deposits Settled Fine**

Distance (ft): **8.9**
Structural Grade: **0**
O&M Grade: **2**
Clock Start/From: **12**
Clock To: **12**
1st Value:
2nd Value:
Value Percent: **5.000**
Step: **NO**
Remarks:

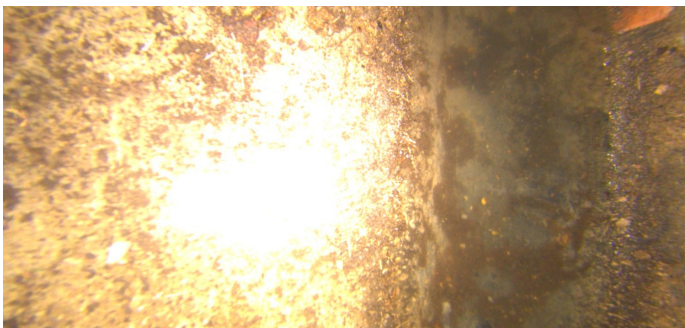
Code:	MGO
Description:	General Observation

Distance (ft):	9.2
Structural Grade:	0
O&M Grade:	0
Clock Start/From:	
Clock To:	
1st Value:	
2nd Value:	
Value Percent:	
Step:	NO
Remarks:	End Of Survey
