# Manhole Inspection Report

Date:	<b>04/28/2018</b>	Weather:		Coding:	<b>RZMACP</b>
MH#:	<b>M-305-035</b>	Owner:	<b>NA</b>	Len. Surveyed:	<b>4.9</b>
P.O.#:		Surveyor:	<b>Jen Costello</b>	Rim to Invert:	<b>6.3</b>
Customer:		Cert. #:	<b>U-907-5518</b>	Wall Material:	<b>Concrete (reinforced)</b>

Street:	<b>North of Crab Apple Ln. 545' East of</b>	Project:	<b>Hobart, IN</b>
City:	<b>Hobart, IN</b>	GPS Northing:	<b>2895951.215</b>
Location:		GPS Easting:	<b>2895951.215</b>
Drain Area:	<b>West</b>	GPS Accuracy:	<b>Sub-Meter</b>
Cover Shape:	<b>Circular</b>	Evidence of Surcharge:	<b>No</b>
Cover Size:	<b>23.0</b>	Potential for Runoff:	<b>None</b>
Comments:

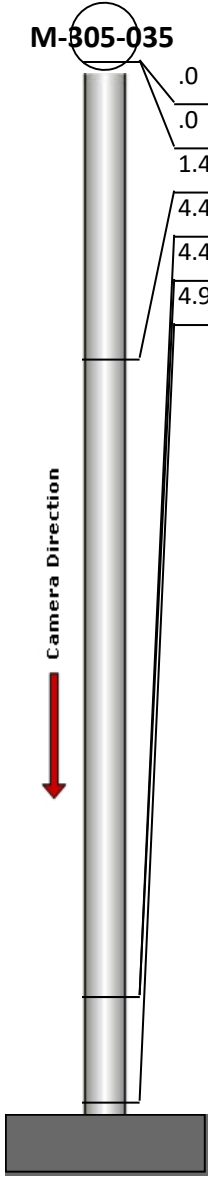
.0	MGO	General Observation	10	NA
	.0	CM	Crack Multiple	20	S 3
	1.4	MGO	General Observation	36	NA
	4.4	SAV	Surface Aggregate Visible	55	S 3
	4.4	CM	Crack Multiple	66	S 3
	4.9	MGO	General Observation	79	NA

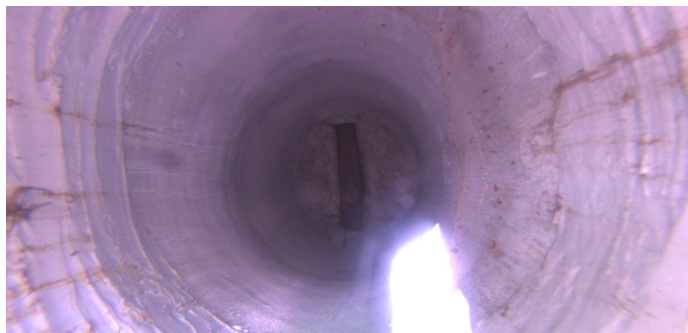
Code: **MGO**  
Description: **General Observation**

Distance (ft): **.0**  
Structural Grade: **0**  
O&M Grade: **0**  
Clock Start/From:  
Clock To:  
1st Value:  
2nd Value:  
Value Percent:  
Step: **NO**  
Remarks: **ACCESS MH**

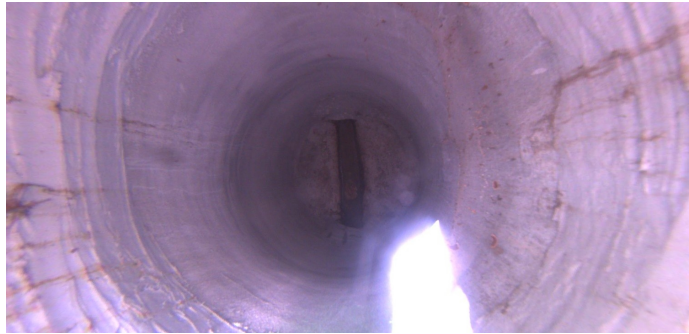
Code: **CM**  
Description: **Crack Multiple**

Distance (ft): **.0**  
Structural Grade: **3**  
O&M Grade: **0**  
Clock Start/From: **12**  
Clock To: **12**  
1st Value:  
2nd Value:  
Value Percent:  
Step: **NO**  
Remarks:

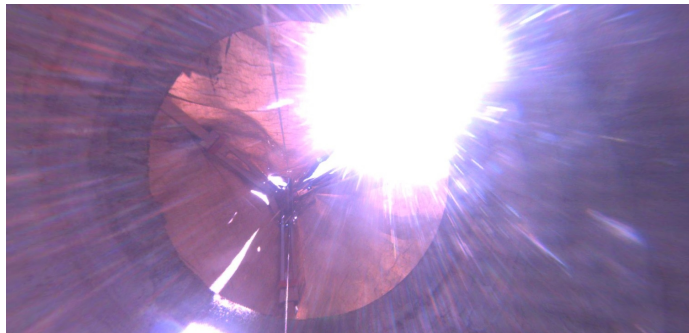
Code: **MGO**  
Description: **General Observation**

Distance (ft): **1.4**  
Structural Grade: **0**  
O&M Grade: **0**  
Clock Start/From:  
Clock To:  
1st Value:  
2nd Value:  
Value Percent:  
Step: **NO**  
Remarks: **UNDERSIDE OF FRAME**

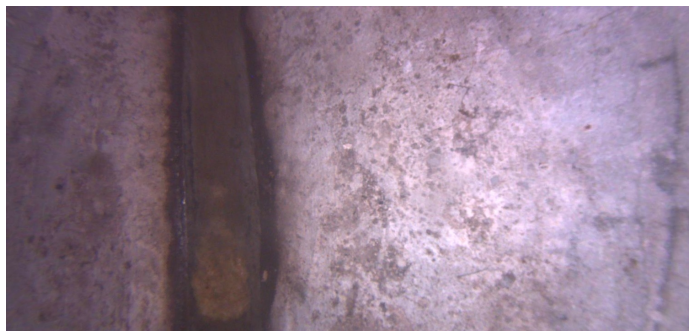
Code: **SAV**  
Description: **Surface Aggregate Visible**

Distance (ft): **4.4**  
Structural Grade: **3**  
O&M Grade: **0**  
Clock Start/From: **12**  
Clock To: **12**  
1st Value:  
2nd Value:  
Value Percent:  
Step: **NO**  
Remarks:

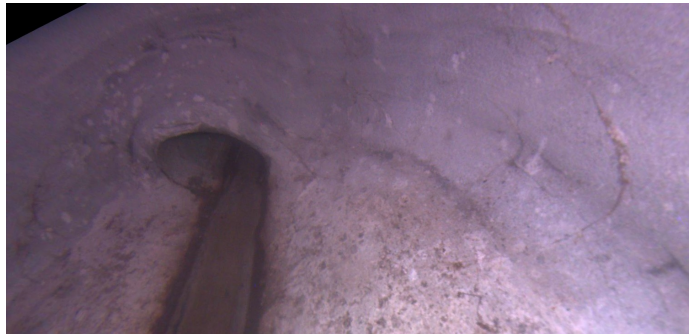
Code: **CM**  
Description: **Crack Multiple**

Distance (ft): **4.4**  
Structural Grade: **3**  
O&M Grade: **0**  
Clock Start/From: **10**  
Clock To: **3**  
1st Value:  
2nd Value:  
Value Percent:  
Step: **NO**  
Remarks:

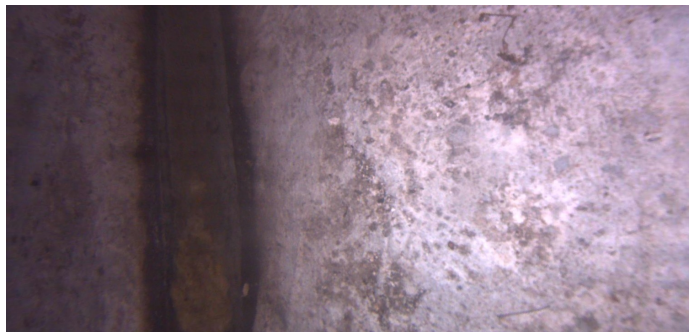
Code: **MGO**  
Description: **General Observation**

Distance (ft): **4.9**  
Structural Grade: **0**  
O&M Grade: **0**  
Clock Start/From:  
Clock To:  
1st Value:  
2nd Value:  
Value Percent:  
Step: **NO**  
Remarks: **END SURVEY**
