Manhole Inspection Report

Date:	05/16/2018	Weather:		Coding:	RZMACP
MH#:	M-305-042	Owner:	NA	Len. Surveyed:	7.7
P.O.#:		Surveyor:	Jen Costello	Rim to Invert:	7.8
Customer:		Cert. #:	U-907-5518	Wall Material:	Concrete (reinforced)

Street:	West 3rd. Pl. Crestwood Dr. to the N	Project:	Hobart, IN
City:	Hobart, IN	GPS Northing:	41.53160858
Location:		GPS Easting:	-87.28777313
Drain Area:	West	GPS Accuracy:	Nearest Meter
Cover Shape:	Circular	Evidence of Surcharge:	No
Cover Size:	22.5	Potential for Runoff:	None
Comments:

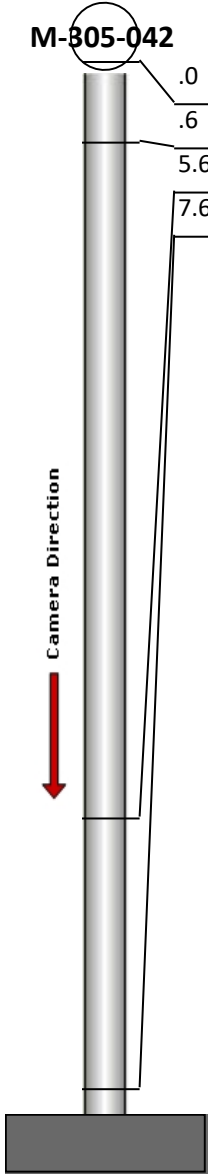
Position	Code	Observation	Video (sec)	Grade

.0	MGO	General Observation	10	NA
	.6	RFJ	Roots Fine Joint	23	M 1
	5.6	DSF	Deposits Settled Fine	44	M 2
	7.6	MGO	General Observation	59	NA

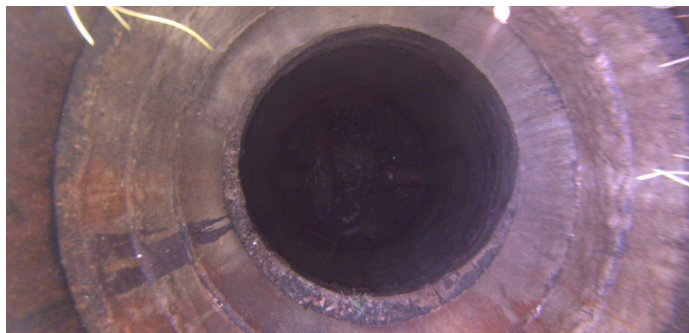
Code: **MGO**
Description: **General Observation**

Distance (ft): **.0**
Structural Grade: **0**
O&M Grade: **0**
Clock Start/From:
Clock To:
1st Value:
2nd Value:
Value Percent:
Step: **NO**
Remarks: **access mh**

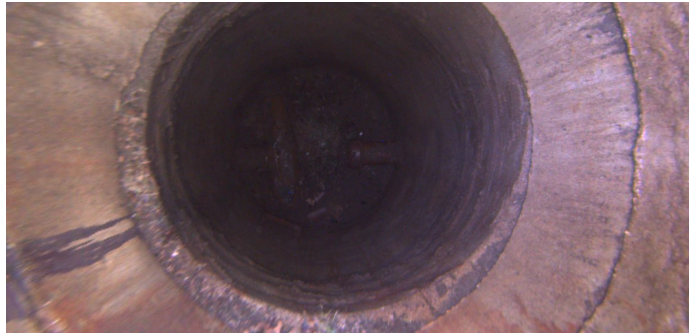
Code: **RFJ**
Description: **Roots Fine Joint**

Distance (ft): **.6**
Structural Grade: **0**
O&M Grade: **1**
Clock Start/From: **6**
Clock To: **9**
1st Value:
2nd Value:
Value Percent:
Step: **NO**
Remarks:

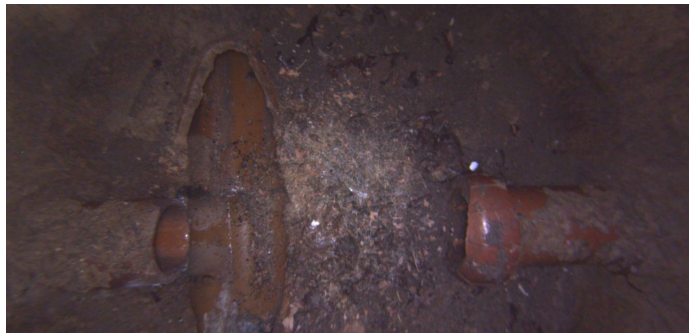
Code: **DSF**
Description: **Deposits Settled Fine**

Distance (ft): **5.6**
Structural Grade: **0**
O&M Grade: **2**
Clock Start/From: **12**
Clock To: **12**
1st Value:
2nd Value:
Value Percent: **5.000**
Step: **NO**
Remarks:

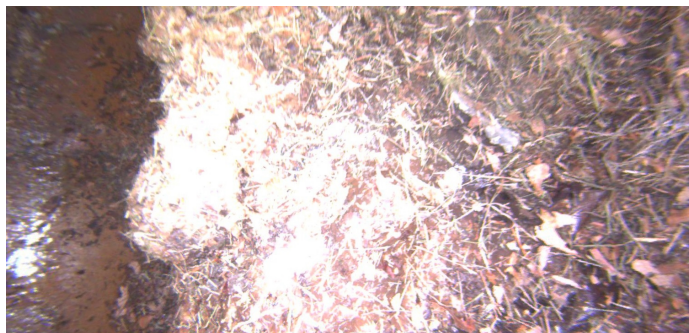
Code: **MGO**
Description: **General Observation**

Distance (ft): **7.6**
Structural Grade: **0**
O&M Grade: **0**
Clock Start/From:
Clock To:
1st Value:
2nd Value:
Value Percent:
Step: **NO**
Remarks: **end survey**
