# Manhole Inspection Report

| Date: | <b>04/20/2018</b> | Weather: | | Coding: | <b>RZMACP</b> |

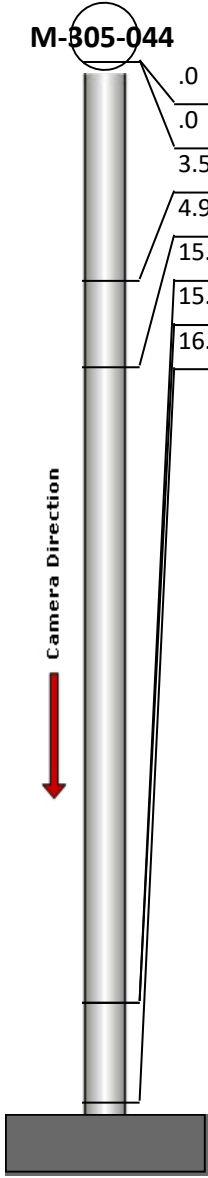
| | Position | Code | Observation | Video (sec) | Grade |
|--|---|---|---|---|---|
| | .0 | MGO | General Observation | 11 | NA |

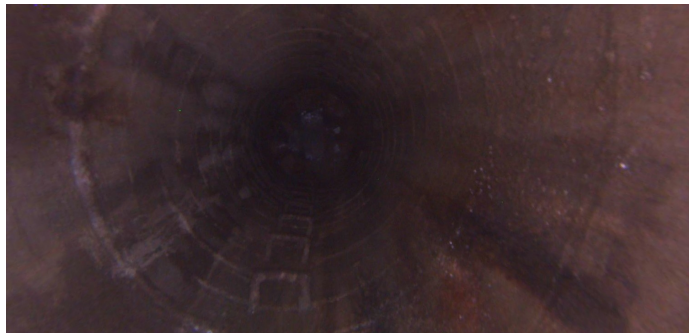
Code: **IS**  
Description: **Infil Stain**

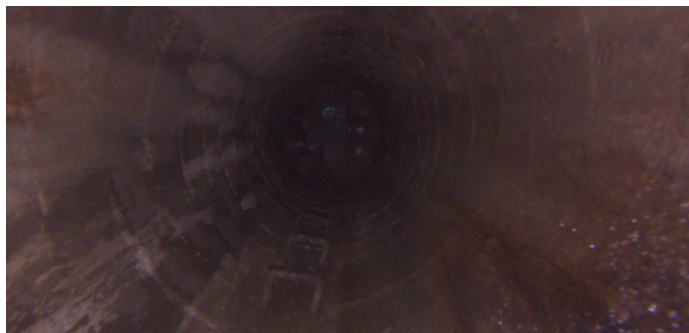
Code: **IS**  
Description: **Infil Stain**

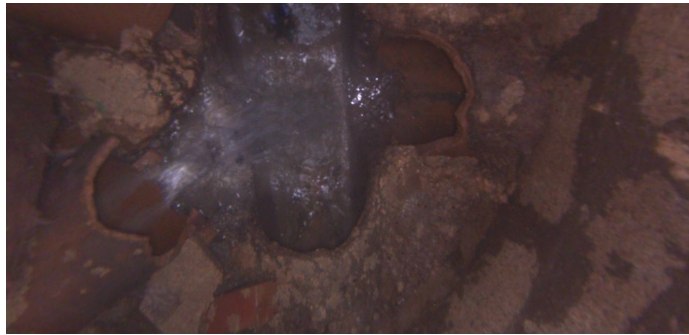
Code: **DSF**  
Description: **Deposits Settled Fine**
