Manhole Inspection Report

Date:	09/30/2022	Weather:		Coding:	RZMACP
MH#:	M-305-055	Owner:	NA	Len. Surveyed:	6.9
P.O.#:		Surveyor:	Jen Costello	Rim to Invert:	7.7
Customer:		Cert. #:	U-907-5518	Wall Material:	Concrete (cast in place)

Street:	325' South of West 2nd Pl. West of C	Project:	Hobart, IN
City:	Hobart, IN	GPS Northing:	2289747.604
Location:	Yard	GPS Easting:	2896781.89
Drain Area:	West	GPS Accuracy:	Sub-Meter
Cover Shape:	Circular	Evidence of Surcharge:	No
Cover Size:	24.0	Potential for Runoff:	None
Comments:

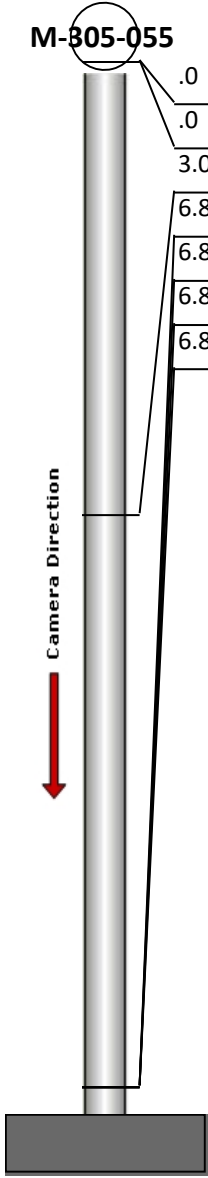
.0	MGO	General Observation	10	NA
	.0	SRI	Surface Roughness Increased	21	S 1
	3.0	MGO	General Observation	41	NA
	6.8	DSF	Deposits Settled Fine	62	M 2
	6.8	DSF	Deposits Settled Fine	74	M 2
	6.8	SRI	Surface Roughness Increased	85	S 1
	6.8	MGO	General Observation	96	NA

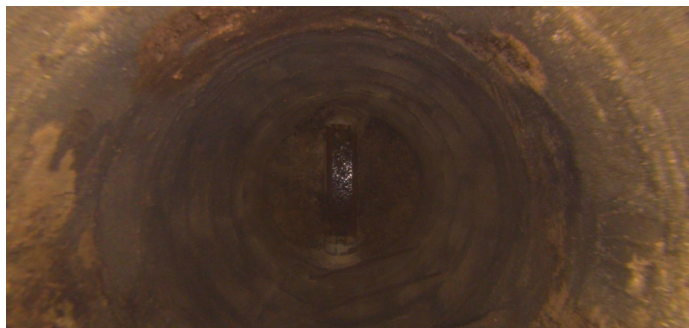
Code: **MGO**
Description: **General Observation**

Distance (ft): **.0**
Structural Grade: **0**
O&M Grade: **0**
Clock Start/From:
Clock To:
1st Value:
2nd Value:
Value Percent:
Step: **NO**
Remarks: **access mh**

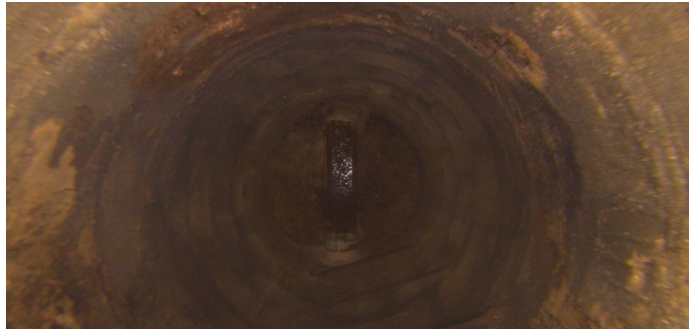
Code:	SRI
Description:	Surface Roughness Increased
Distance (ft):	.0
Structural Grade:	1
O&M Grade:	0
Clock Start/From:	12
Clock To:	12
1st Value:	
2nd Value:	
Value Percent:	
Step:	NO
Remarks:

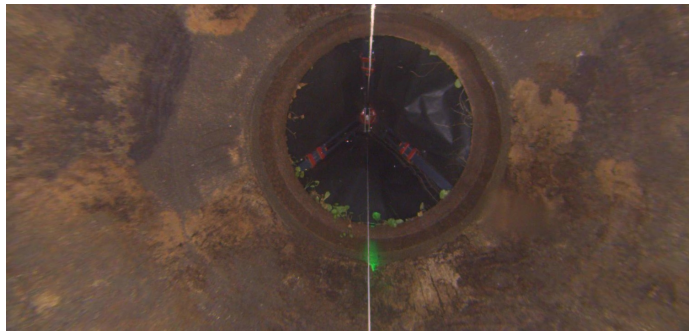
Code:	MGO
Description:	General Observation
Distance (ft):	3.0
Structural Grade:	0
O&M Grade:	0
Clock Start/From:	
Clock To:	
1st Value:	
2nd Value:	
Value Percent:	
Step:	NO
Remarks:	underside of frame

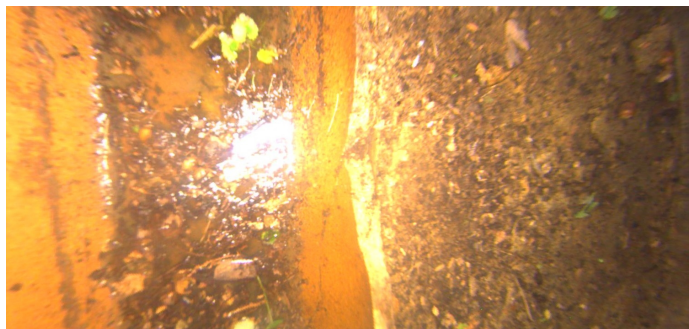
Code:	DSF
Description:	Deposits Settled Fine
Distance (ft):	6.8
Structural Grade:	0
O&M Grade:	2
Clock Start/From:	12
Clock To:	12
1st Value:	
2nd Value:	
Value Percent:	5.000
Step:	NO
Remarks:

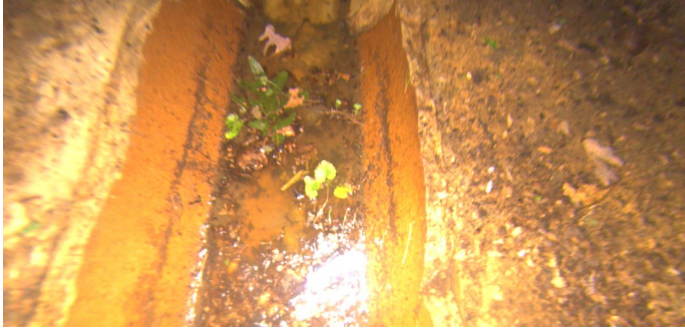
Code:	DSF
Description:	Deposits Settled Fine

Distance (ft):	6.8
Structural Grade:	0
O&M Grade:	2
Clock Start/From:	5
Clock To:	7
1st Value:	
2nd Value:	
Value Percent:	10.000
Step:	NO
Remarks:

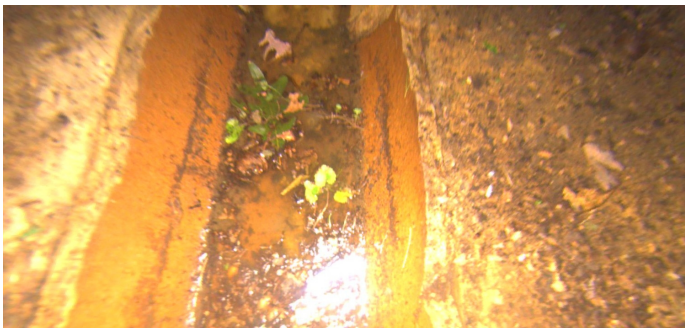
Code:	SRI
Description:	Surface Roughness Increased

Distance (ft):	6.8
Structural Grade:	1
O&M Grade:	0
Clock Start/From:	12
Clock To:	12
1st Value:	
2nd Value:	
Value Percent:	
Step:	NO
Remarks:

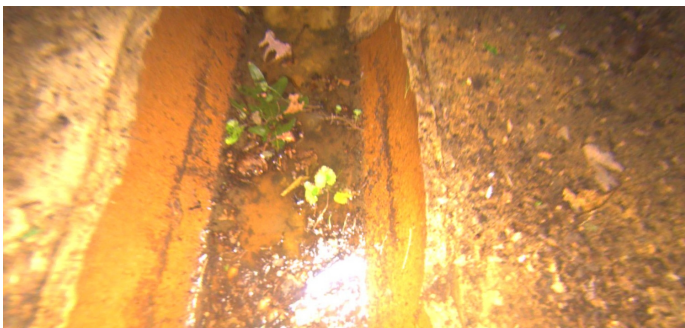
Code:	MGO
Description:	General Observation

Distance (ft):	6.8
Structural Grade:	0
O&M Grade:	0
Clock Start/From:	
Clock To:	
1st Value:	
2nd Value:	
Value Percent:	
Step:	NO
Remarks:	end of survey
