# Manhole Inspection Report

Date:	<b>03/23/2018</b>	Weather:		Coding:	<b>RZMACP</b>
MH#:	<b>M-308-003</b>	Owner:	<b>NA</b>	Len. Surveyed:	<b>18.6</b>
P.O.#:		Surveyor:	<b>John Kuglmaier</b>	Rim to Invert:	<b>19.3</b>
Customer:		Cert. #:	<b>U-1215-07002349</b>	Wall Material:	<b>Concrete (reinforced)</b>

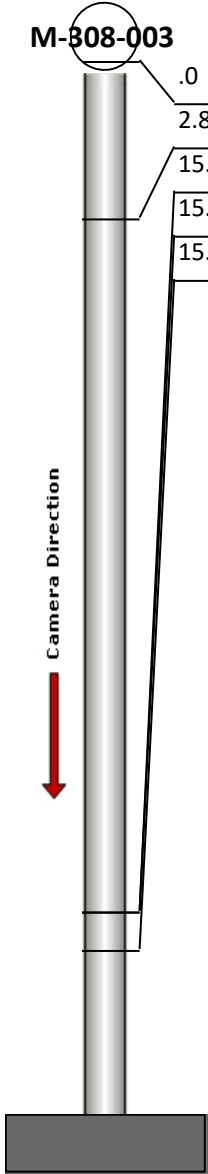
M-308-003				
	.0	MGP	General Photo	10	NA
	2.8	MGP	General Photo	29	NA
	15.2	IS	Infil Stain	68	NA
	15.2	DAZ	Deposits Attached Other	79	M 2
	15.9	MGO	General Observation	92	NA

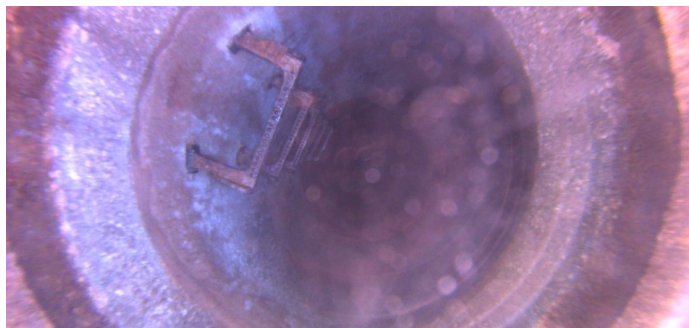
Code: **MGP**  
 Description: **General Photo**

Distance (ft): **.0**  
 Structural Grade: **0**  
 O&M Grade: **0**  
 Clock Start/From:  
 Clock To:  
 1st Value:  
 2nd Value:  
 Value Percent:  
 Step: **NO**  
 Remarks:

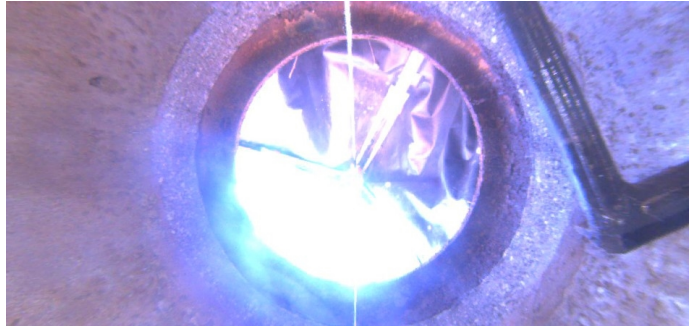
Code: **MGP**  
Description: **General Photo**

Distance (ft): **2.8**  
Structural Grade: **0**  
O&M Grade: **0**  
Clock Start/From:  
Clock To:  
1st Value:  
2nd Value:  
Value Percent:  
Step: **NO**  
Remarks:

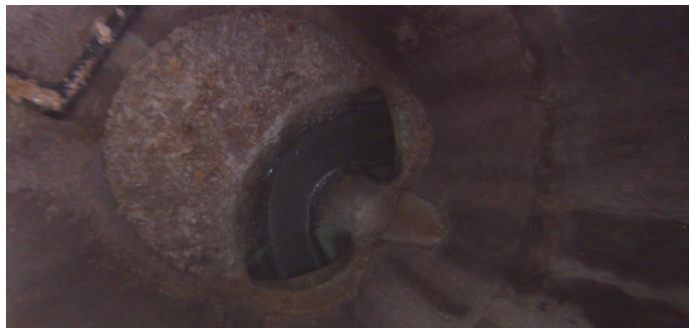
Code: **IS**  
Description: **Infil Stain**

Distance (ft): **15.2**  
Structural Grade: **0**  
O&M Grade: **0**  
Clock Start/From: **4**  
Clock To:  
1st Value:  
2nd Value:  
Value Percent:  
Step: **NO**  
Remarks:

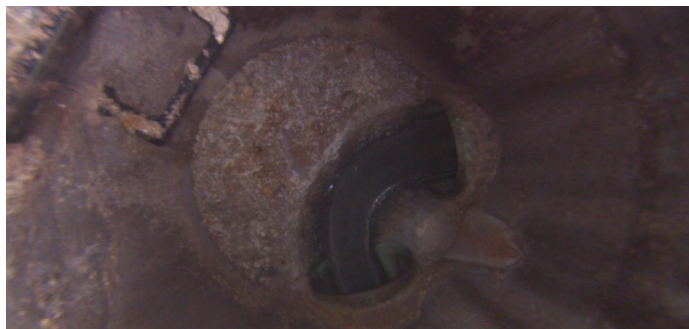
Code: **DAZ**  
Description: **Deposits Attached Other**

Distance (ft): **15.2**  
Structural Grade: **0**  
O&M Grade: **2**  
Clock Start/From: **12**  
Clock To: **12**  
1st Value:  
2nd Value:  
Value Percent: **10.000**  
Step: **NO**  
Remarks: **Mixed materials**

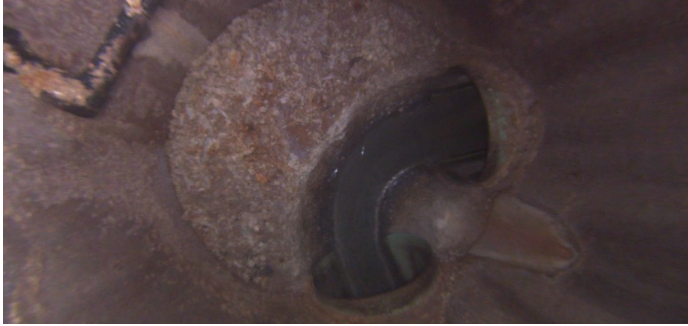
Code:	<b>MGO</b>
Description:	<b>General Observation</b>
Distance (ft):	<b>15.9</b>
Structural Grade:	<b>0</b>
O&M Grade:	<b>0</b>
Clock Start/From:	
Clock To:	
1st Value:	
2nd Value:	
Value Percent:	
Step:	<b>NO</b>
Remarks:	<b>Ins. Comp.</b>
