# Manhole Inspection Report

Date:	<b>03/23/2018</b>	Weather:		Coding:	<b>RZMACP</b>
MH#:	<b>M-308-007</b>	Owner:	<b>NA</b>	Len. Surveyed:	<b>12.1</b>
P.O.#:		Surveyor:	<b>John Kuglmaier</b>	Rim to Invert:	<b>18.5</b>
Customer:		Cert. #:	<b>U-1215-07002349</b>	Wall Material:	<b>Concrete (reinforced)</b>

Street:	<b>61st Ave. 481' East of Amber Dr.</b>	Project:	<b>Hobart, IN</b>
City:	<b>Hobart, IN</b>	GPS Northing:	<b>0.0</b>
Location:		GPS Easting:	<b>0.0</b>
Drain Area:	<b>Southwest</b>	GPS Accuracy:	<b>Nearest Meter</b>
Cover Shape:	<b>Circular</b>	Evidence of Surcharge:	<b>Yes</b>
Cover Size:	<b>22.5</b>	Potential for Runoff:	<b>None</b>
Comments:

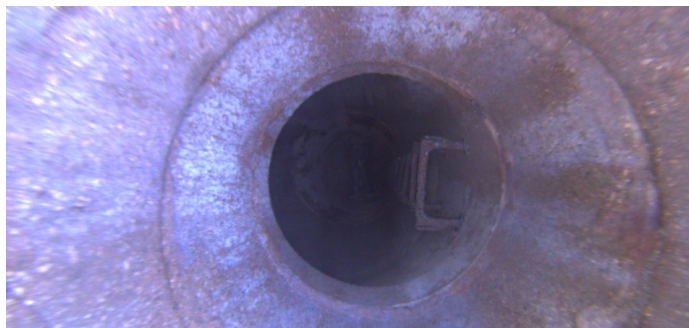
Code: **MGP**  
Description: **General Photo**

Distance (ft): **.0**  
Structural Grade: **0**  
O&M Grade: **0**  
Clock Start/From:  
Clock To:  
1st Value:  
2nd Value:  
Value Percent:  
Step: **NO**  
Remarks:

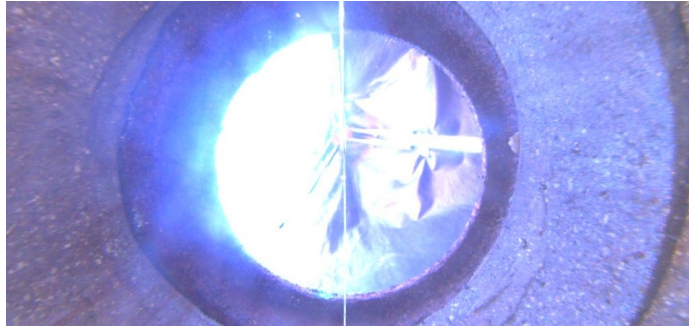
Code: **MGP**  
Description: **General Photo**

Distance (ft): **2.1**  
Structural Grade: **0**  
O&M Grade: **0**  
Clock Start/From:  
Clock To:  
1st Value:  
2nd Value:  
Value Percent:  
Step: **NO**  
Remarks:

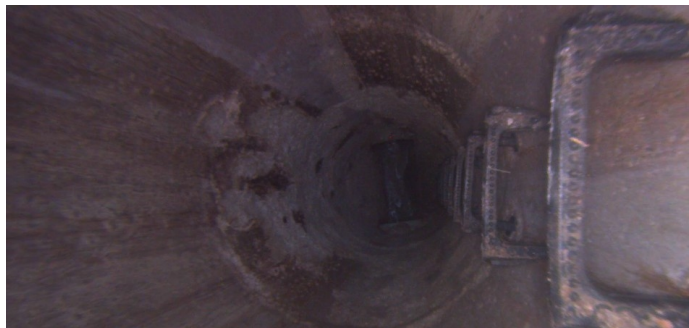
Code: **DAGS**  
Description: **Deposits Attached Grease**

Distance (ft): **6.7**  
Structural Grade: **0**  
O&M Grade: **3**  
Clock Start/From: **12**  
Clock To: **12**  
1st Value:  
2nd Value:  
Value Percent: **15.000**  
Step: **NO**  
Remarks:

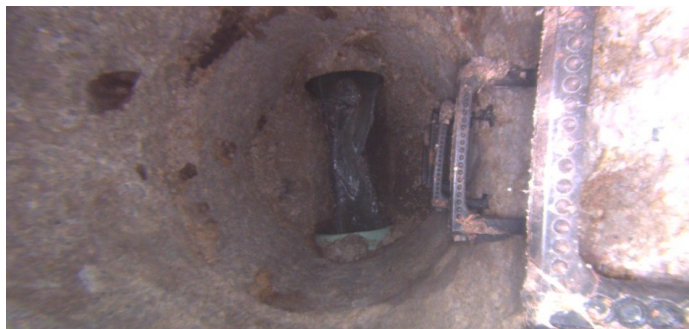
Code: **MGO**  
Description: **General Observation**

Distance (ft): **12.1**  
Structural Grade: **0**  
O&M Grade: **0**  
Clock Start/From:  
Clock To:  
1st Value:  
2nd Value:  
Value Percent:  
Step: **NO**  
Remarks: **Ins. Comp.**

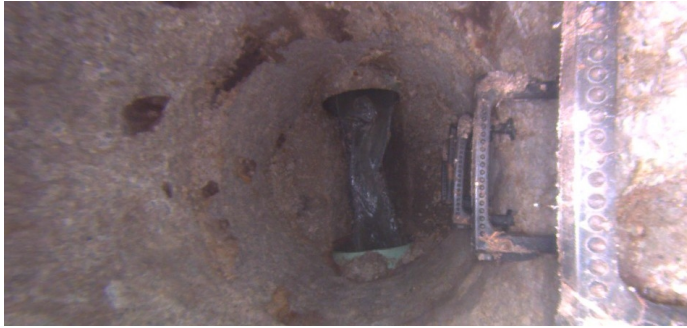
Code:	DAGS
Description:	Deposits Attached Grease
Distance (ft):	12.1
Structural Grade:	0
O&M Grade:	3
Clock Start/From:	12
Clock To:	12
1st Value:	
2nd Value:	
Value Percent:	15.000
Step:	NO
Remarks:
