Manhole Inspection Report

Date:	03/23/2018	Weather:		Coding:	RZMACP
MH#:	M-308-009	Owner:	NA	Len. Surveyed:	16.3
P.O.#:		Surveyor:	John Kuglmaier	Rim to Invert:	17.9
Customer:		Cert. #:	U-1215-07002349	Wall Material:	Concrete (reinforced)

Street:	61st Ave. Amber St. West Side.	Project:	Hobart, IN
City:	Hobart, IN	GPS Northing:	0.0
Location:		GPS Easting:	0.0
Drain Area:	Southwest	GPS Accuracy:	Nearest Meter
Cover Shape:	Circular	Evidence of Surcharge:	Yes
Cover Size:	22.5	Potential for Runoff:	None
Comments:

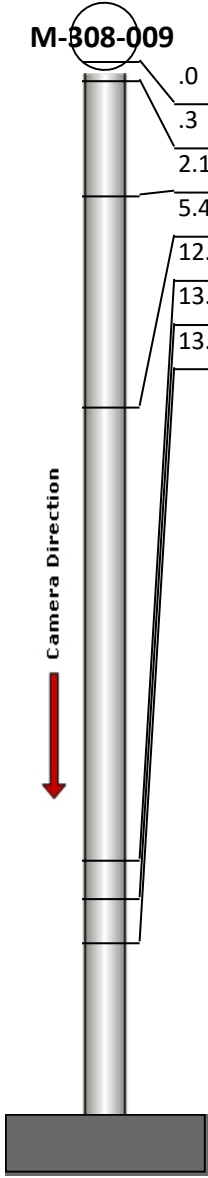
.0	MGP	General Photo	10	NA
	.3	DAGS	Deposits Attached Grease	22	M 2
	2.1	MGP	General Photo	39	NA
	5.4	DAGS	Deposits Attached Grease	60	M 2
	12.5	DAZ	Deposits Attached Other	85	M 2
	13.1	DAGS	Deposits Attached Grease	98	M 2
	13.8	MGO	General Observation	111	NA

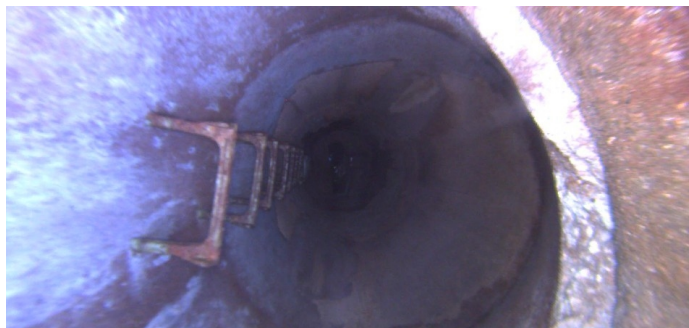
Code: **MGP**
Description: **General Photo**

Distance (ft): **.0**
Structural Grade: **0**
O&M Grade: **0**
Clock Start/From:
Clock To:
1st Value:
2nd Value:
Value Percent:
Step: **NO**
Remarks:

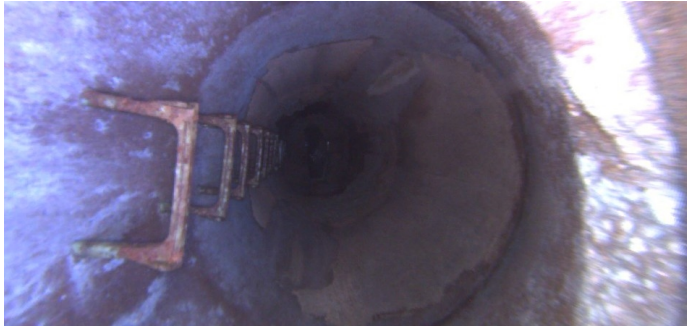
Code: **DAGS**
Description: **Deposits Attached Grease**

Distance (ft): **.3**
Structural Grade: **0**
O&M Grade: **2**
Clock Start/From: **7**
Clock To: **2**
1st Value:
2nd Value:
Value Percent: **5.000**
Step: **NO**
Remarks:

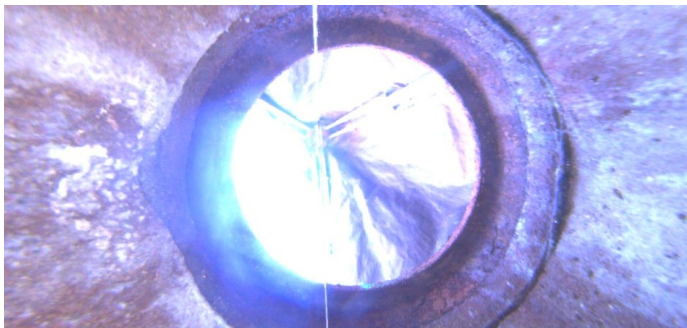
Code: **MGP**
Description: **General Photo**

Distance (ft): **2.1**
Structural Grade: **0**
O&M Grade: **0**
Clock Start/From:
Clock To:
1st Value:
2nd Value:
Value Percent:
Step: **NO**
Remarks:

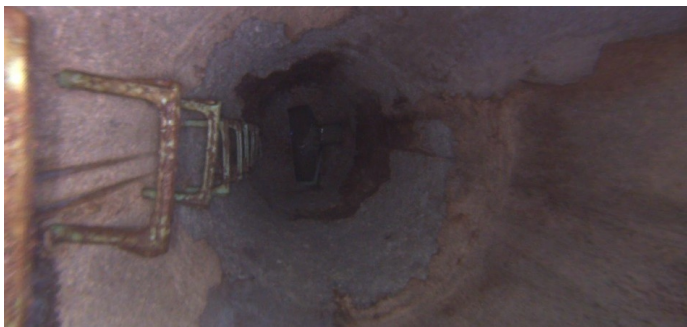
Code: **DAGS**
Description: **Deposits Attached Grease**

Distance (ft): **5.4**
Structural Grade: **0**
O&M Grade: **2**
Clock Start/From: **12**
Clock To: **12**
1st Value:
2nd Value:
Value Percent: **10.000**
Step: **NO**
Remarks:

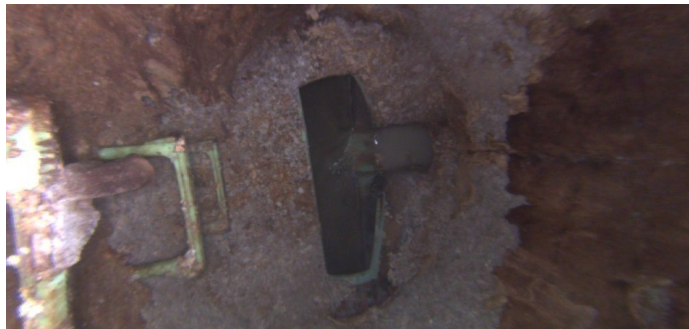
Code: **DAZ**
Description: **Deposits Attached Other**

Distance (ft): **12.5**
Structural Grade: **0**
O&M Grade: **2**
Clock Start/From: **12**
Clock To: **12**
1st Value:
2nd Value:
Value Percent: **10.000**
Step: **NO**
Remarks: **Mixed materials**

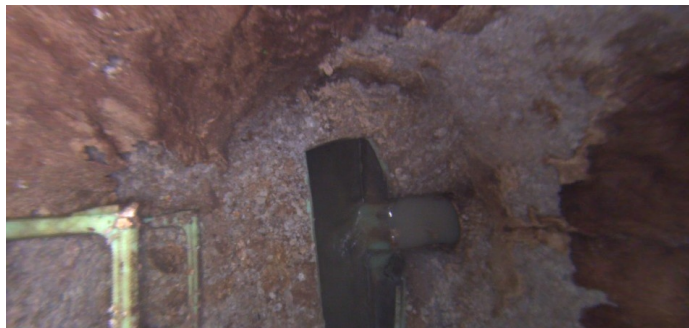
Code: **DAGS**
Description: **Deposits Attached Grease**

Distance (ft): **13.1**
Structural Grade: **0**
O&M Grade: **2**
Clock Start/From: **12**
Clock To: **12**
1st Value:
2nd Value:
Value Percent: **10.000**
Step: **NO**
Remarks:

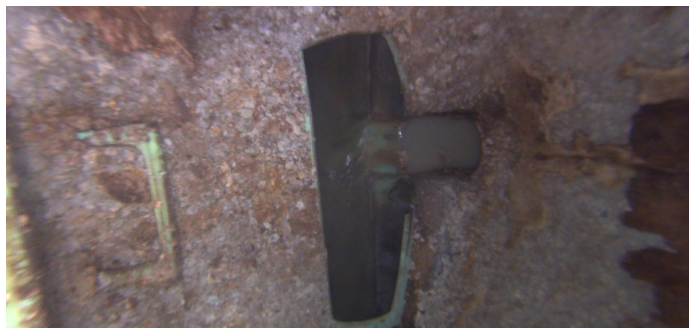
Code: **MGO**
Description: **General Observation**

Distance (ft): **13.8**
Structural Grade: **0**
O&M Grade: **0**
Clock Start/From:
Clock To:
1st Value:
2nd Value:
Value Percent:
Step: **NO**
Remarks: **Ins. Comp.**
