Manhole Inspection Report

Date:	03/27/2018	Weather:		Coding:	RZMACP
MH#:	M-308-030	Owner:	NA	Len. Surveyed:	12.9
P.O.#:		Surveyor:	John Kuglmaier	Rim to Invert:	14.5
Customer:		Cert. #:	U-1215-07002349	Wall Material:	Concrete (reinforced)

Street:	161' Northeast of 61st Ave. and Colo	Project:	Hobart, IN
City:	Hobart, IN	GPS Northing:	0.0
Location:		GPS Easting:	0.0
Drain Area:	Southwest	GPS Accuracy:	Nearest Meter
Cover Shape:	Circular	Evidence of Surcharge:	Yes
Cover Size:	22.5	Potential for Runoff:	None
Comments:

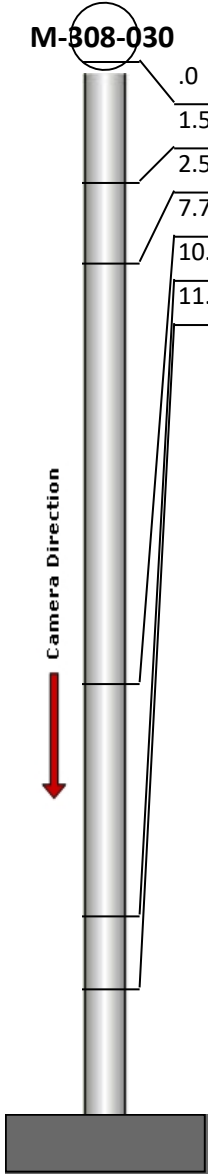
.0	MGP	General Photo	10	NA
	1.5	IS	Infil Stain	25	NA
	2.5	MGP	General Photo	41	NA
	7.7	IS	Infil Stain	65	NA
	10.6	OBZ	Obstacle Other	82	M 2
	11.5	MGO	General Observation	95	NA

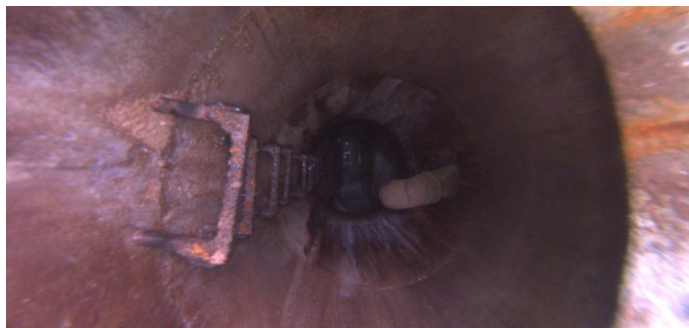
Code: **MGP**
Description: **General Photo**

Distance (ft): **.0**
Structural Grade: **0**
O&M Grade: **0**
Clock Start/From:
Clock To:
1st Value:
2nd Value:
Value Percent:
Step: **NO**
Remarks:

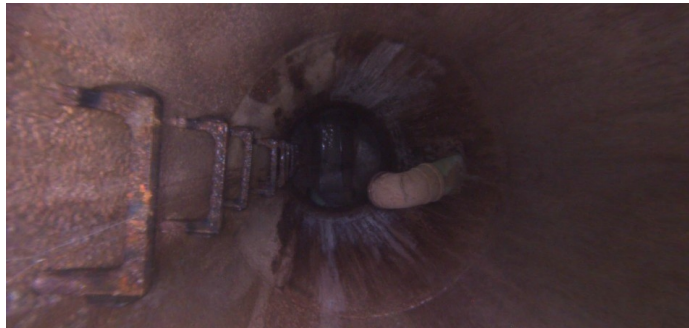
Code: **IS**
Description: **Infil Stain**

Distance (ft): **1.5**
Structural Grade: **0**
O&M Grade: **0**
Clock Start/From: **10**
Clock To: **8**
1st Value:
2nd Value:
Value Percent:
Step: **NO**
Remarks:

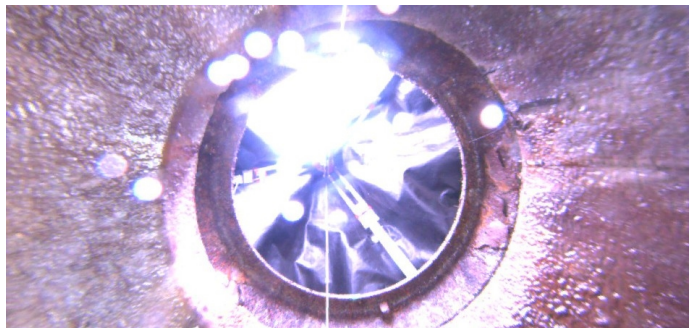
Code: **MGP**
Description: **General Photo**

Distance (ft): **2.5**
Structural Grade: **0**
O&M Grade: **0**
Clock Start/From:
Clock To:
1st Value:
2nd Value:
Value Percent:
Step: **NO**
Remarks:

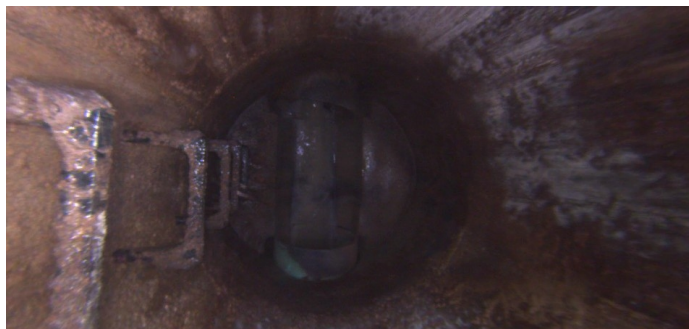
Code: **IS**
Description: **Infil Stain**

Distance (ft): **7.7**
Structural Grade: **0**
O&M Grade: **0**
Clock Start/From: **12**
Clock To: **12**
1st Value:
2nd Value:
Value Percent:
Step: **NO**
Remarks:

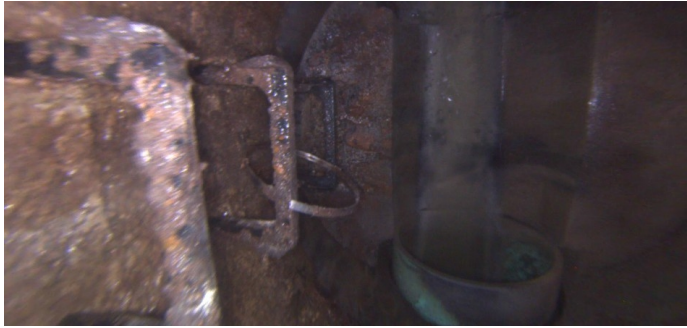
Code: **OBZ**
Description: **Obstacle Other**

Distance (ft): **10.6**
Structural Grade: **0**
O&M Grade: **2**
Clock Start/From: **8**
Clock To:
1st Value:
2nd Value:
Value Percent: **5.000**
Step: **YES**
Remarks: **Metal ring**

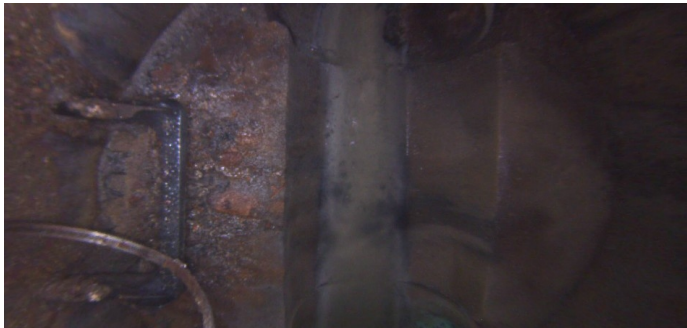
Code: **MGO**
Description: **General Observation**

Distance (ft): **11.5**
Structural Grade: **0**
O&M Grade: **0**
Clock Start/From:
Clock To:
1st Value:
2nd Value:
Value Percent:
Step: **NO**
Remarks: **Ins. Comp.**
