# Manhole Inspection Report

Date:	<b>03/27/2018</b>	Weather:		Coding:	<b>RZMACP</b>
MH#:	<b>M-308-031</b>	Owner:	<b>NA</b>	Len. Surveyed:	<b>11.3</b>
P.O.#:		Surveyor:	<b>John Kuglmaier</b>	Rim to Invert:	<b>16.3</b>
Customer:		Cert. #:	<b>U-1215-07002349</b>	Wall Material:	<b>Concrete (reinforced)</b>

Street:	<b>On 61st Ave. 401' East of Colorado S</b>	Project:	<b>Hobart, IN</b>
City:	<b>Hobart, IN</b>	GPS Northing:	<b>0.0</b>
Location:		GPS Easting:	<b>0.0</b>
Drain Area:	<b>Southwest</b>	GPS Accuracy:	<b>Nearest Meter</b>
Cover Shape:	<b>Circular</b>	Evidence of Surcharge:	<b>Yes</b>
Cover Size:	<b>22.5</b>	Potential for Runoff:	<b>None</b>
Comments:

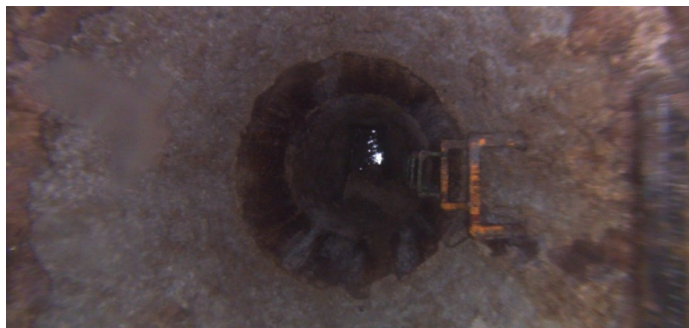
Code: **MGP**  
Description: **General Photo**

Distance (ft): **.0**  
Structural Grade: **0**  
O&M Grade: **0**  
Clock Start/From:  
Clock To:  
1st Value:  
2nd Value:  
Value Percent:  
Step: **NO**  
Remarks:

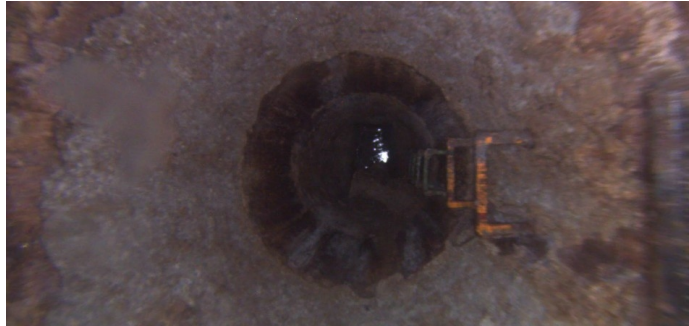
Code: **DAZ**  
Description: **Deposits Attached Other**

Distance (ft): **.0**  
Structural Grade: **0**  
O&M Grade: **2**  
Clock Start/From: **12**  
Clock To: **12**  
1st Value:  
2nd Value:  
Value Percent: **10.000**  
Step: **NO**  
Remarks: **Mixed materials**

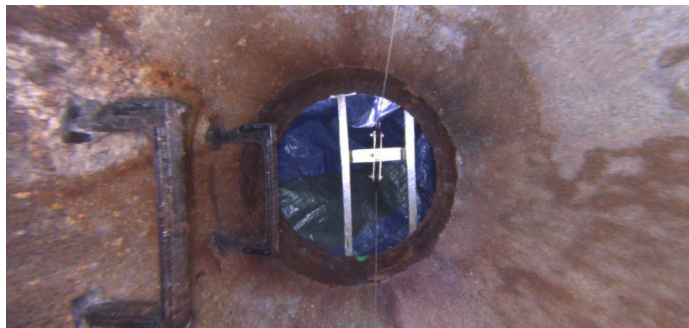
Code: **MGP**  
Description: **General Photo**

Distance (ft): **1.0**  
Structural Grade: **0**  
O&M Grade: **0**  
Clock Start/From:  
Clock To:  
1st Value:  
2nd Value:  
Value Percent:  
Step: **NO**  
Remarks:

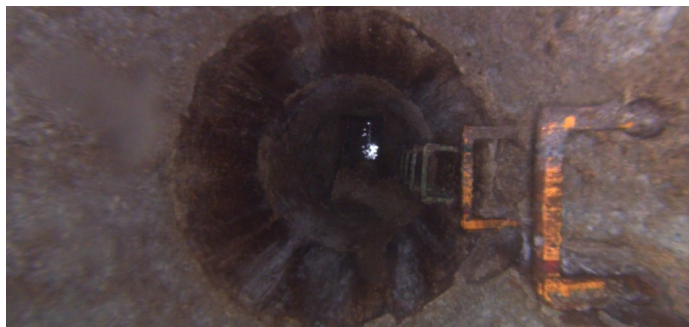
Code: **IS**  
Description: **Infil Stain**

Distance (ft): **1.3**  
Structural Grade: **0**  
O&M Grade: **0**  
Clock Start/From: **12**  
Clock To: **12**  
1st Value:  
2nd Value:  
Value Percent:  
Step: **NO**  
Remarks:

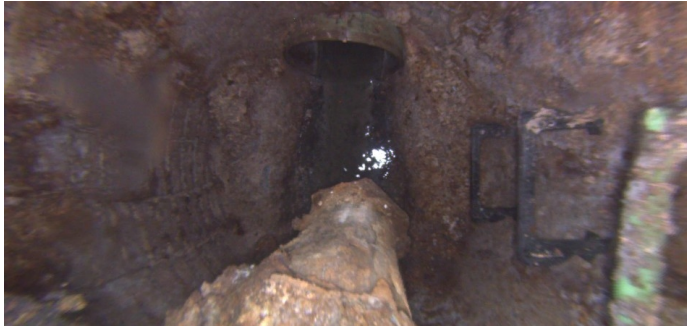
Code:	<b>DAZ</b>
Description:	<b>Deposits Attached Other</b>
Distance (ft):	<b>9.4</b>
Structural Grade:	<b>0</b>
O&M Grade:	<b>2</b>
Clock Start/From:	<b>12</b>
Clock To:	<b>12</b>
1st Value:	
2nd Value:	
Value Percent:	<b>10.000</b>
Step:	<b>NO</b>
Remarks:	<b>Mixed materials</b>

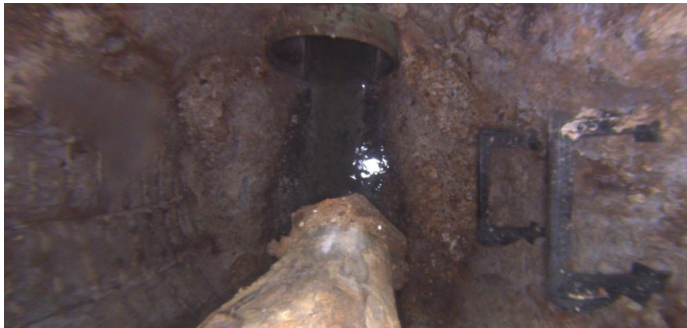
Code:	<b>MGO</b>
Description:	<b>General Observation</b>
Distance (ft):	<b>9.8</b>
Structural Grade:	<b>0</b>
O&M Grade:	<b>0</b>
Clock Start/From:	
Clock To:	
1st Value:	
2nd Value:	
Value Percent:	
Step:	<b>NO</b>
Remarks:	<b>Ins. Comp.</b>
