Manhole Inspection Report

Date:	03/27/2018	Weather:		Coding:	RZMACP
MH#:	M-308-035	Owner:	NA	Len. Surveyed:	7.5
P.O.#:		Surveyor:	John Kuglmaier	Rim to Invert:	8.8
Customer:		Cert. #:	U-1215-07002349	Wall Material:	Concrete (reinforced)

Street:	North of 61st Ave. 719' West of Am	Project:	Hobart, IN
City:	Hobart, IN	GPS Northing:	0.0
Location:		GPS Easting:	0.0
Drain Area:	Southwest	GPS Accuracy:	Nearest Meter
Cover Shape:	Circular	Evidence of Surcharge:	Yes
Cover Size:	22.5	Potential for Runoff:	None
Comments:

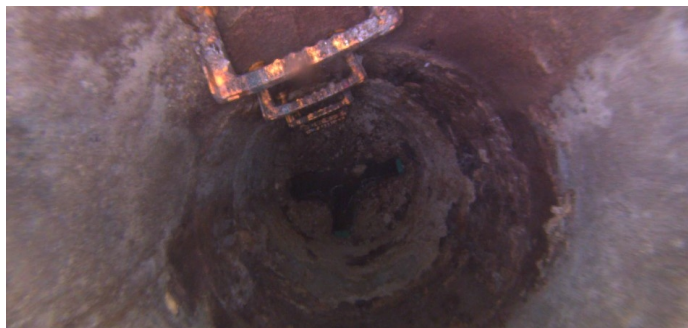
Code: **MGP**
Description: **General Photo**

Distance (ft): **.0**
Structural Grade: **0**
O&M Grade: **0**
Clock Start/From:
Clock To:
1st Value:
2nd Value:
Value Percent:
Step: **NO**
Remarks:

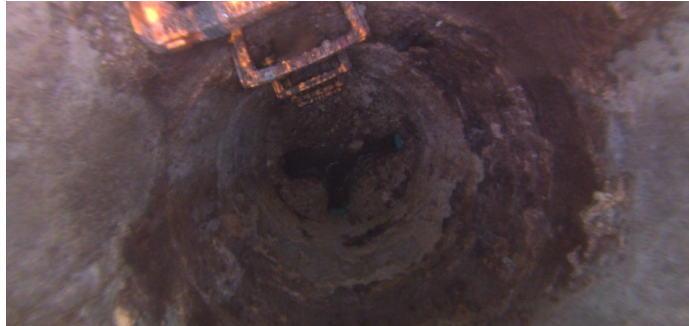
Code:	DAZ
Description:	Deposits Attached Other
Distance (ft):	.5
Structural Grade:	0
O&M Grade:	2
Clock Start/From:	12
Clock To:	12
1st Value:	
2nd Value:	
Value Percent:	10.000
Step:	NO
Remarks:	Mixed materials

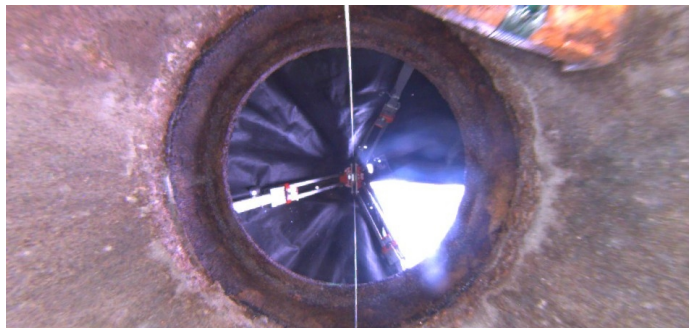
Code:	MGP
Description:	General Photo
Distance (ft):	2.3
Structural Grade:	0
O&M Grade:	0
Clock Start/From:	
Clock To:	
1st Value:	
2nd Value:	
Value Percent:	
Step:	NO
Remarks:

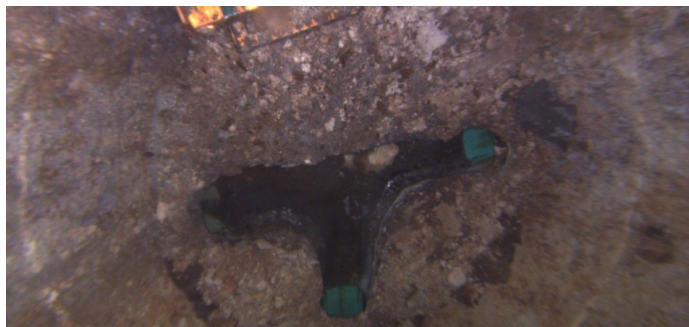
Code:	DAZ
Description:	Deposits Attached Other
Distance (ft):	5.2
Structural Grade:	0
O&M Grade:	3
Clock Start/From:	12
Clock To:	12
1st Value:	
2nd Value:	
Value Percent:	20.000
Step:	NO
Remarks:	Mixed materials

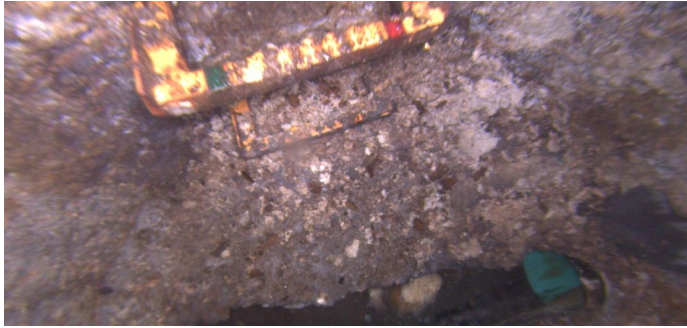
Code:	DAZ
Description:	Deposits Attached Other
Distance (ft):	5.7
Structural Grade:	0
O&M Grade:	2
Clock Start/From:	12
Clock To:	12
1st Value:	
2nd Value:	
Value Percent:	10.000
Step:	NO
Remarks:	Mixed materials

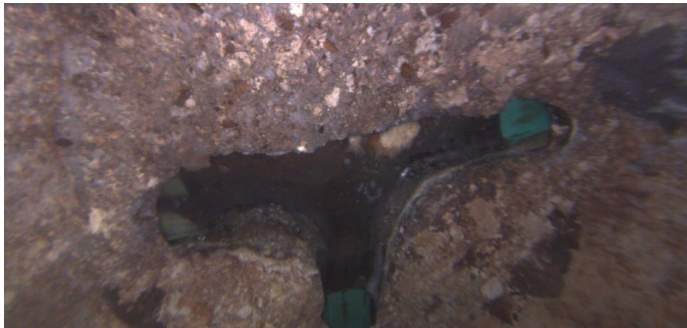
Code:	MGO
Description:	General Observation
Distance (ft):	6.1
Structural Grade:	0
O&M Grade:	0
Clock Start/From:	
Clock To:	
1st Value:	
2nd Value:	
Value Percent:	
Step:	NO
Remarks:	Ins. Comp.
