Manhole Inspection Report

Date:	04/13/2018	Weather:		Coding:	RZMACP
MH#:	M-403-002	Owner:	NA	Len. Surveyed:	7.0
P.O.#:		Surveyor:	Jen Costello	Rim to Invert:	8.4
Customer:		Cert. #:	U-907-5518	Wall Material:	Concrete (reinforced)

Street:	Intersection of 38th Ave. and Gill St.	Project:	Hobart, IN
City:	Hobart, IN	GPS Northing:	0.0
Location:		GPS Easting:	0.0
Drain Area:	Northwest	GPS Accuracy:	Nearest Meter
Cover Shape:	Circular	Evidence of Surcharge:	No
Cover Size:	23.0	Potential for Runoff:	None
Comments:

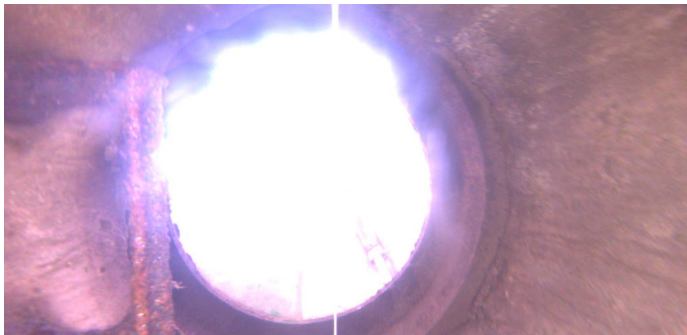
Code: **MGO**
Description: **General Observation**

Distance (ft): **2.2**
Structural Grade: **0**
O&M Grade: **0**
Clock Start/From:
Clock To:
1st Value:
2nd Value:
Value Percent:
Step: **NO**
Remarks: **UNDERSIDE OF FRAME**

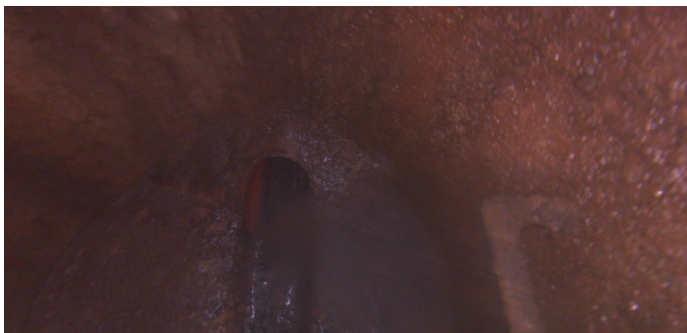
Code: **SAV**
Description: **Surface Aggregate Visible**

Distance (ft): **4.9**
Structural Grade: **3**
O&M Grade: **0**
Clock Start/From: **12**
Clock To: **12**
1st Value:
2nd Value:
Value Percent:
Step: **NO**
Remarks:

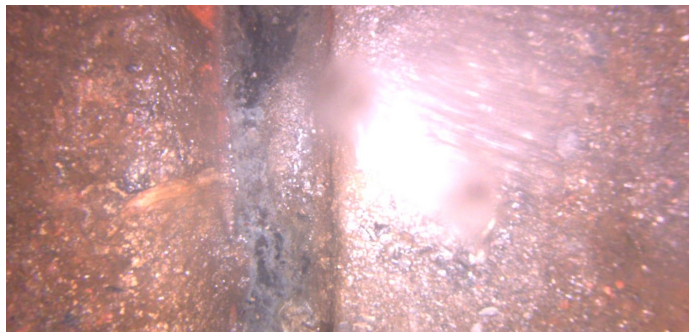
Code: **MGO**
Description: **General Observation**

Distance (ft): **7.0**
Structural Grade: **0**
O&M Grade: **0**
Clock Start/From:
Clock To:
1st Value:
2nd Value:
Value Percent:
Step: **NO**
Remarks: **END SURVEY**
