Manhole Inspection Report

Date:	04/13/2018	Weather:		Coding:	RZMACP
MH#:	M-403-003	Owner:	NA	Len. Surveyed:	7.4
P.O.#:		Surveyor:	Jen Costello	Rim to Invert:	8.7
Customer:		Cert. #:	U-907-5518	Wall Material:	Concrete (reinforced)

Street:	Gill St. 244' North of 38th Ave.	Project:	Hobart, IN
City:	Hobart, IN	GPS Northing:	0.0
Location:		GPS Easting:	0.0
Drain Area:	Northwest	GPS Accuracy:	Nearest Meter
Cover Shape:	Circular	Evidence of Surcharge:	No
Cover Size:	23.0	Potential for Runoff:	None
Comments:

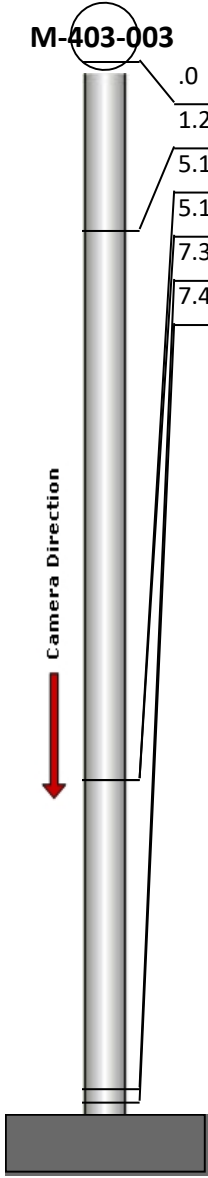
.0	MGO	General Observation	10	NA
	1.2	MGO	General Observation	25	NA
	5.1	IW	Infil Weeper	46	M 2
	5.1	IW	Infil Weeper	58	M 2
	7.3	DSF	Deposits Settled Fine	74	M 2
	7.4	MGO	General Observation	86	NA

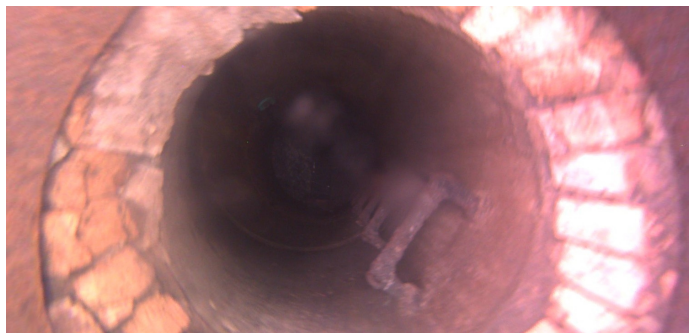
Code: **MGO**
Description: **General Observation**

Distance (ft): **.0**
Structural Grade: **0**
O&M Grade: **0**
Clock Start/From:
Clock To:
1st Value:
2nd Value:
Value Percent:
Step: **NO**
Remarks: **access MH**

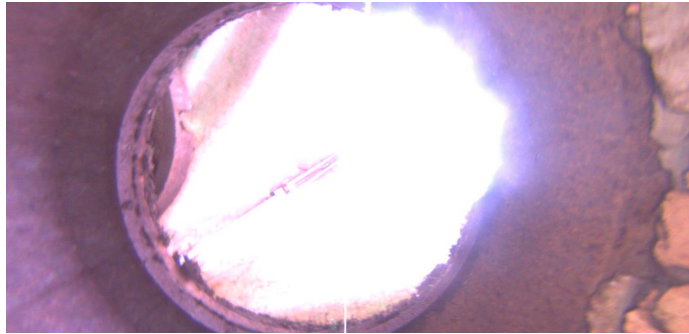
Code:	MGO
Description:	General Observation
Distance (ft):	1.2
Structural Grade:	0
O&M Grade:	0
Clock Start/From:	
Clock To:	
1st Value:	
2nd Value:	
Value Percent:	
Step:	NO
Remarks:	UNDERSIDE OF FRAME

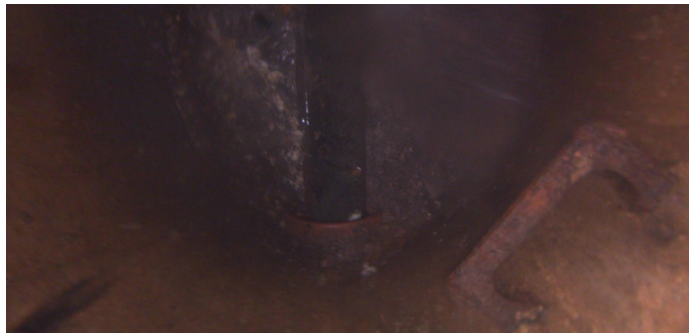
Code:	IW
Description:	Infil Weeper
Distance (ft):	5.1
Structural Grade:	0
O&M Grade:	2
Clock Start/From:	7
Clock To:	
1st Value:	
2nd Value:	
Value Percent:	
Step:	NO
Remarks:

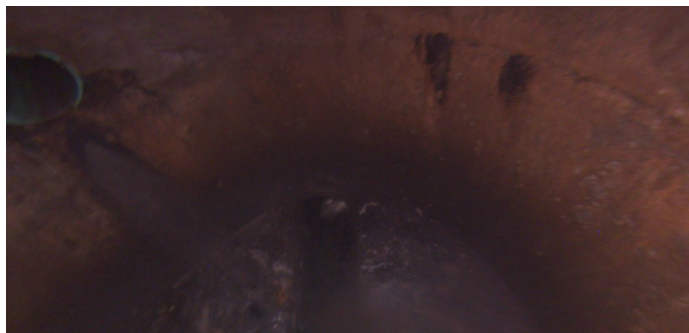
Code:	IW
Description:	Infil Weeper
Distance (ft):	5.1
Structural Grade:	0
O&M Grade:	2
Clock Start/From:	12
Clock To:	1
1st Value:	
2nd Value:	
Value Percent:	
Step:	NO
Remarks:

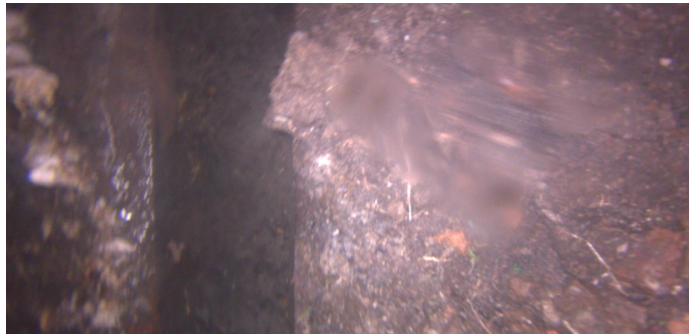
Code: **DSF**
Description: **Deposits Settled Fine**

Distance (ft): **7.3**
Structural Grade: **0**
O&M Grade: **2**
Clock Start/From: **12**
Clock To: **12**
1st Value:
2nd Value:
Value Percent: **5.000**
Step: **NO**
Remarks:

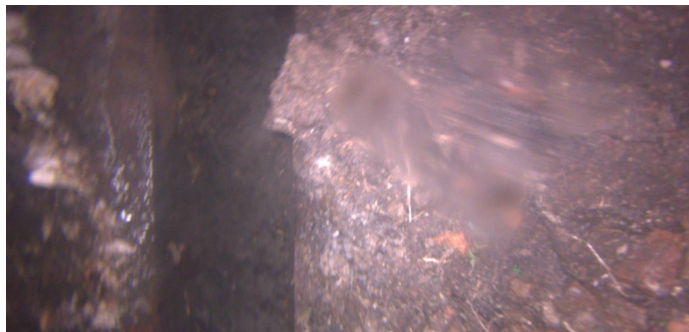
Code: **MGO**
Description: **General Observation**

Distance (ft): **7.4**
Structural Grade: **0**
O&M Grade: **0**
Clock Start/From:
Clock To:
1st Value:
2nd Value:
Value Percent:
Step: **NO**
Remarks: **END SURVEY**
