Manhole Inspection Report

Date:	04/13/2018	Weather:		Coding:	RZMACP
MH#:	M-403-005	Owner:	NA	Len. Surveyed:	6.3
P.O.#:		Surveyor:	Jen Costello	Rim to Invert:	7.8
Customer:		Cert. #:	U-907-5518	Wall Material:	Concrete (reinforced)

Street:	Kreft St. and Route 6. to the South.	Project:	Hobart, IN
City:	Hobart, IN	GPS Northing:	0.0
Location:		GPS Easting:	0.0
Drain Area:	Northwest	GPS Accuracy:	Nearest Meter
Cover Shape:	Circular	Evidence of Surcharge:	No
Cover Size:	23.0	Potential for Runoff:	None
Comments:

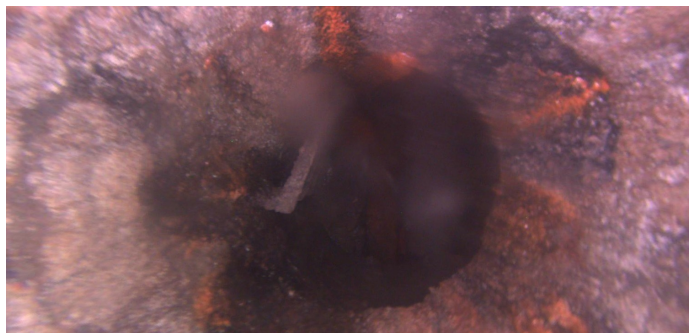
Code: **MGO**
Description: **General Observation**

Distance (ft): **.0**
Structural Grade: **0**
O&M Grade: **0**
Clock Start/From:
Clock To:
1st Value:
2nd Value:
Value Percent:
Step: **NO**
Remarks: **ACCESS MH**

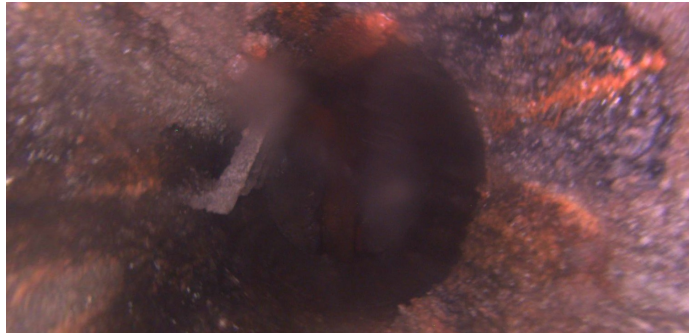
Code: **IW**
Description: **Infil Weeper**

Distance (ft): **.6**
Structural Grade: **0**
O&M Grade: **2**
Clock Start/From: **12**
Clock To: **12**
1st Value:
2nd Value:
Value Percent:
Step: **NO**
Remarks:

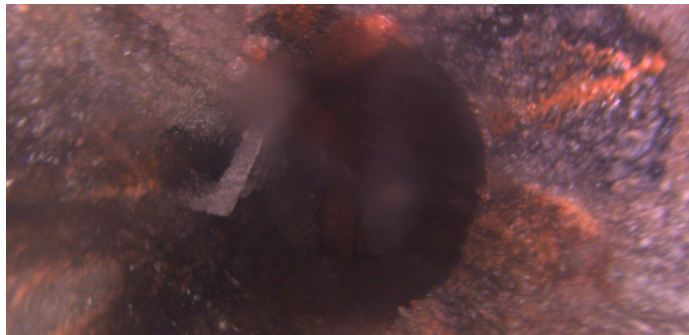
Code: **DAE**
Description: **Deposits Attached Encrustation**

Distance (ft): **.6**
Structural Grade: **0**
O&M Grade: **2**
Clock Start/From: **12**
Clock To: **12**
1st Value:
2nd Value:
Value Percent: **5.000**
Step: **NO**
Remarks:

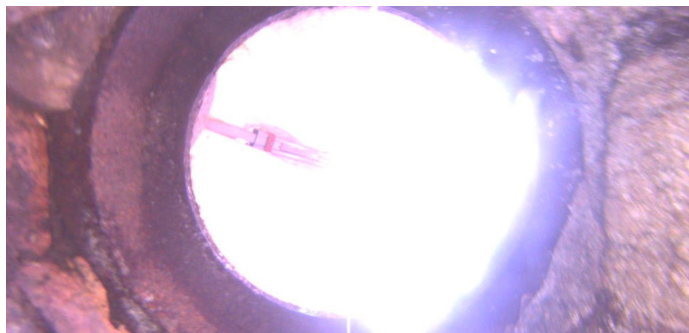
Code: **MGP**
Description: **General Photo**

Distance (ft): **1.8**
Structural Grade: **0**
O&M Grade: **0**
Clock Start/From:
Clock To:
1st Value:
2nd Value:
Value Percent:
Step: **NO**
Remarks: **UNDERSIDE OF FRAME**

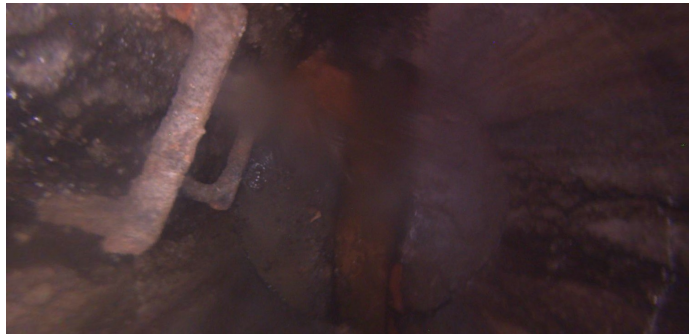
Code: **IW**
Description: **Infil Weeper**

Distance (ft): **3.3**
Structural Grade: **0**
O&M Grade: **2**
Clock Start/From: **12**
Clock To: **12**
1st Value:
2nd Value:
Value Percent:
Step: **NO**
Remarks:

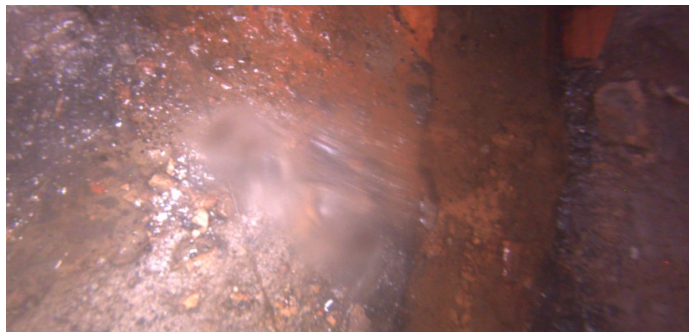
Code: **MGO**
Description: **General Observation**

Distance (ft): **6.3**
Structural Grade: **0**
O&M Grade: **0**
Clock Start/From:
Clock To:
1st Value:
2nd Value:
Value Percent:
Step: **NO**
Remarks: **END SURVEY**
